# Hewitts Creek Catchment REVIEW OF FLOOD STUDY

**Appendix B-2      Comparison of Observed and Modelled Flood Extents and Mechanisms  
for the August 1998 Flood Event**

**Appendix B.1      Longitudinal Profiles of Peak Flood Levels for the August 1998 Event**

**Appendix C-1 Design Peak Flood Level Longitudinal Profiles**

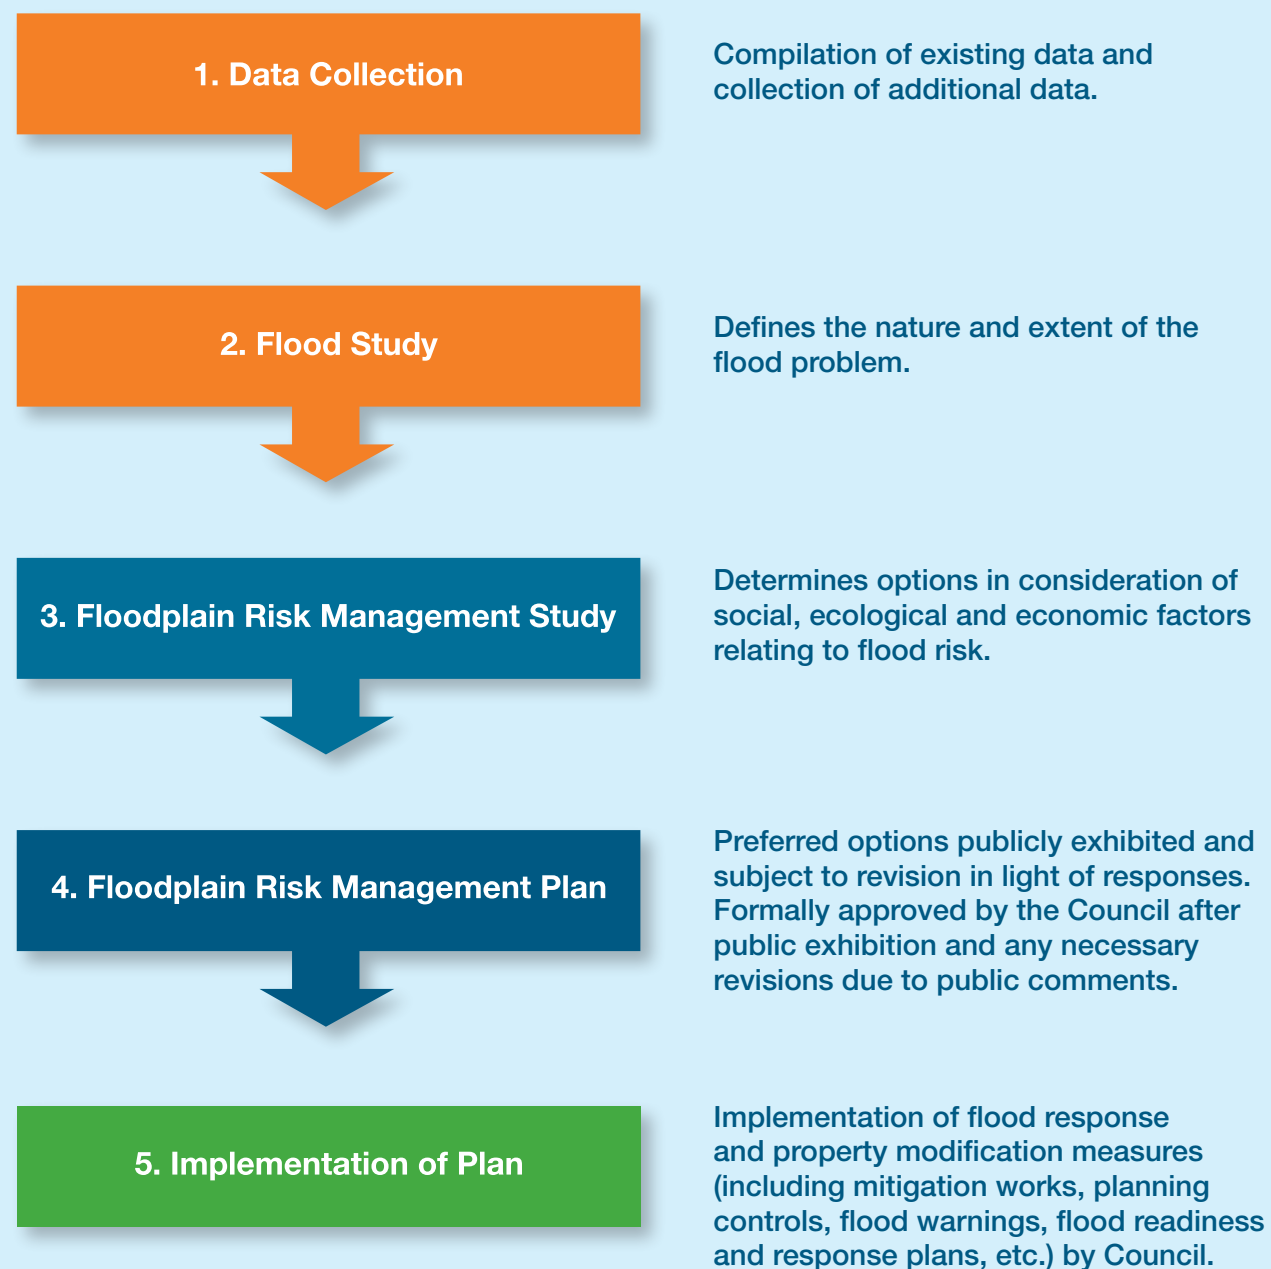
The orange elements in the flow chart detail the steps being carried out as part of this review of the Hewitts Creek Flood Study.

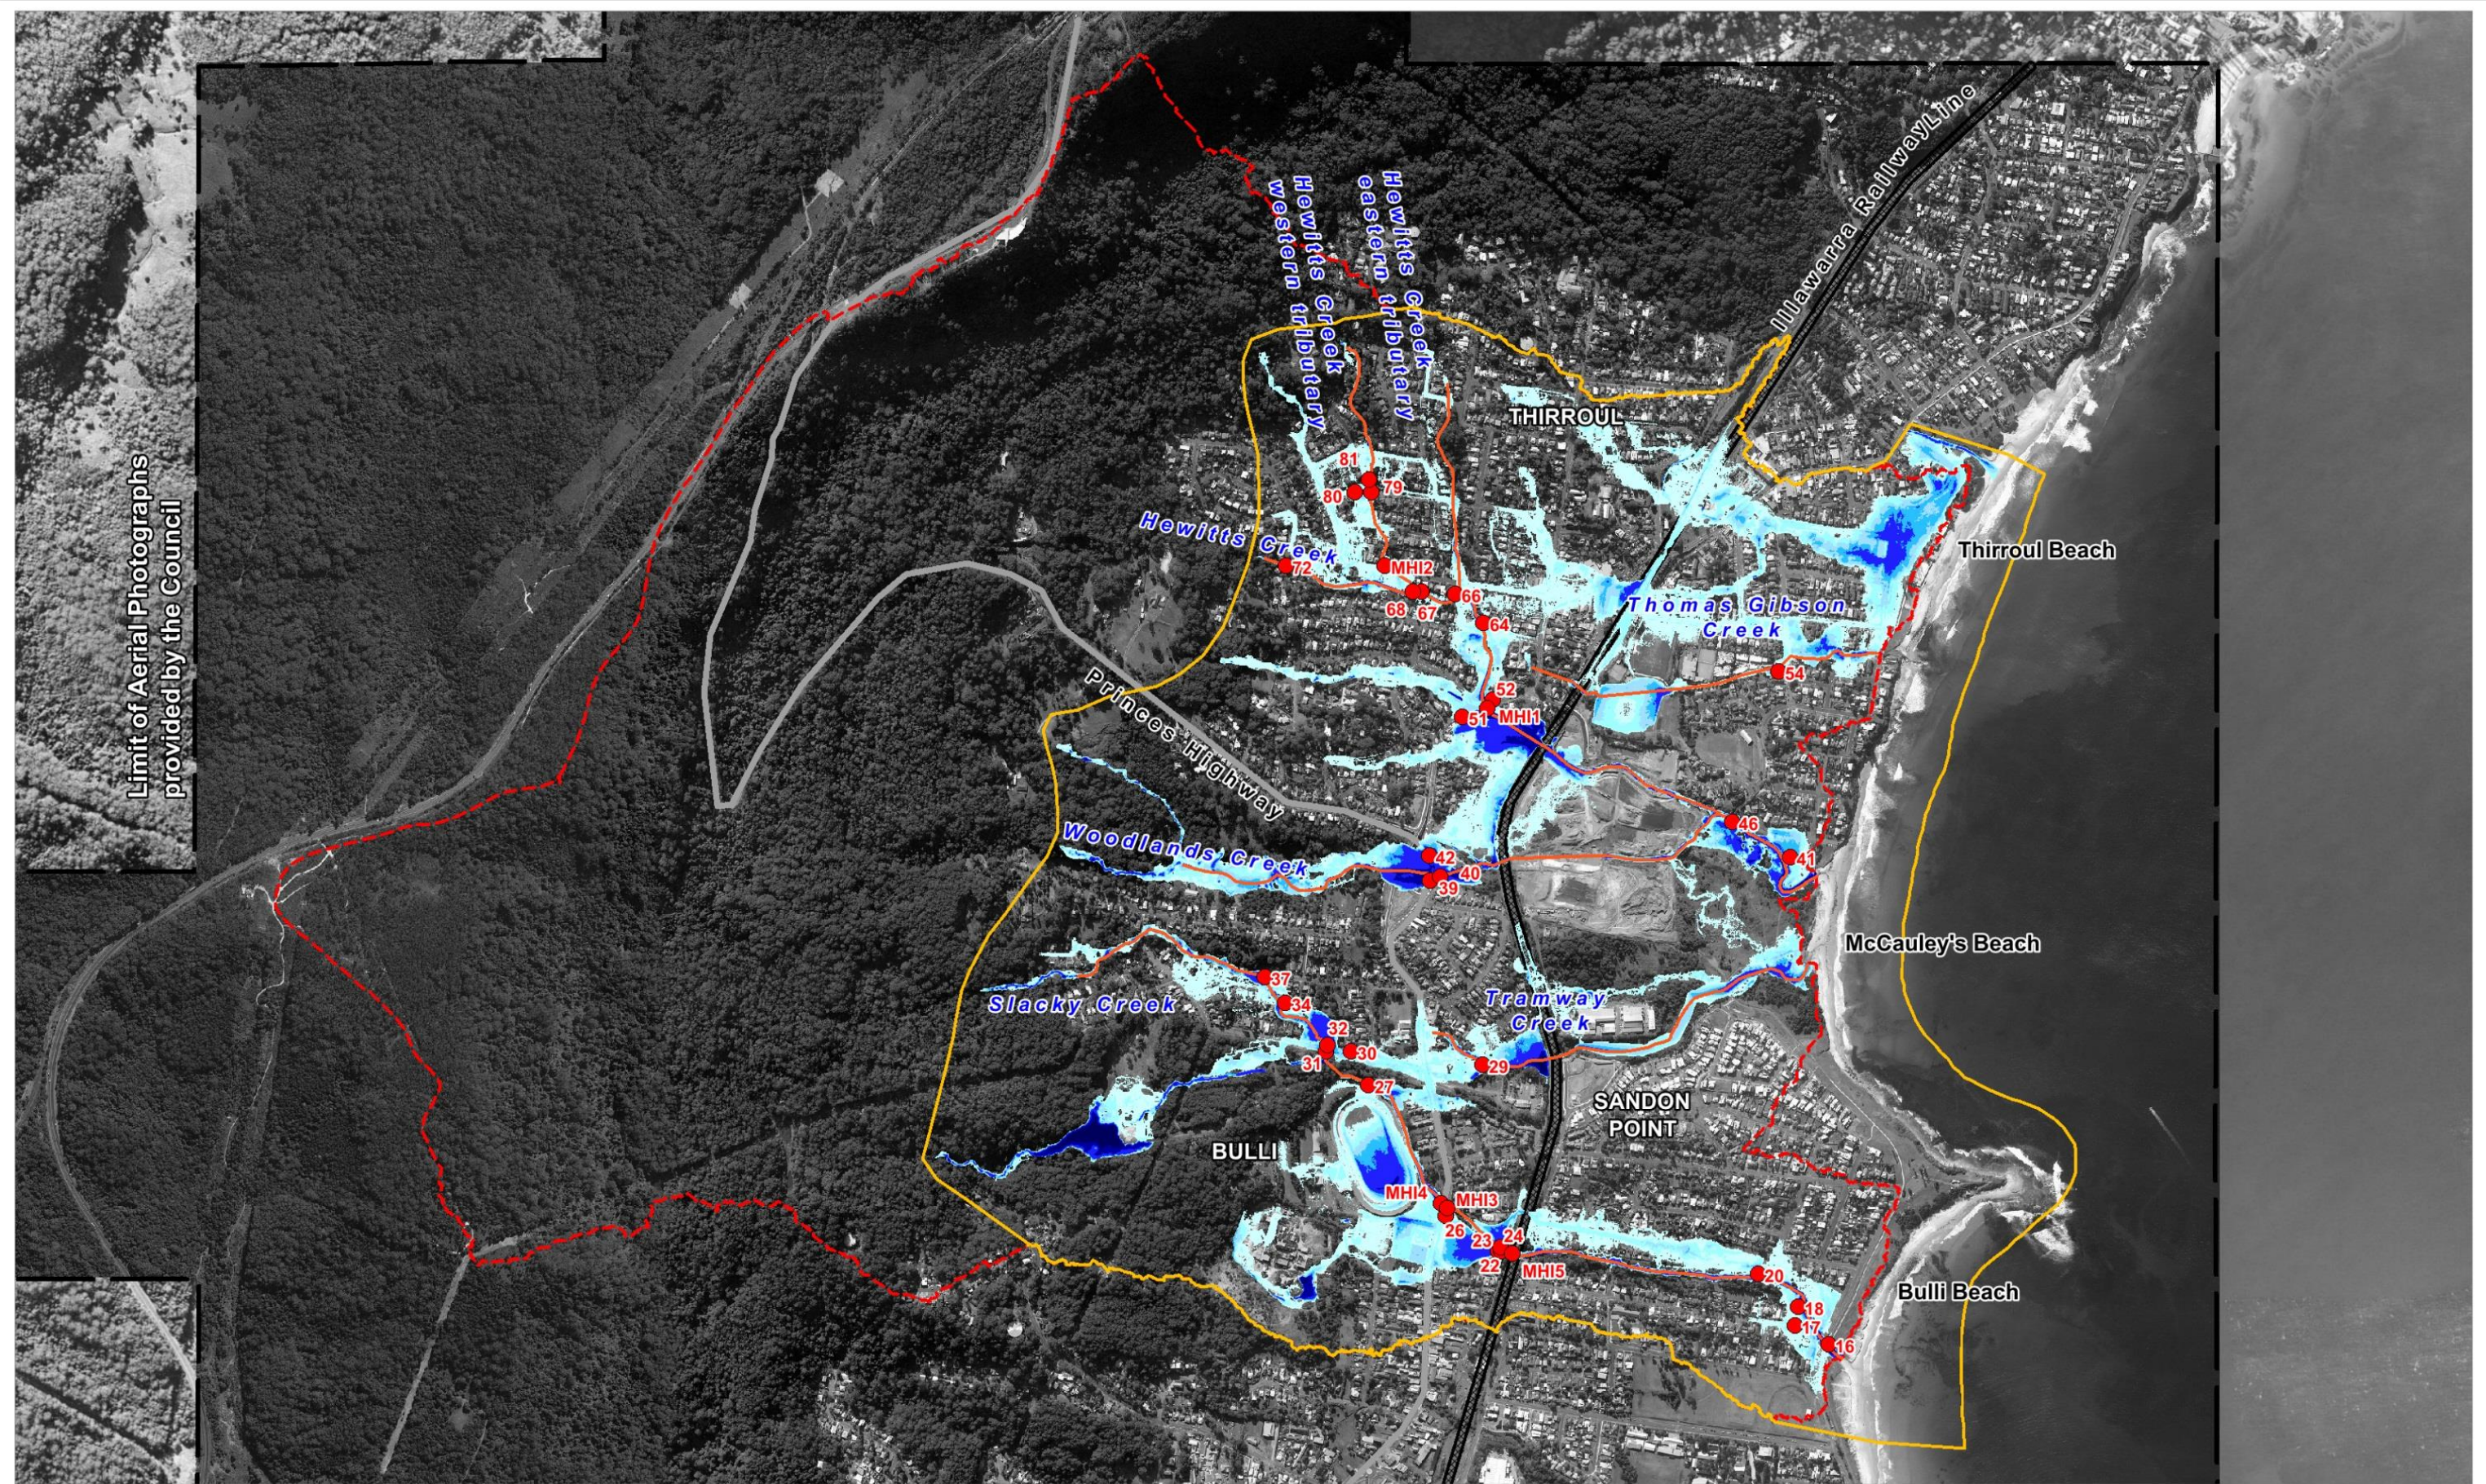
Limit of Aerial Photographs  
provided by the Council

Figure B-2 to Figure B-7 show longitudinal profiles of observed flood levels and simulated peak flood levels for the August 1998 flood event for the TUFLOW model developed as part of the current study. Observed flood levels are presented on the graphs where flood marks have been recorded either directly along the creeks (i.e. at structures) or adjacent to (i.e. creek banks) the modelled creeks. The ID for the observed flood levels presented in Figure B-2 to Figure B-7 corresponds with the observed flood mark ID in Figures 7-5.1 to Figure 7-5.10 and Figure B-1.
