LAKE ILLAWARRA

HYDROGRAPHIC SURVEY REPORT

Wollongong City Council

HCS Job Ref: HCS539
Survey Date Start: 29 Aug 22
Survey Date End: 02 Jun 23
Report Date: 18 Nov 23

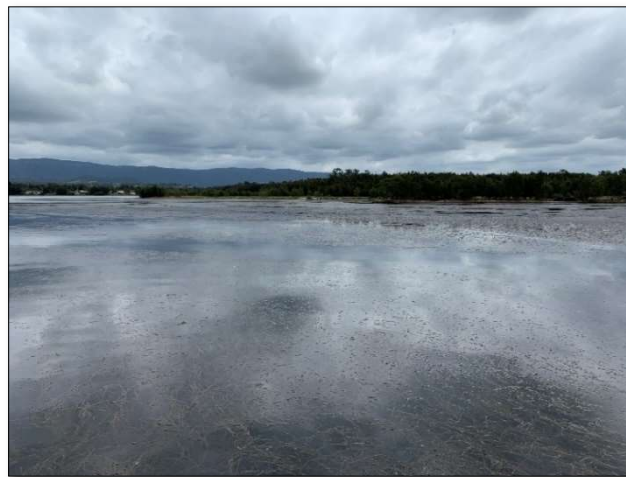
Another constraint observed related to seagrass was during processing the data from sounding systems, more evident on the shallow areas and edges of the lake. The existence of underwater vegetation, the variation of its heights during periods of high and low tides, as well as a possible seasonal variation increases the difficulty in determining the real bottom of the lake in those sections.

Figure 9: Seagrass coverage at Hooka Bay

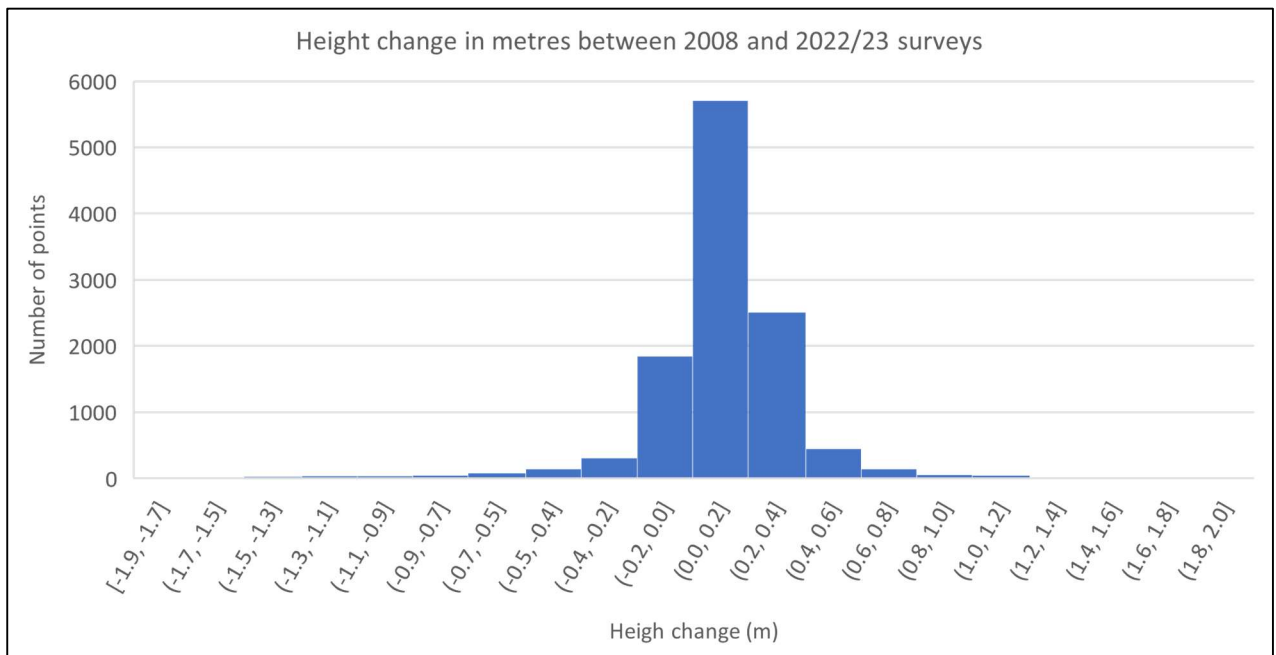
Figure 11: Height change distribution comparing 2008 – 2022/2023 surveys.

The amount of sedimentation or erosion is generally small (Figure 11), and realistically, a high proportion of the analysed variation in sediment is generated by the combined uncertainty values of the measurement equipment, survey methods and environmental influences during the survey, rather than sediment transportation itself.

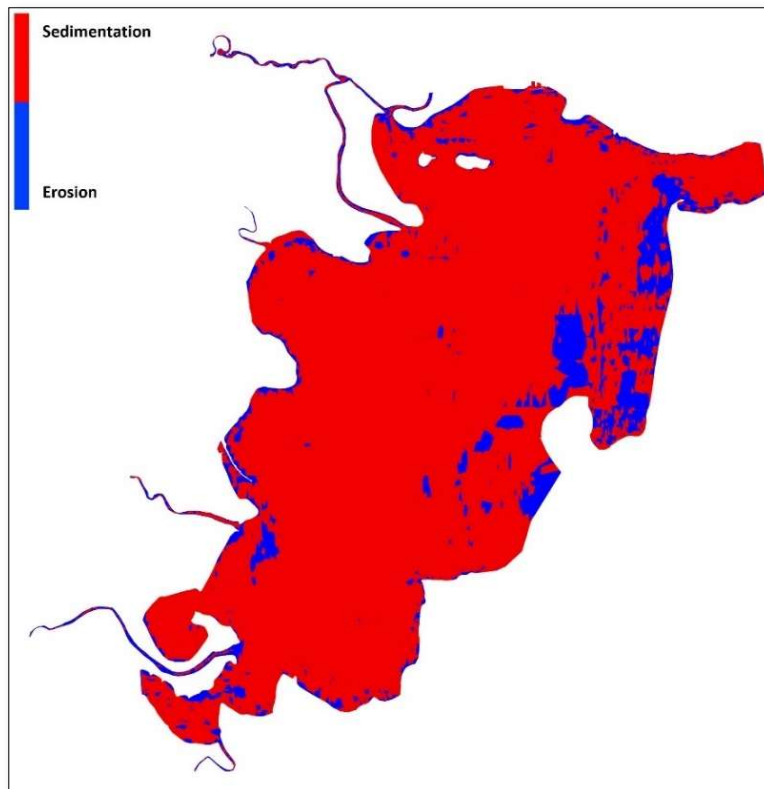
Figure 13: High/Low difference between 2008 – 2022/2023 showing areas where sedimentation or erosion may have occurred.

Sedimentation was observed adjacent to Macquarie Rivulet and Mullet Creek deltas, in the area of influence of the lake entrance channel, along the shelf extending from the lake entrance towards North and within Primbee Bay/Jones Bay.

Erosion was noticed in some areas of the central part of the lake however not significantly. Similar process was observed on banks in the lake and tributaries (Albion and Brooks).

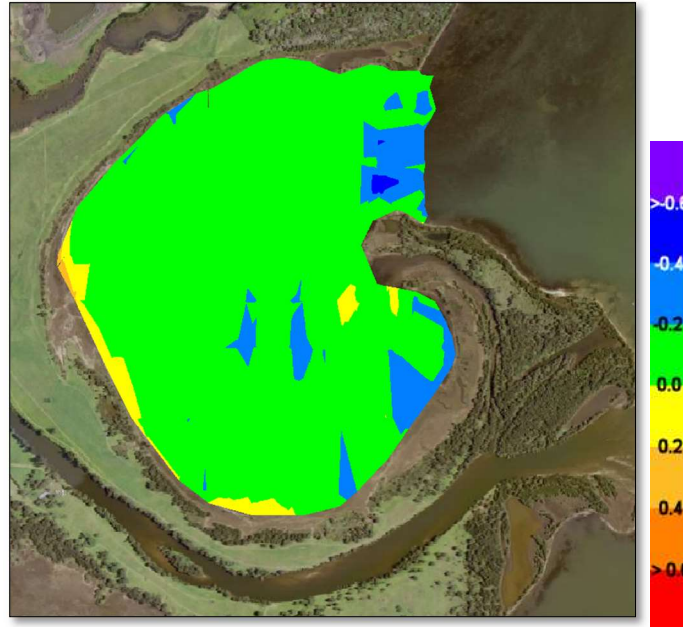
- Deepening of approximately 0.12m on average.
- Noticeable shoaling area at the western side of the bay in the order 0.2m, where dense patches of seagrass were found.

Figure 17: Lake 3 difference plot between 2008 and 2022/2023 surveys – Negative values = possible erosion/deepening (data within Plan 539-1 Sheet 4).

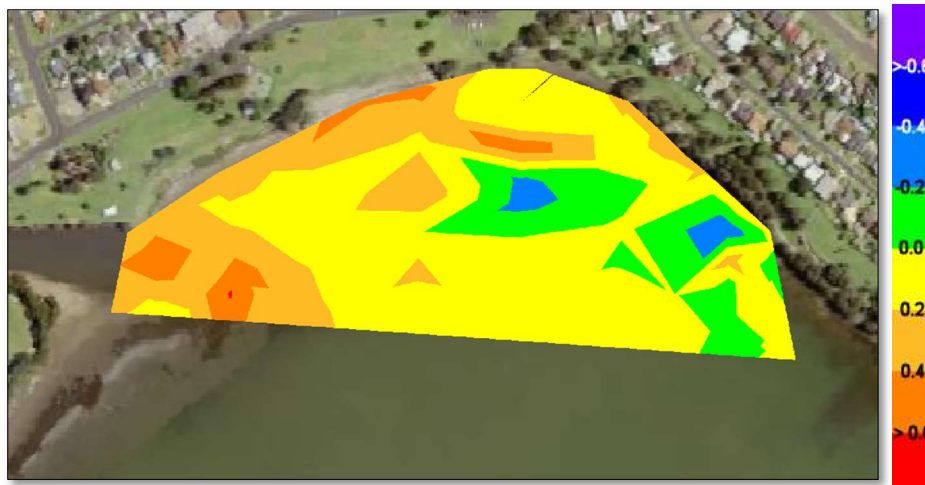
- Sedimentation trend ranging from 0.2-0.5m adjacent to Brooks Creek inlet and existing jetty in the middle of bay.
- Erosion (deeper area) observed at an area east of existing jetty.

Figure 18: Lake 4 difference plot between 2008 and 2022/2023 surveys – Negative values = possible erosion/deepening (data within Plan 539-1 Sheet 2).

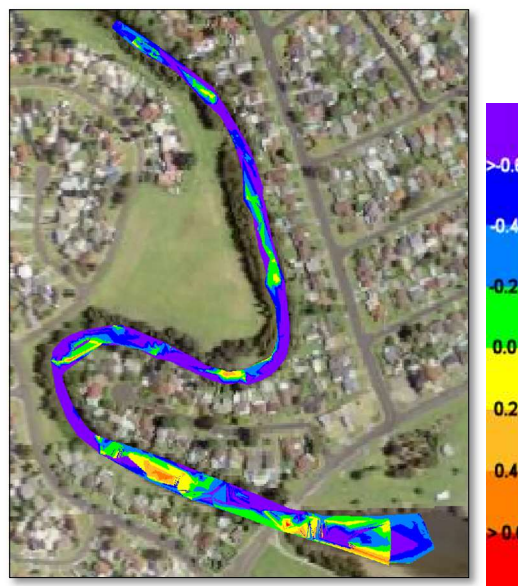
- Shoaling was observed in the bottom half and mouth of the creek reaching approximately 1m in elevation change in areas.
- Two thirds of the creek shows deepening of up to 0.6m with isolated areas deeper than this. The lows and highs undulate throughout the creek.

Figure 21: Brooks Creek difference plot between 2008 and 2022/2023 surveys – Negative values = possible erosion/deepening (data within Plan 539-1 Sheet 2).

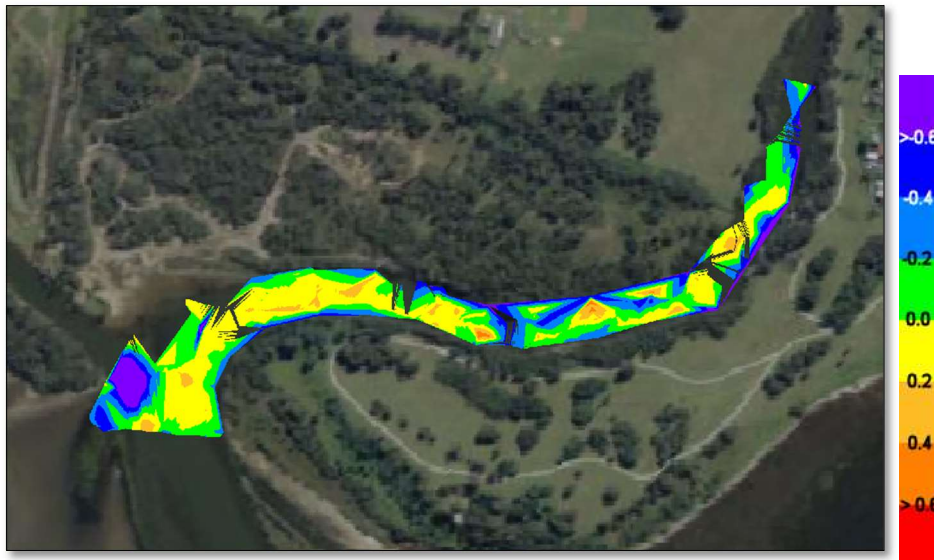
- Shoaling of up to 0.60m observed in the middle of the channel
- Potential erosion on banks along the creek, most notably adjacent to Mullet Creek Tank Trap

Figure 23: Hooka Creek difference plot between 2008 and 2022/2023 surveys – Negative values = possible erosion/deepening (data within Plan 539-1 Sheet 2).

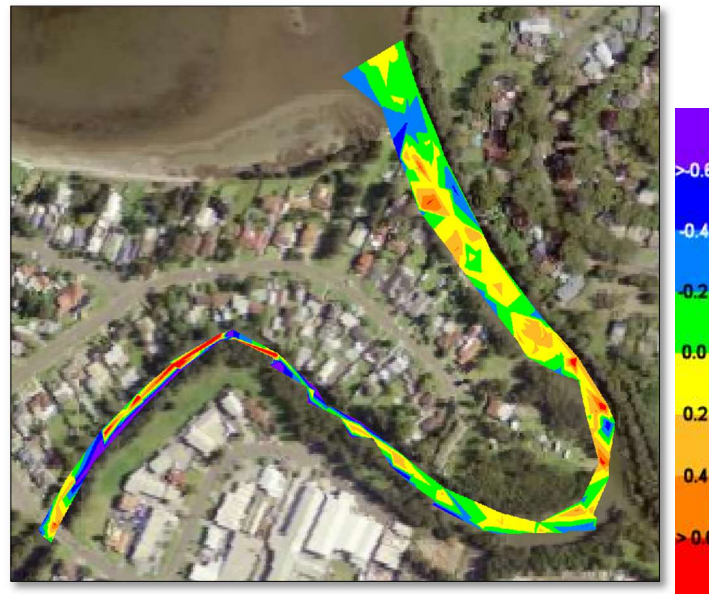
- Shoaling observed along central section of the creek
- Potential erosion on banks within the top half of the creek

Figure 24: Horsley Creek difference plot between 2008 and 2022/2023 surveys – Negative values = possible erosion/deepening (data within Plan 539-1 Sheet 5).

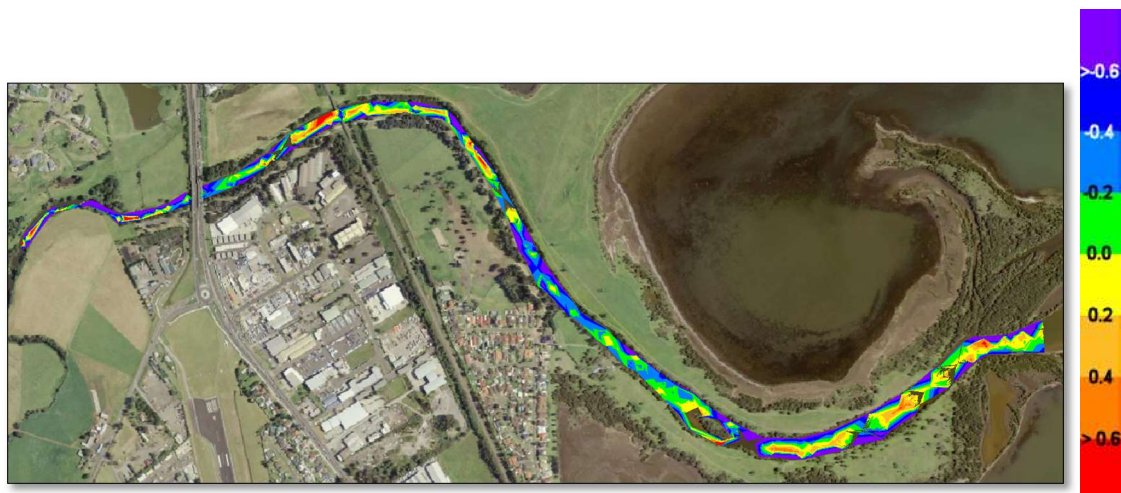
- Shoaling trend observed within the channel at distinct locations as seen in Figure 25.
- Potential erosion on banks exceeding 1.5m in some areas adjacent to outside bends.

Figure 25: Macquarie Rivulet difference plot between 2008 and 2022/2023 surveys – Negative values = possible erosion/deepening (data within Plan 539-1 Sheet 5).

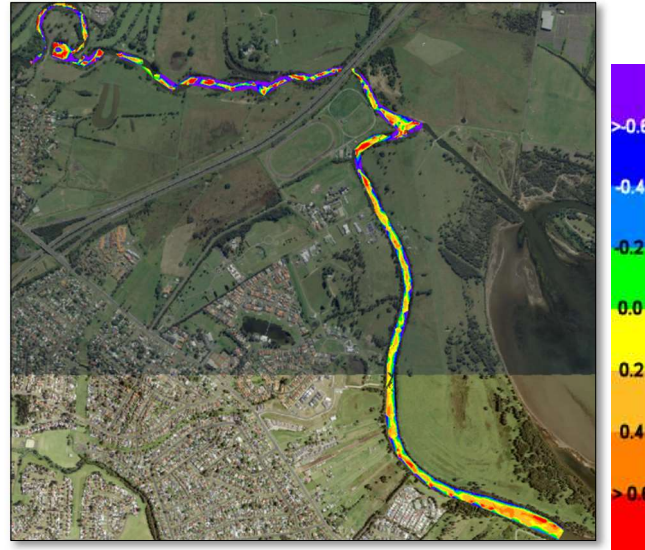
- Most noticeable shoaling observed from the junction of Mullet Creek Tank Trap along the centre of the creek to its interface with the main lake.
- Potential erosion on banks adjacent to outside bends.

Figure 26: Mullet Creek difference plot between 2008 and 2022/2023 surveys – Negative values = possible erosion/deepening (data within Plan 539-1 Sheet 2).

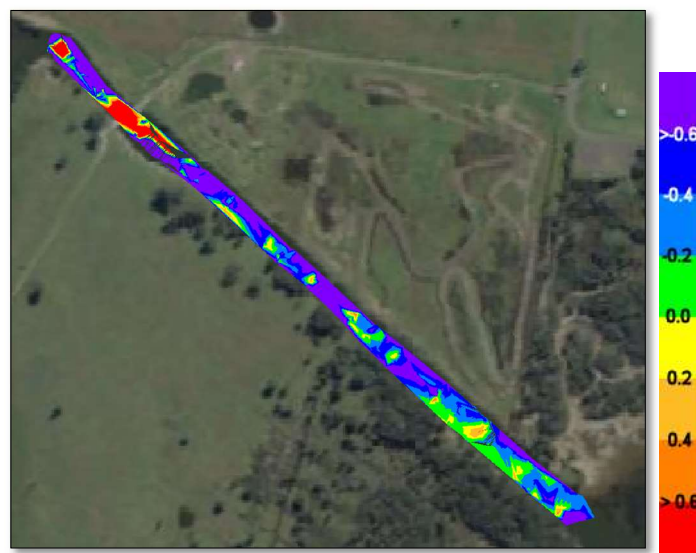
- Shoaling observed adjacent to the junction with Mullet Creek and near a bridge downstream.
- Potential erosion on banks along the creek from a bridge at the top section towards Hooka Creek and Lake Illawarra.

Figure 27: Mullet Creek Tank Trap difference plot between 2008 and 2022/2023 surveys – Negative values = possible erosion/deepening (data within Plan 539-1 Sheet 2).
