Lake Illawarra Water Quality and Estuary Health Monitoring and Reporting

Summary Report

February 2020

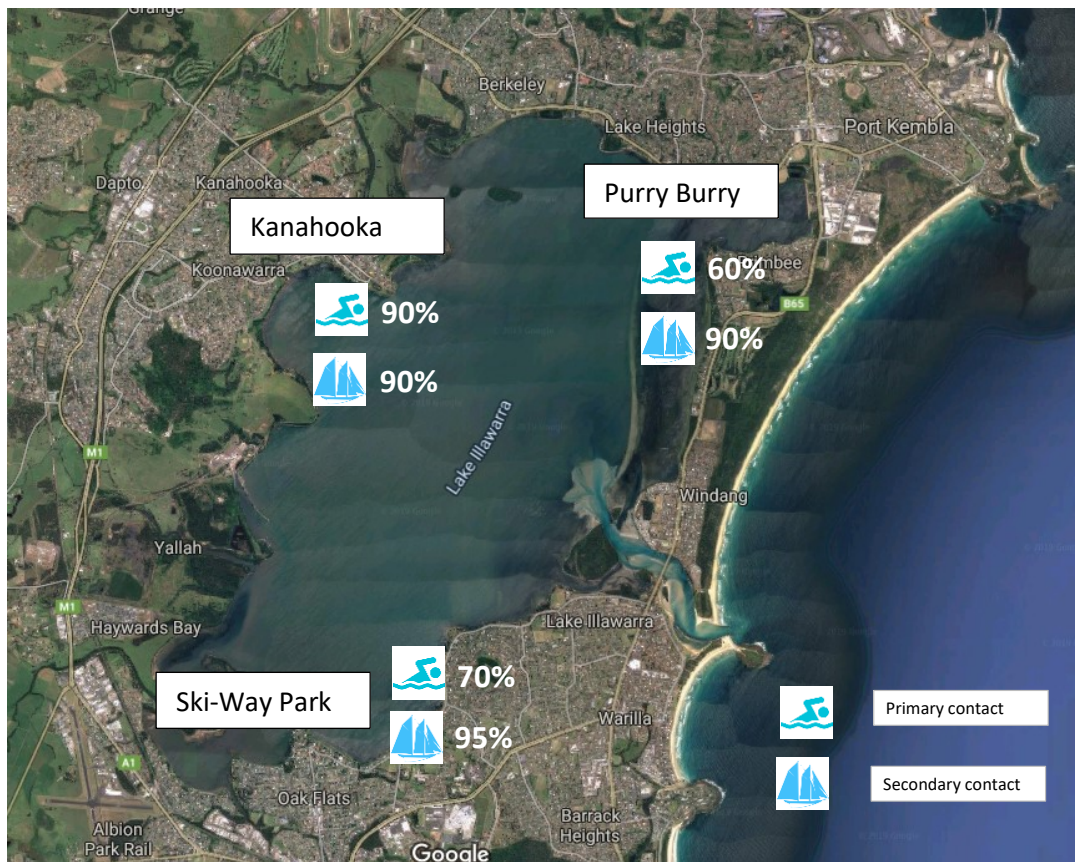
Figure 4-9 shows the percentage of the 21 test occasions meeting the recreational water guideline for primary (35 cfu/100 ml) and secondary (230 cfu/100 ml) contact. These results may look encouraging but need to be treated with caution as they may not be representative of the situation in these areas all the time. Rainfall is known to have a significant effect on water quality, and a plot of the results against rainfall shows that high levels of enterococci are clustered around rainfall events (Figure 4-10). Recent years have been unusually dry and

Figure 4-9 Percentage of the test occasions meeting primary (35 cfu/100 ml) and secondary (230 cfu/100 ml) contact recreational water quality guidelines
