WHYTES GULLY LANDFILL ANNUAL REPORT 2020/2021

Prepared for	Wollongong City Council
Project Name	Whytes Gully Annual Report 2020/2021
Date	10 August 2021
Version Number	2

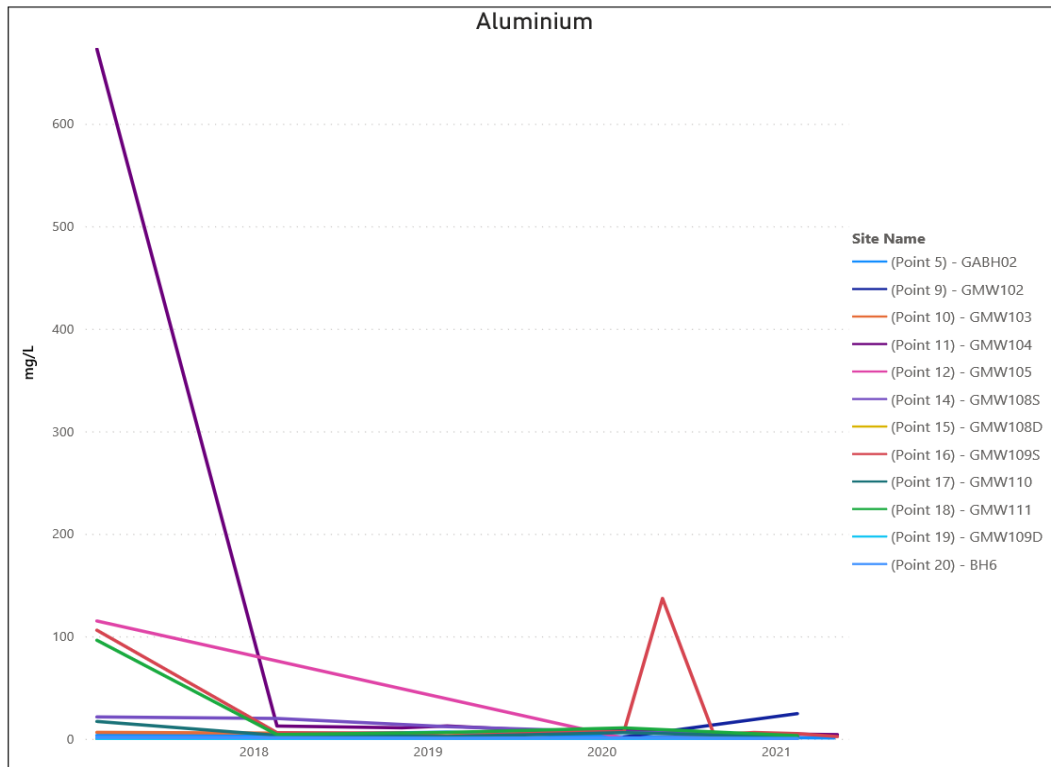
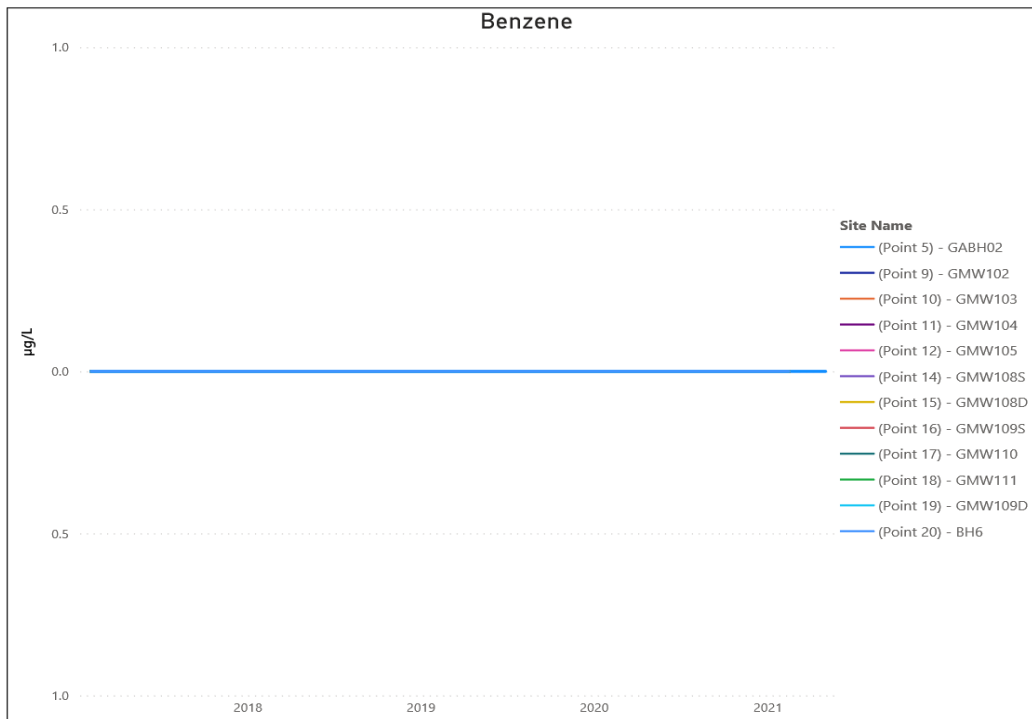
Groundwater Results

The trend graphs from the annual groundwater monitoring event shows that contaminant and parameter concentrations have remained steady and relatively consistent with the three years prior, with a general decline in contaminant concentrations. It is noted that several monitoring wells were dry during the annual monitoring event and therefore trend analysis was unable to be completed for the entire well network.
