WHYTES GULLY LANDFILL ANNUAL REPORT 2021/22

Wollongong City Council
Waste Services

Prepared for Wollongong City Council
Project Name Whytes Gully Annual Report
20221/22
Date 27 July 2022
Version Number 1

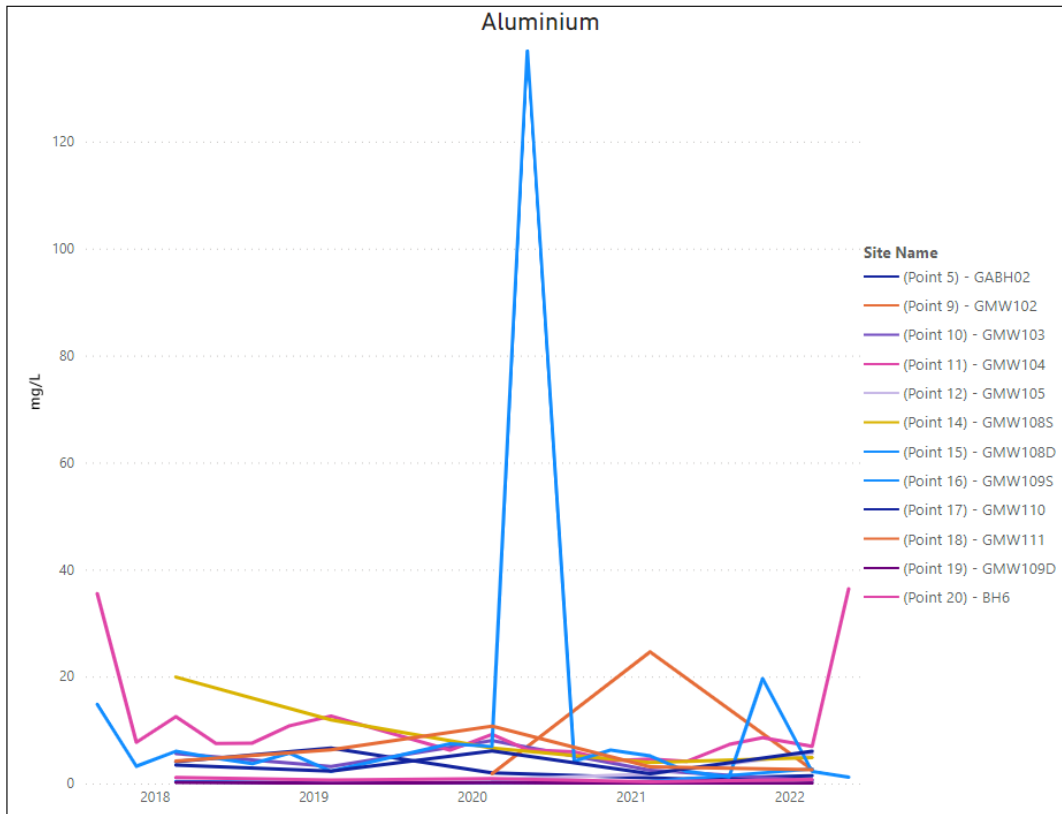
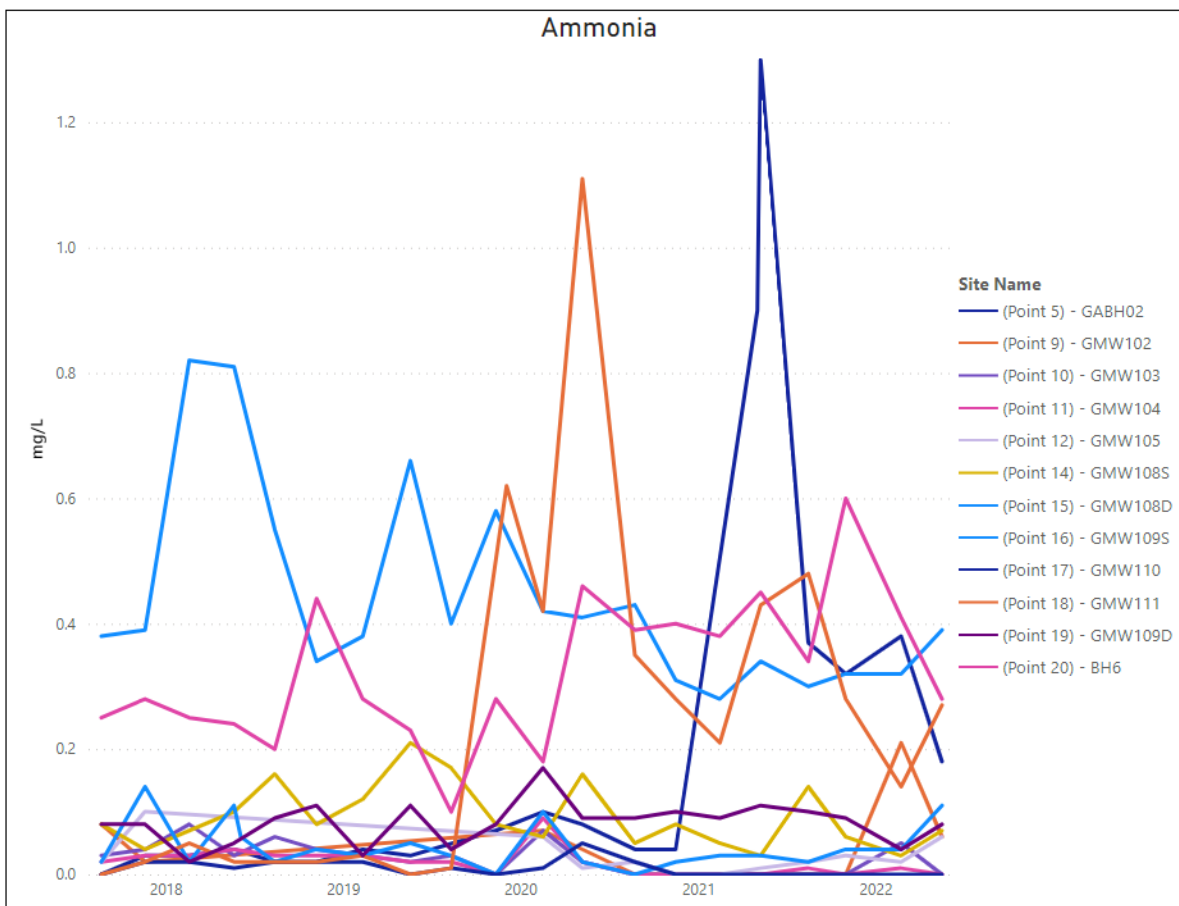
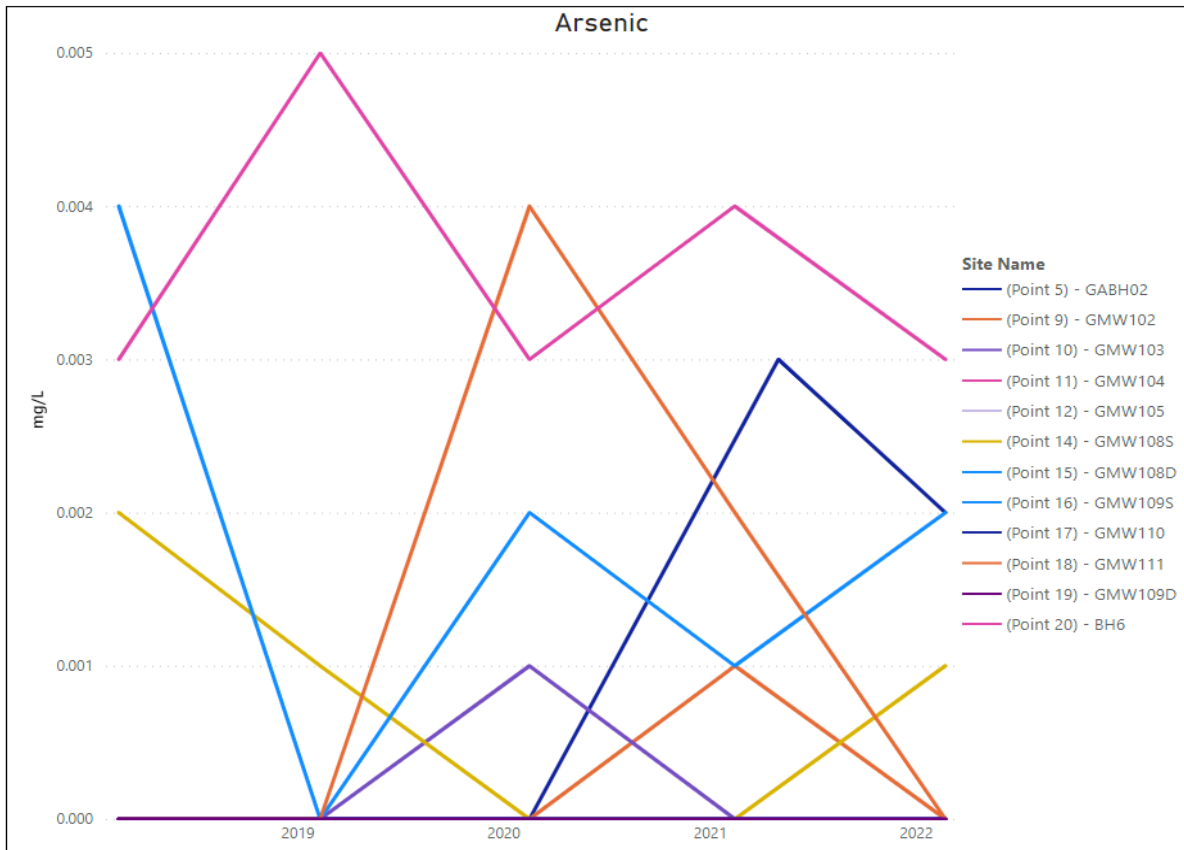
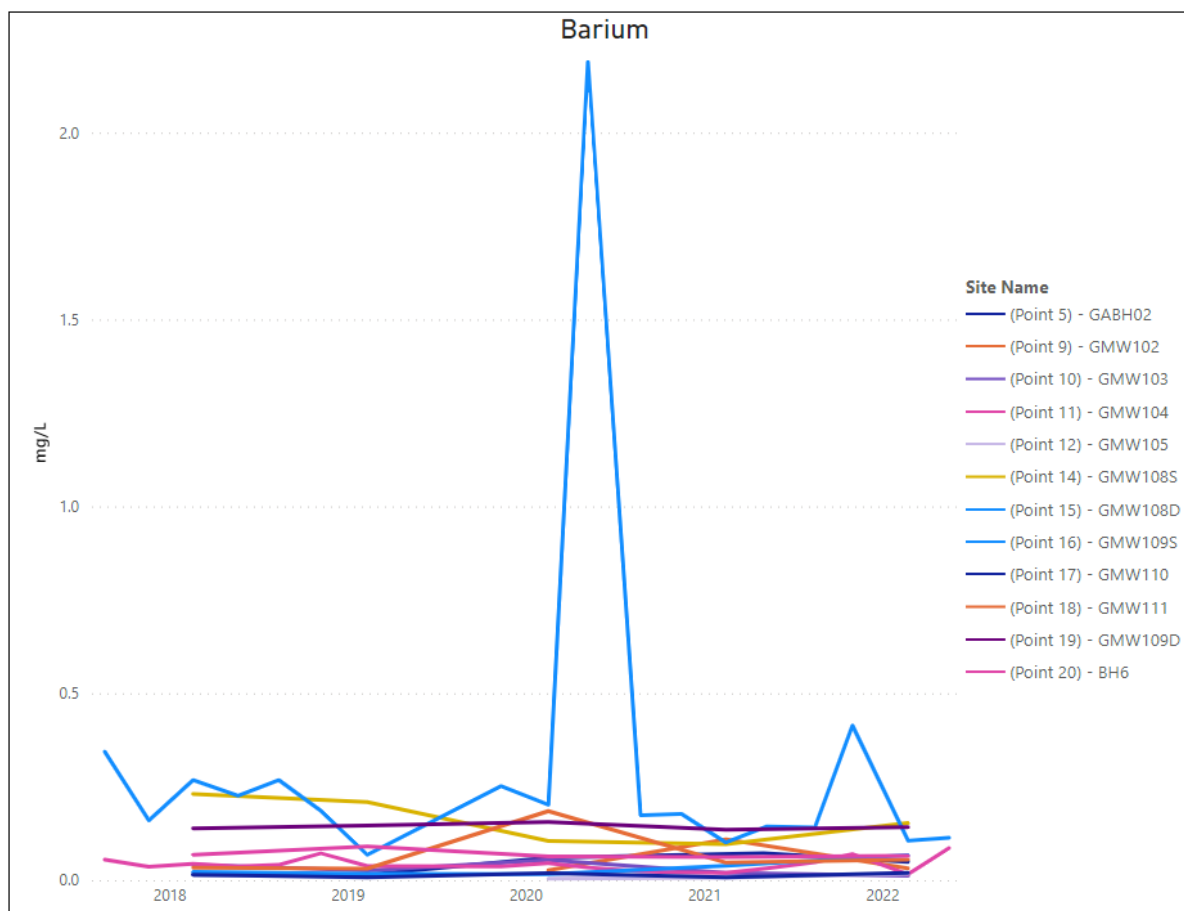
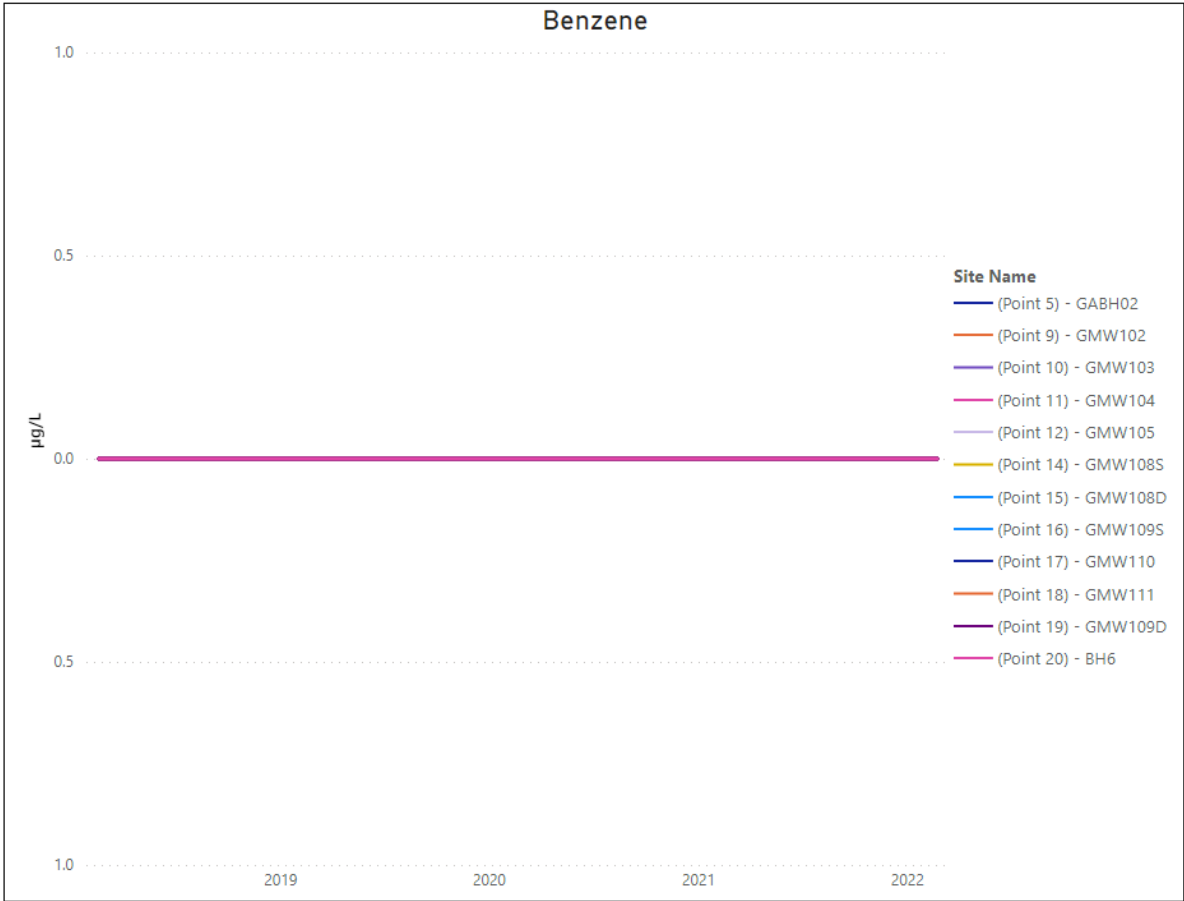
Ground Water Results 2021-2022

A series of graphs showing groundwater level trends are provided in Appendix C and discussed below. It can be seen that there has been significant movement in the levels of groundwater parameters including nitrate, ammonia, total organic carbon, pH and conductivity as water enters the groundwater system and soluble analytes are mobilised. It is hard to discern any trends until heavy rainfall stops and groundwater levels and flow stabilise under normal climatic conditions.

The trend graphs from the annual groundwater monitoring event shows that contaminant and parameter concentrations have remained steady and relatively consistent with the three years prior, with a general decline in contaminant concentrations. It is noted that several monitoring wells were dry during the annual monitoring event and therefore trend analysis was unable to be completed for the entire well network.
