## PUBLIC EXHIBITION - FLAGSTAFF HILL AND SMITHS HILL FORTS CONSERVATION MANAGEMENT PLAN

A draft Conservation Management Plan has been prepared for the Flagstaff Hill and Smith's Hill Fortifications. This report seeks Council's endorsement of the draft Conservation Management Plan for public exhibition to allow stakeholders and the community feedback.

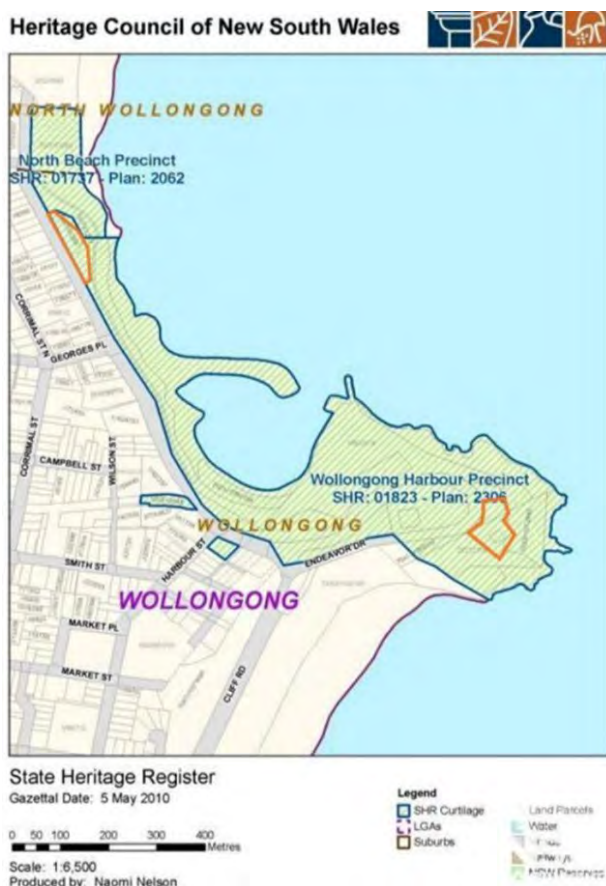
**Figure 1: Map showing the two CMP study areas overlaid on the Wollongong Harbour Precinct State Heritage Register Map.**

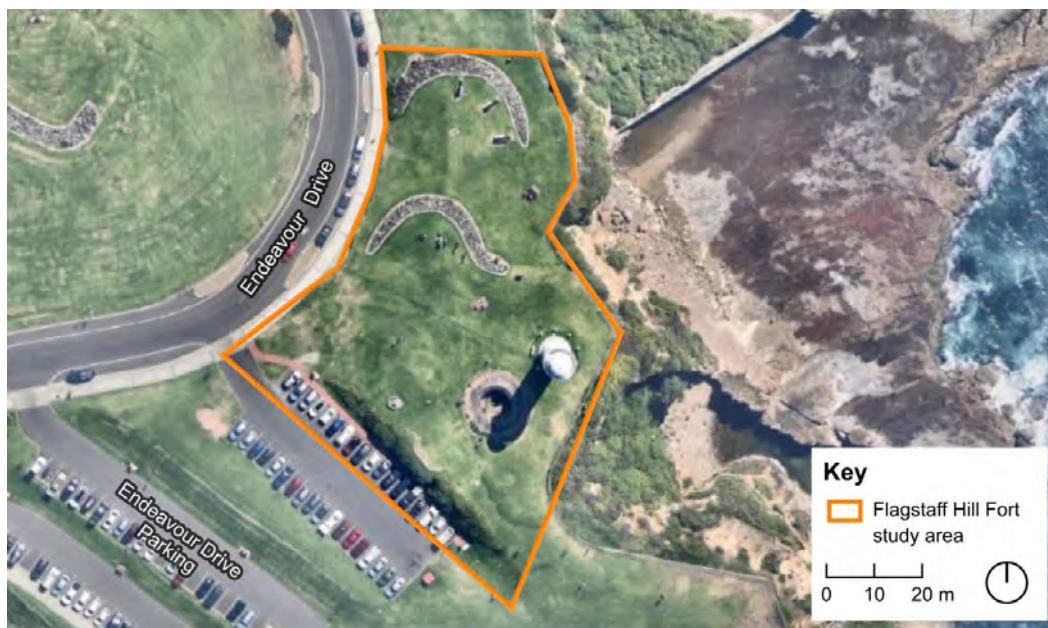
Figure 1.4 Approximate study area for the Flagstaff Hill Fort, outlined in orange (noting that the 1937 Wollongong Head Lighthouse is excluded from the study area for this CMP). (Source: © Nearmap 2024 with GML overlay)

The study area for the Flagstaff Hill Fort includes the physical extent of the fortifications (above and below ground), as well as three cannons. This study area also includes grassed areas and landscape elements associated with the Flagstaff Point Crown reserve, which is currently used as a public park.

This approximate extent of the study area is shown outlined in orange in Figure 1.5. Although the 1937 Wollongong Head Lighthouse is located within the boundaries of the study area, it is excluded from further investigation as part of this CMP.

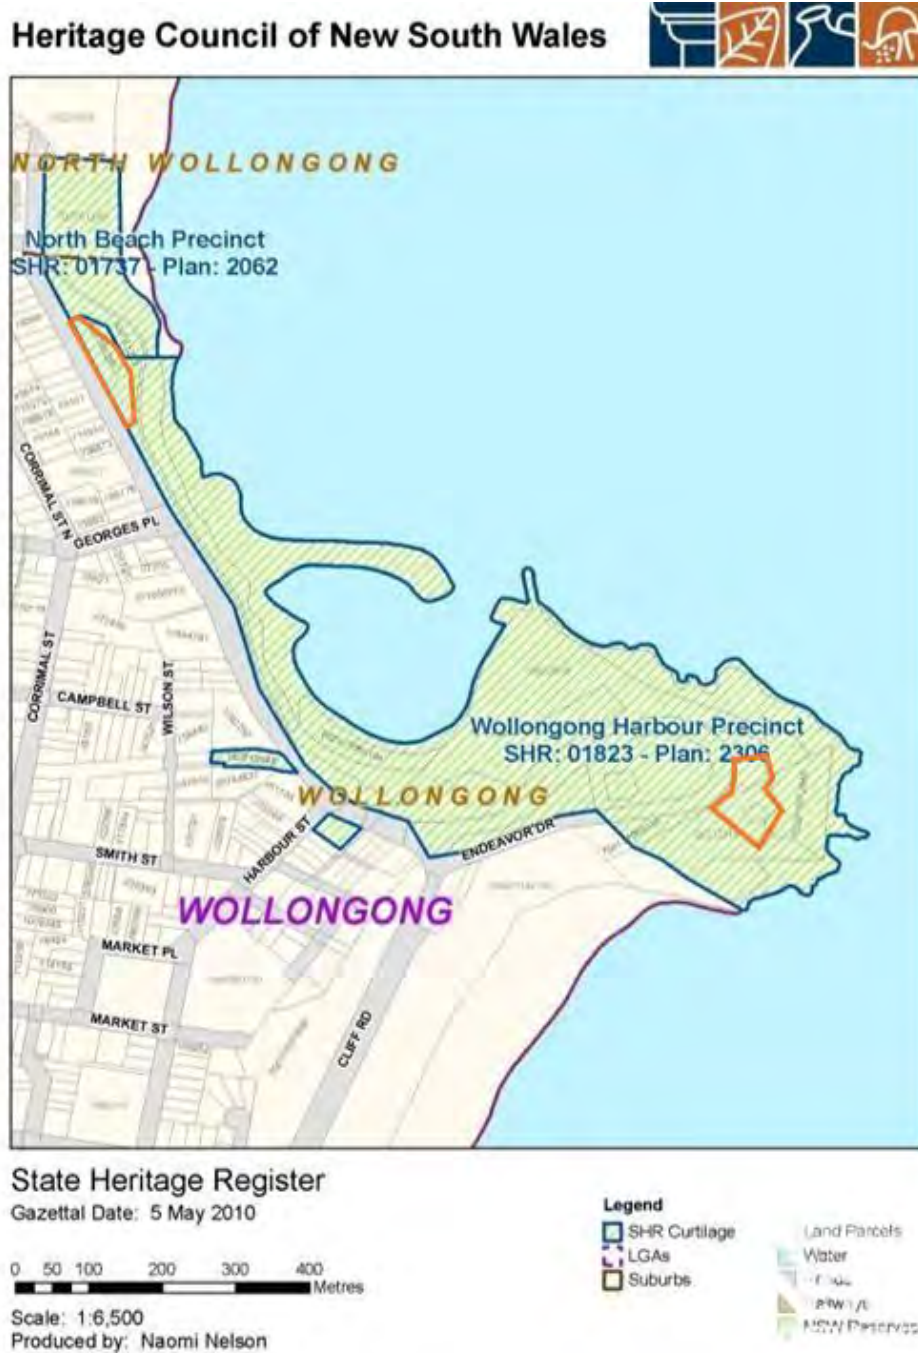
Figure 1.6 Wollongong Harbour Precinct and North Beach Precinct State Heritage Register (SHR) listed curtilages, with the approximate location of the study areas outlined in orange. (Source: Heritage Council of NSW, with GML overlay)

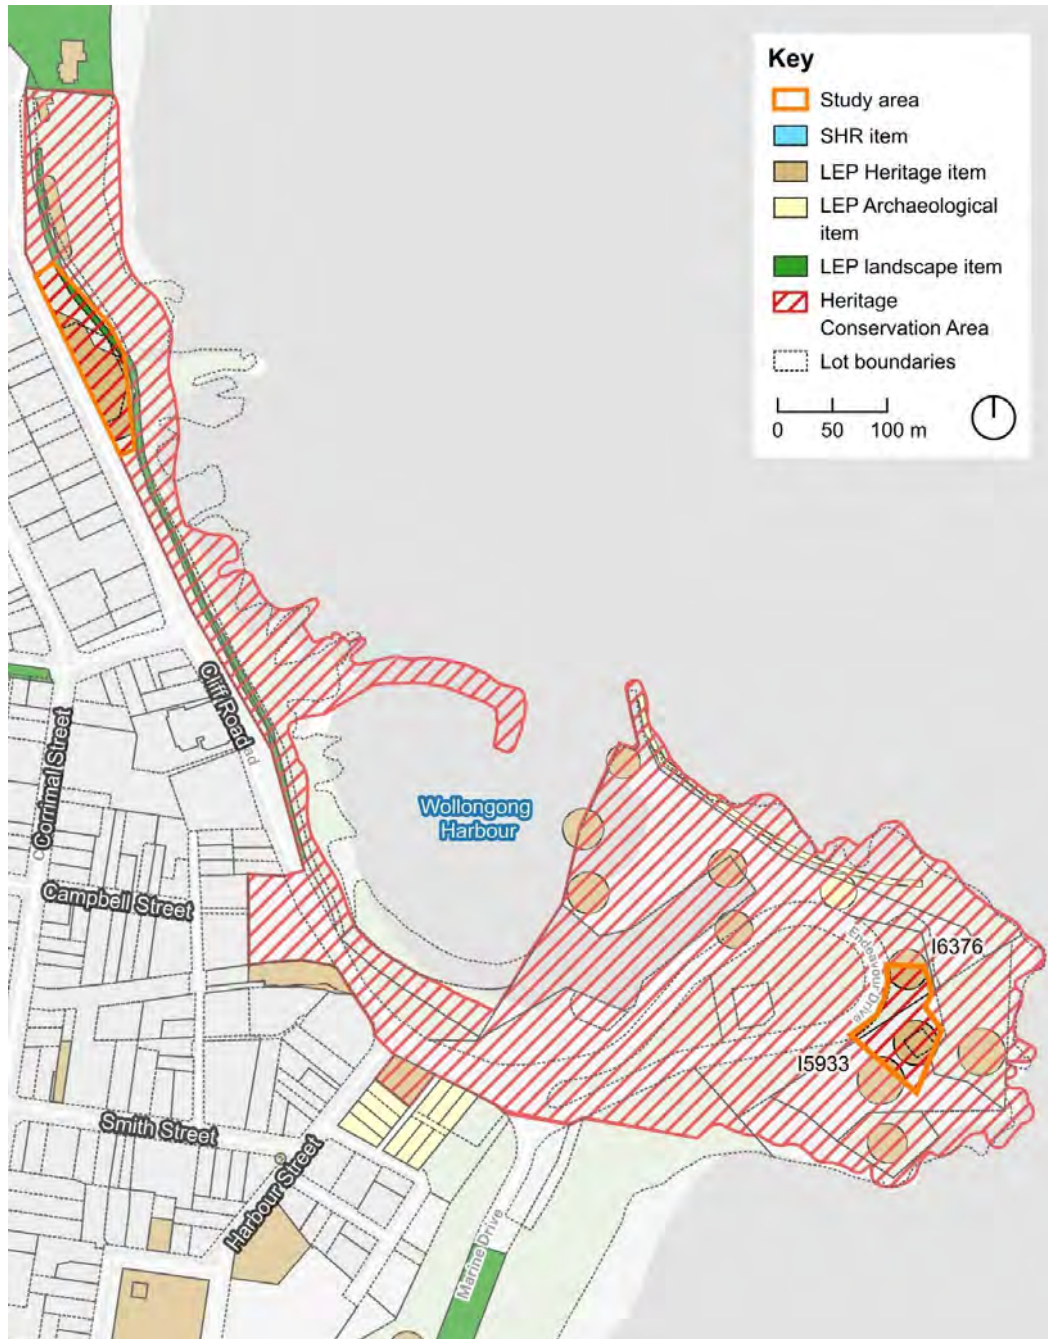
Figure 1.7 Heritage map from the Wollongong LEP 2009, with the approximate location of the study areas outlined in orange. (Source: Wollongong LEP 2009, NSW Spatial Services basemap with GML overlay)

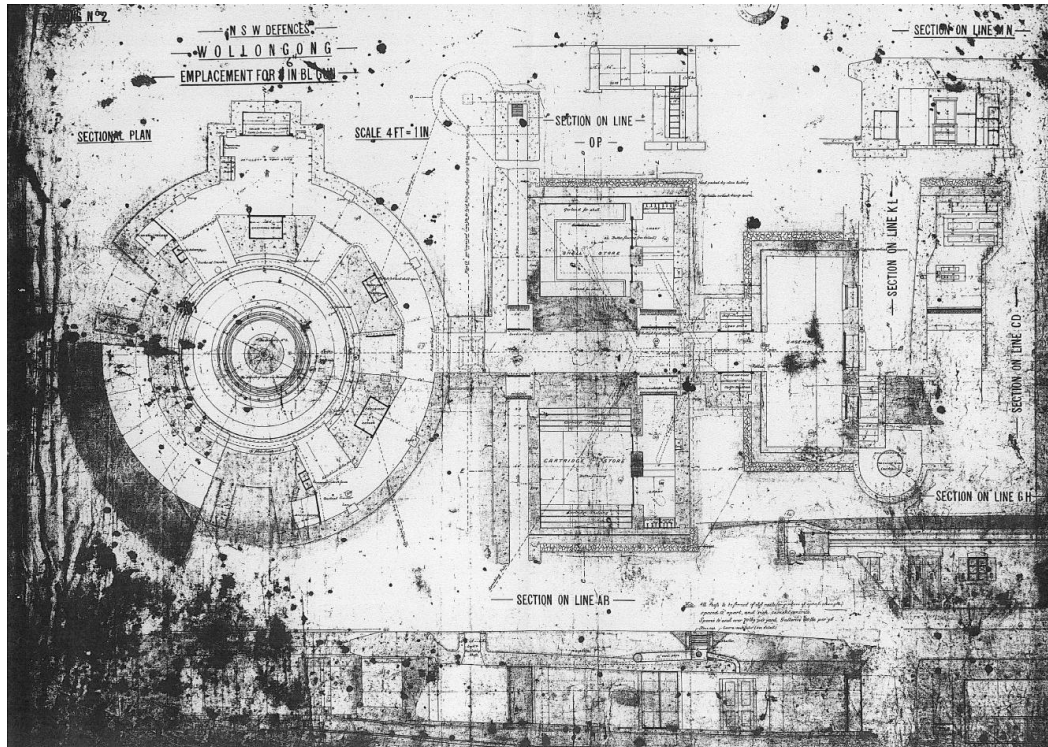
Figure 2.3 Flagstaff Hill Fort drawing showing the plan layout, elevation and sections, date unknown (Source: Wollongong City Libraries)

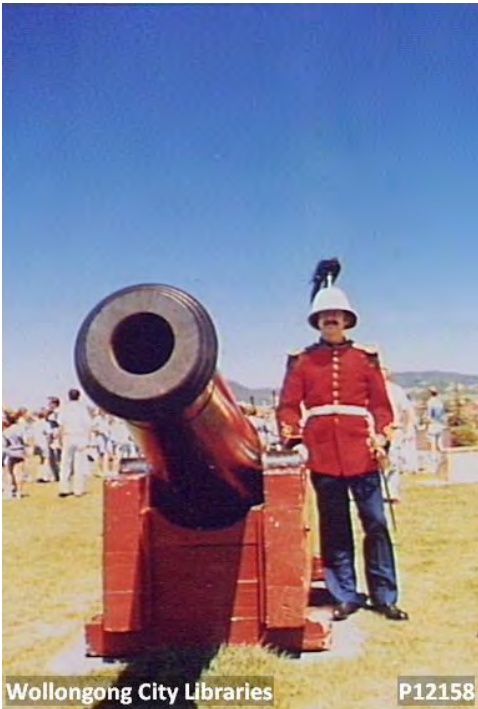
Figure 2.12 Restored gun ready for firing, Heritage Week 1983. Photographed by Steve Dillon. (Source: Wollongong City Libraries, P12/P12158.)

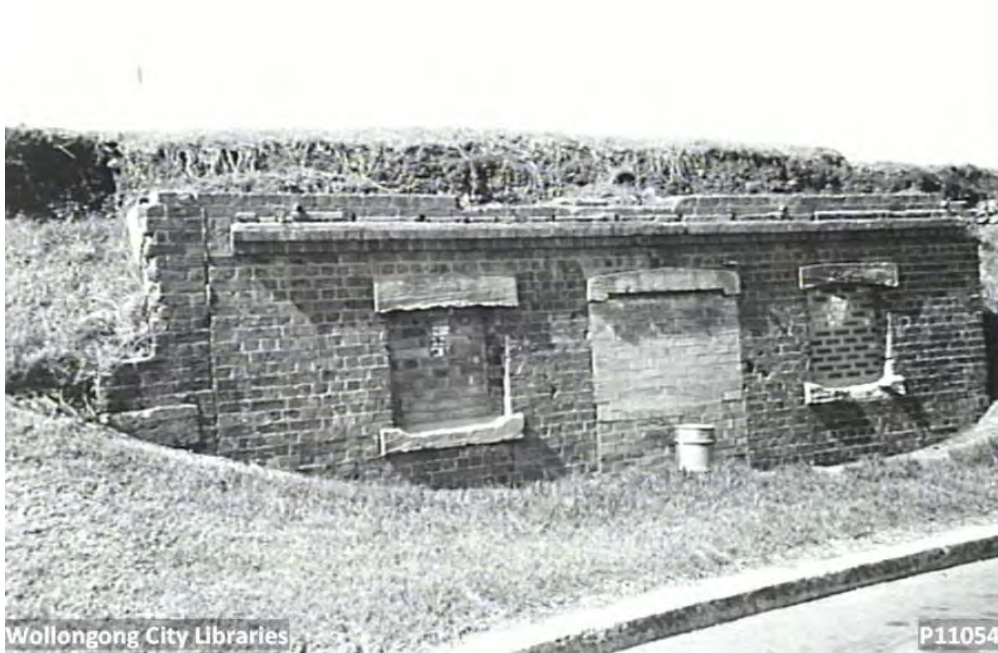
Figure 2.14 Fortifications in 1994. Photograph by Patricia Vidal. (Source: Wollongong City Libraries, P11/P11054)

During the second half of 1996 the Department of Education Employment and Training (DEET) provided the funds for jobless people to clean up the Flagstaff Hill Fort site. This involved digging out the exterior walls and inserting steel shutters, bricking up the doors and windows and generally cleaning up the site.<sup>60</sup>

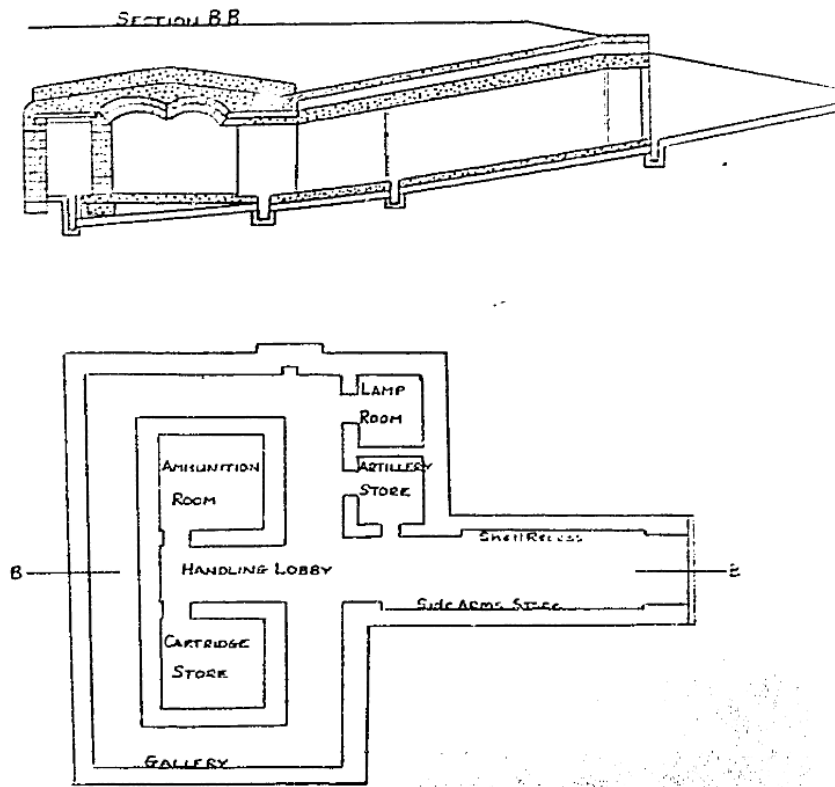
Figure 2.36 Smiths Hill Fort magazine plans and section, 1981. (Source: *Smith's Hill Fort Project*, prepared by GJ Scott, Part E)

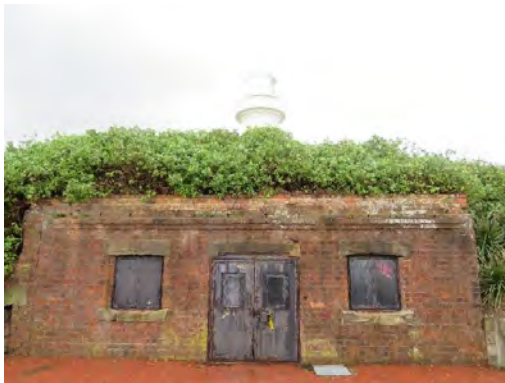
Figure 3.10 Looking northeast towards the entry into the underground areas of Flagstaff Hill Fort from the surrounding carpark area.

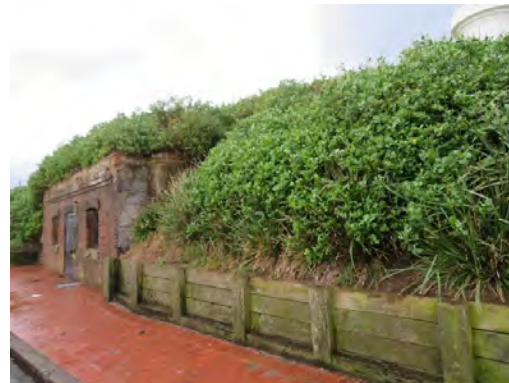
Figure 3.11 Looking north towards the entry into the underground area of Flagstaff Hill Fort.

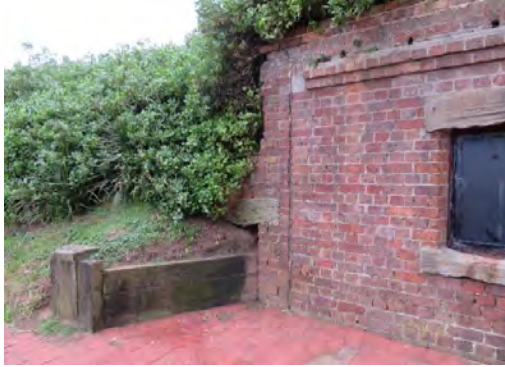
Figure 3.12 Looking towards the northwest portion of the entry into the underground areas of Flagstaff Hill Fort.

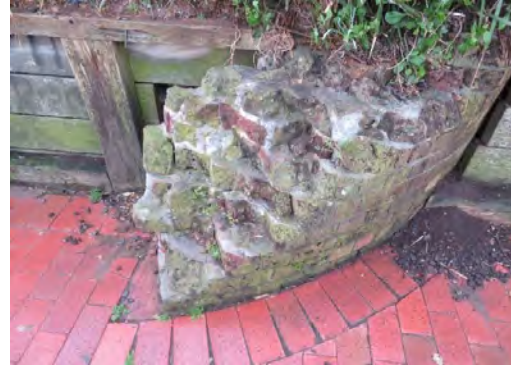
Figure 3.13 Remnant brick retaining wall located to the southeast of the entry into the underground areas of Flagstaff Hill Fort.

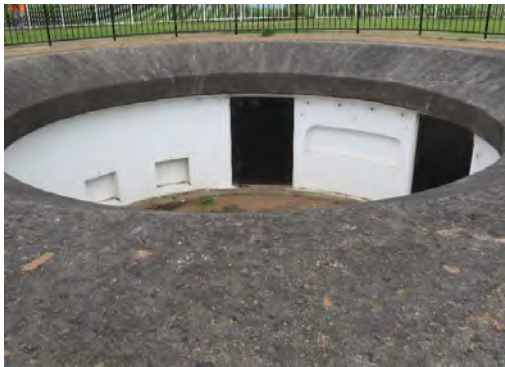
Figure 3.14 Looking down from Flagstaff Hill park into the former gun pit.

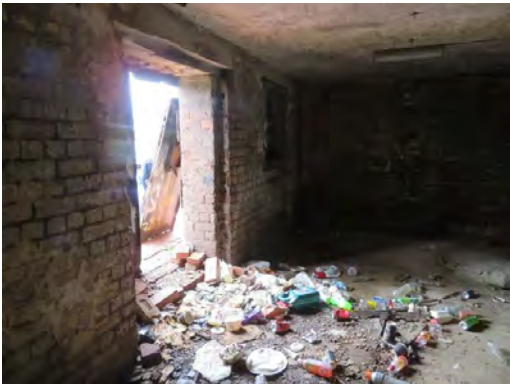
Figure 3.39 Looking from within the former casemate (No. 12) towards the entry into the underground areas of Flagstaff Hill Fort.

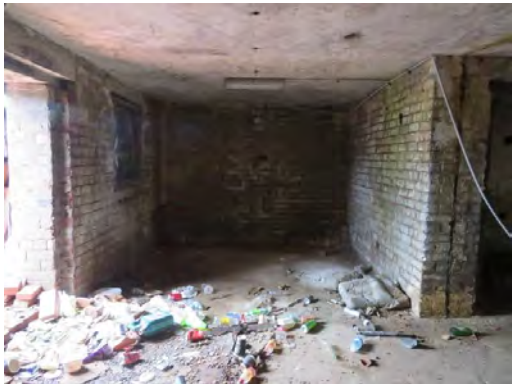
Figure 3.40 Looking northwest through the former casemate (No. 12).

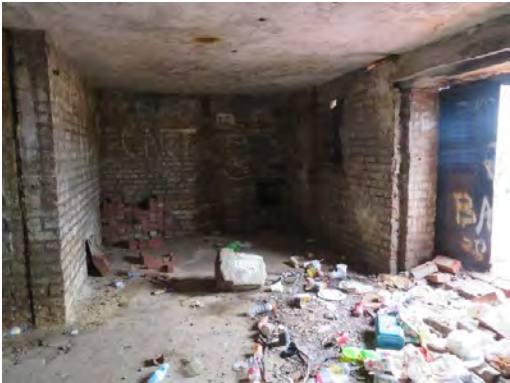
Figure 3.41 Looking southeast through the former casemate (No. 12).

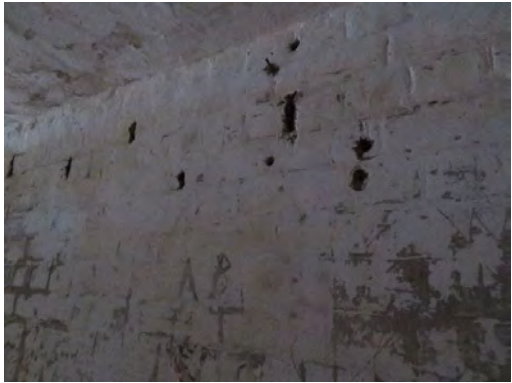
Figure 3.42 Painted brick wall located along the southeast edge of the central passage.

Central passage	<ul style="list-style-type: none"> <li>Painted concrete ceiling. Orange rust stains are located across the ceiling space, indicative of where water leakages may have occurred.</li> <li>Sections of wall are painted concrete whilst other sections are double-brick walls. The walls would have originally been painted; however, sections of paint have worn away.</li> <li>Unpainted concrete floor.</li> <li>A number of small openings and holes are located across the length of each of the walls located on either side of the central passage. These may be evidence of the location of former fixings or niches.</li> <li>A number of metal fixings and fixtures, such as angle brackets, are located along the length of the central passage.</li> </ul>

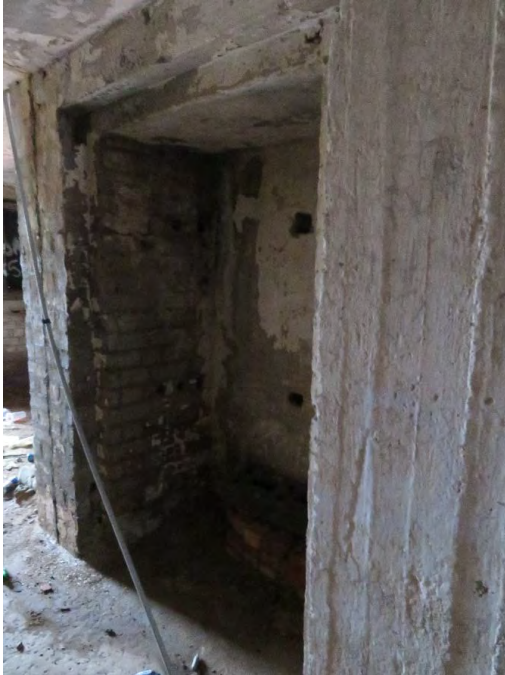
Figure 3.43 Large recess (Store—No. 6) located on the northwestern side of the central passage.

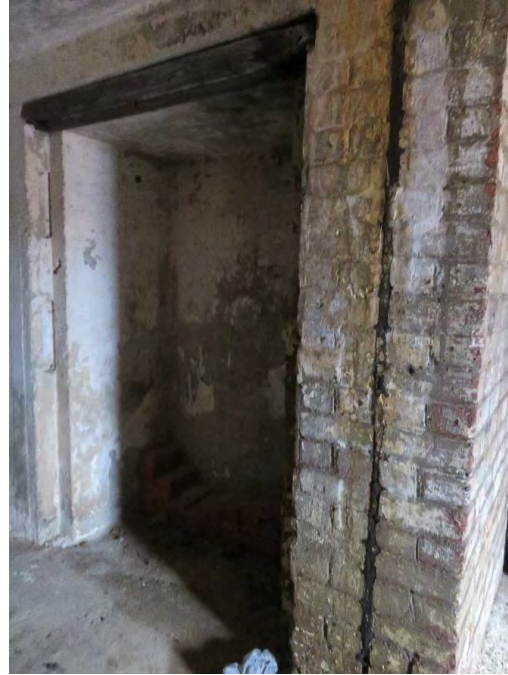
Figure 3.44 Large recess (Laboratory—No. 7) located on the southeastern side of the central passage.

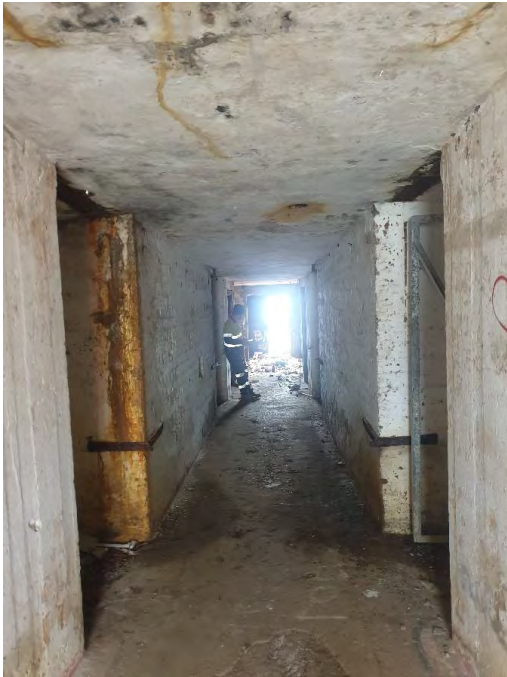
Figure 3.45 Looking northeast along the central passage.

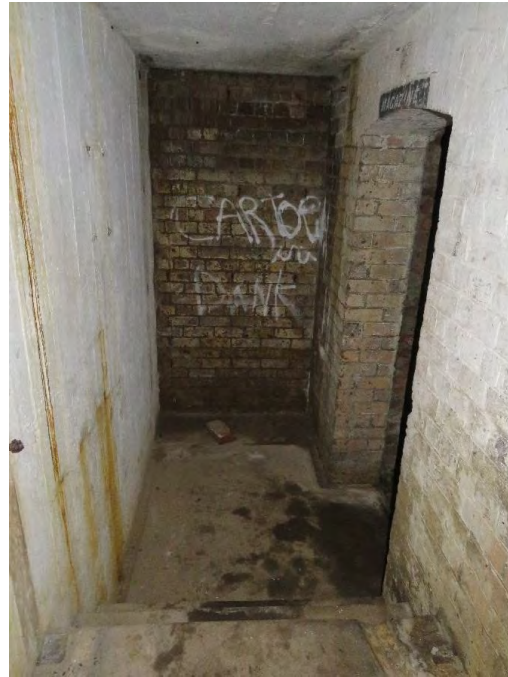
Figure 3.46 Looking northwest down the entry stairs into the magazine (No. 4).

Room/space	Description
Magazine (No. 4)	<ul style="list-style-type: none"> <li>A short walkway along the length of the southwestern edge of the magazine connects the magazine to the central hallway. It has an unpainted concrete ceiling and floor.</li> <li>The southwestern wall of the short walkway is concrete while the northeastern wall is double brick. These walls would have originally been painted; however, sections of paint have worn away.</li> <li>A small niche, likely used to hold a light, is located within the southwestern wall of the short hallway.</li> <li>Three concrete steps connect the short walkway to a landing below.</li> <li>The unpainted brick wall at the end of the short walkway has graffiti painted across it.</li> <li>An arched doorway located along the southwestern wall of the magazine, close to the western corner, provides access from the landing into the former magazine space.</li> <li>The magazine room has an unpainted concrete floor, painted concrete ceiling and unpainted brick walls.</li> <li>A small window opening is located along the southwestern wall of the magazine and another two small window openings are located along the northeastern wall of the magazine, connecting the magazine with the ventilated tunnel to the northeast.</li> <li>Lighting is limited, with one batten light fitting fixed to the ceiling. Cabling associated with this light also hangs from the ceiling.</li> </ul>

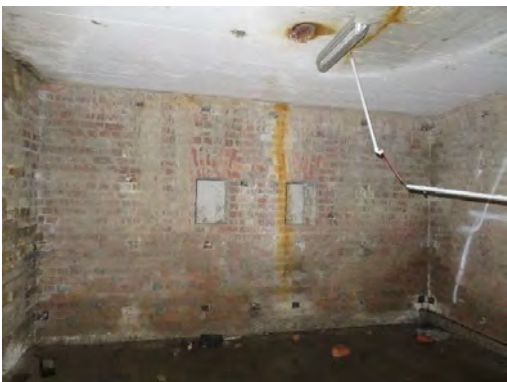
Figure 3.47 Looking northeast through the magazine (No. 4).

Room/space	Description
	<ul style="list-style-type: none"> <li>A small window opening is located along the southwestern wall of the magazine and another two small window openings are located along the northeastern wall of the magazine, connecting the magazine with the ventilated tunnel to the northeast.</li> <li>Lighting is limited, with one batten light fitting fixed to the ceiling. Cabling associated with this light also hangs from the ceiling.</li> </ul>
Ventilated tunnels	<ul style="list-style-type: none"> <li>The ventilated tunnels, located either side of the central hallway directly to the northeast of the magazine and shell store, have painted concrete ceilings and unpainted concrete floors.</li> <li>The walls along the southwestern side are painted brick whilst the walls along the northeastern side are painted concrete. Areas of paint along the walls have worn away over time.</li> <li>Metal grille security gates/doors are located at the entry of each of the ventilated tunnels; the gate/door to the southeast of the central passage is fixed open (No. 3), while the gate/door to the northwest of the central passage is fixed shut (No. 2).</li> <li>Metal elements (refer Figure 3.53) are located atop the ceiling at the end of each of the tunnels. These metal elements indicate the location of where vents would have been originally located.</li> </ul>

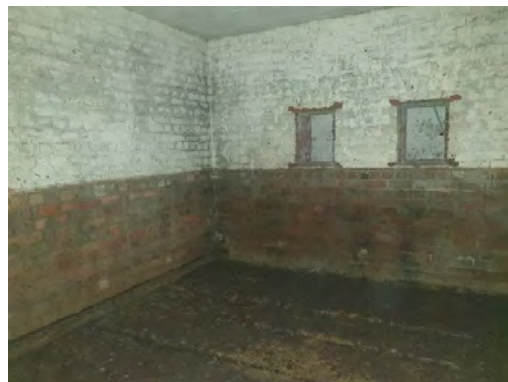
Figure 3.48 Looking north through the main shell store (No. 5).

Shell store (No. 5)	<ul style="list-style-type: none"> <li>A short walkway along the length of the southwestern edge of the shell store connects the shell store to the central hallway. It has an unpainted concrete ceiling and floor.</li> <li>The southwestern wall of the short walkway is concrete whilst the northeastern wall is double brick. These walls would have originally been painted; however, sections of paint have worn away.</li> <li>A small niche, likely used to hold a light, is located within the southwestern wall of the short hallway.</li> <li>Three concrete steps connect the short walkway to a landing below.</li> <li>An arched doorway located along the southwestern wall of the magazine, close to the eastern corner, provides access from the landing into the former shell store space.</li> <li>The shell store has an unpainted concrete floor and painted concrete ceiling.</li> <li>The shell store has brick walls that are painted from the level of the floor to halfway up the walls.</li> </ul>

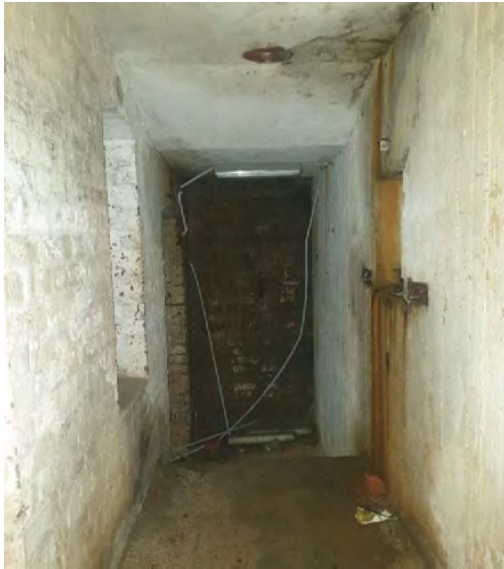
Figure 3.49 Looking southeast towards the entry into the main shell store (No. 5).

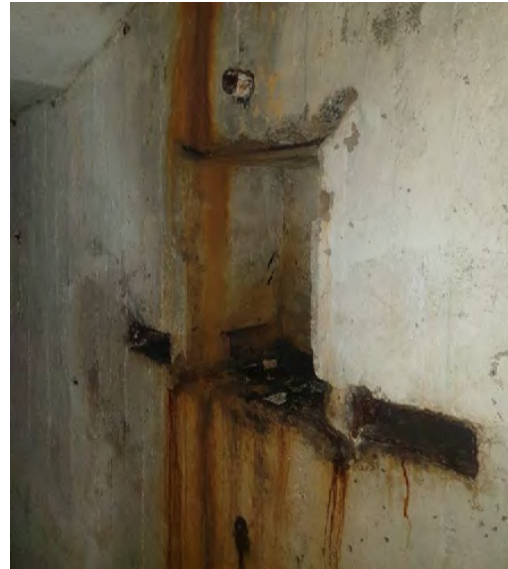
Figure 3.50 Small niche (lamp recess?) located within one of the walls at the entry into the shell store (No. 5).

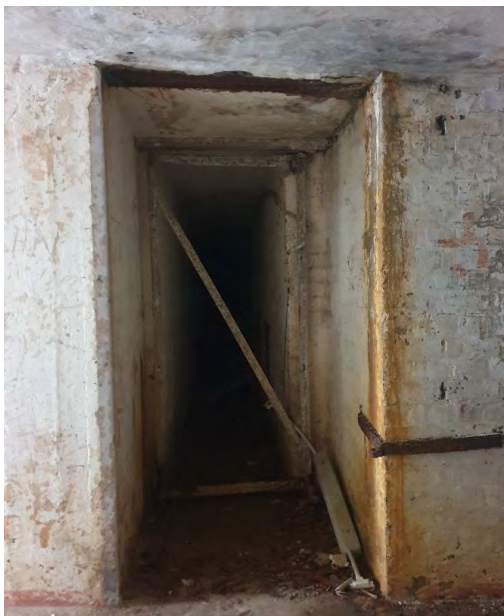
Figure 3.51 Looking northwest towards the entry into the ventilated tunnel (No. 2) located directly to the northwest of the magazine.

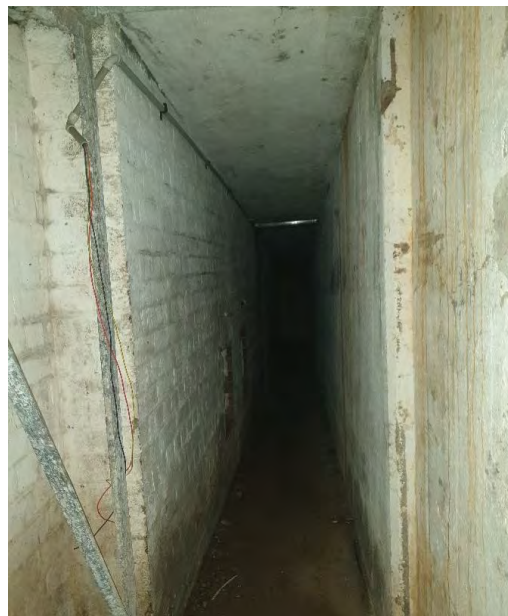
Figure 3.52 Looking southeast to the entry into the ventilated tunnel (No. 3), located directly to the northeast of the shell store.

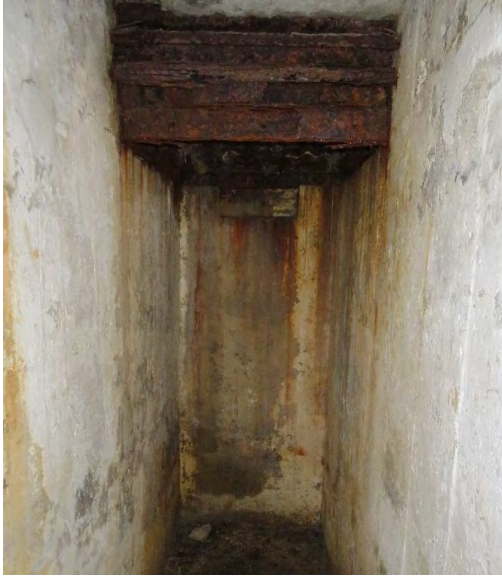
Figure 3.53 The end of one of the ventilated tunnels. It appears the vent has now been covered over.

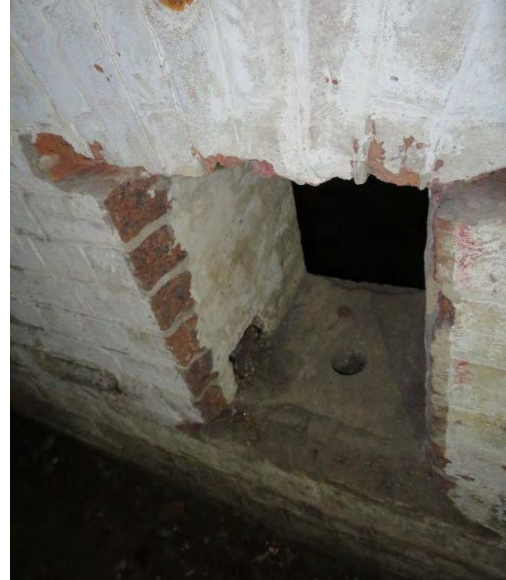
Figure 3.54 Looking from the ventilated tunnel towards an opening located along the wall separating the ventilated tunnel and the magazine (No. 4).

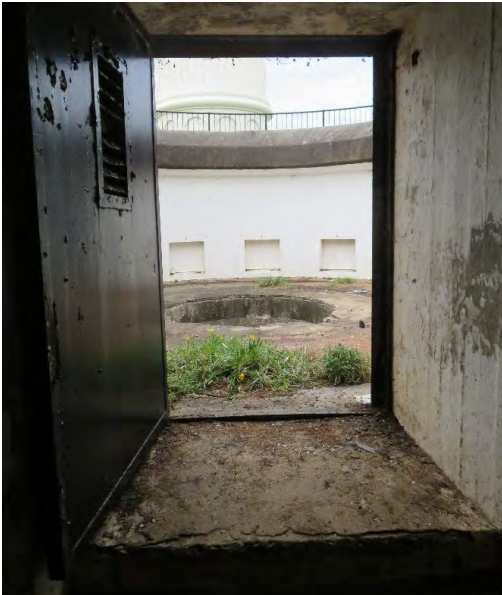
Figure 3.55 Looking northeast towards the gun pit (No. 1) from the central passage.

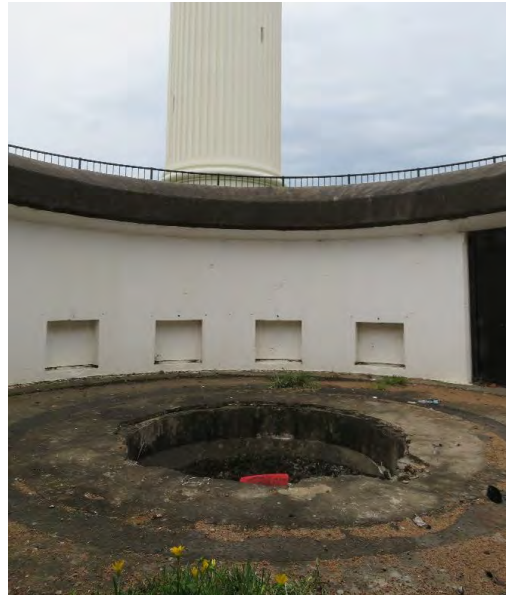
Figure 3.56 Looking northeast towards the gun pit (No. 1) and shell recesses, with the Flagstaff Point Lighthouse in the background.

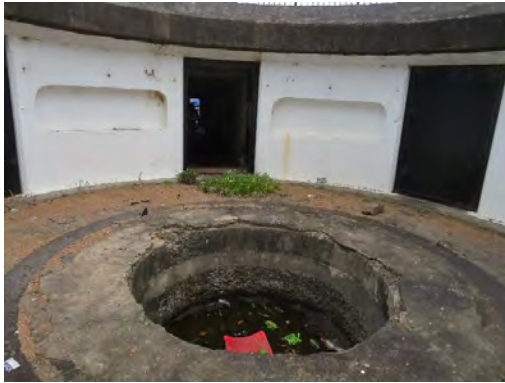
Figure 3.57 Looking down into the gun pit (No. 1).

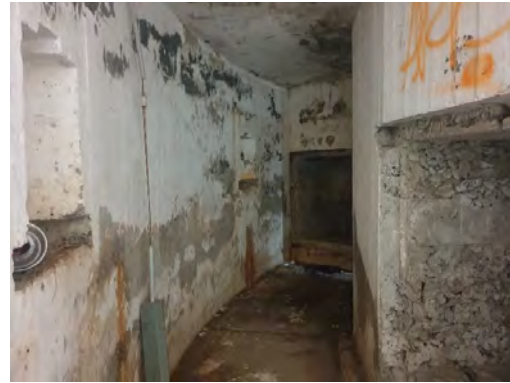
Figure 3.58 Looking north to the shell recess at the end of the curving passageway surrounding the southwestern section of the former gun pit.

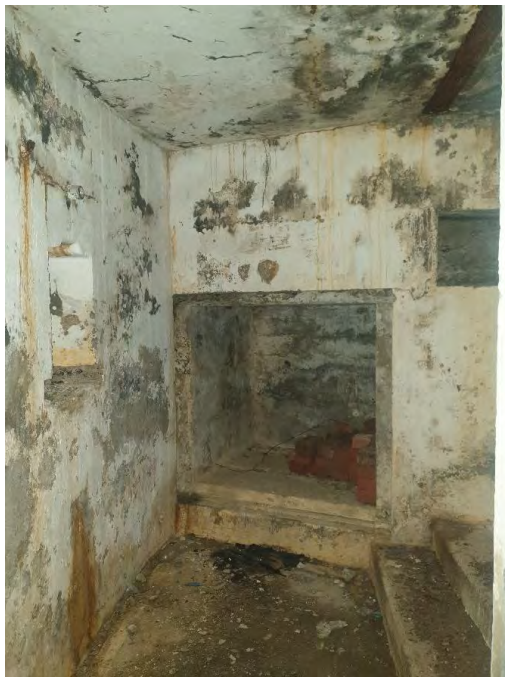
Figure 3.59 Looking to a shell recess (No. 11) located at the end of the curving passageway surrounding the gun battery.

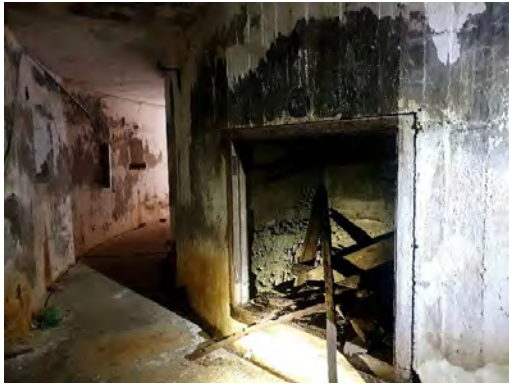
Figure 3.61 A cartridge recess located within the curving passageway surrounding the gun battery.

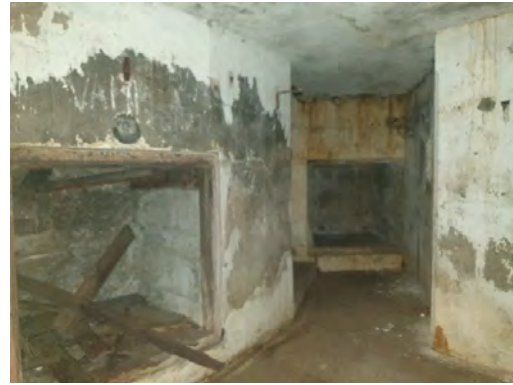
Figure 3.62 Looking to a shell recess (No. 11) located at the eastern end of the curving passageway, shell recess (left) and pump chamber (right).

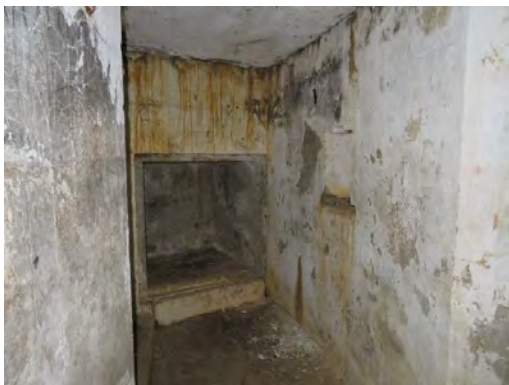
Figure 3.63 Shell recess (No. 11) located at the eastern end of the curving passageway surrounding the gun battery.

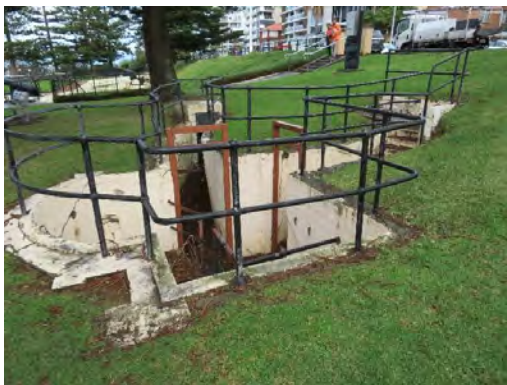
Figure 3.72 Looking south towards the depression range finder.

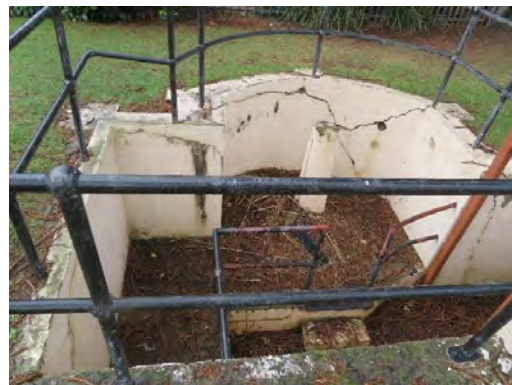
Figure 3.73 Looking into the former interior of the depression range finder.

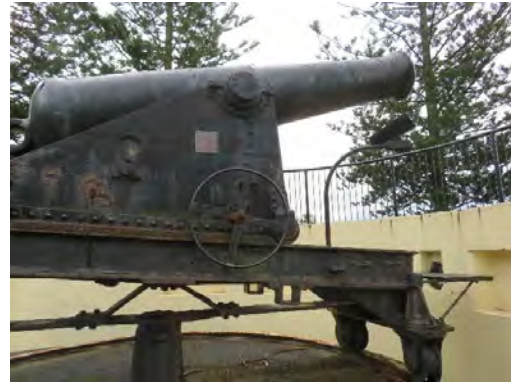
Figure 3.79 Close-up image of the gun located closer to the northern end of the study area.

The excavation of the two 80-pounder guns took place on 22 and 23 May 1986 by volunteers using backhoe, hand tools and a crane. An area of approximately 1.5m around each gun was excavated to safely remove them from the ground. The overall condition of the northern gun mount and carriage was similar to what Wilson reported in 1984. The southern gun was found to be slightly less corroded; its wooden foot plate was better preserved, enabling it to provide the dimensions and details required for its modern reconstruction. A full description of the underground portions of the fort were explored during the excavation.

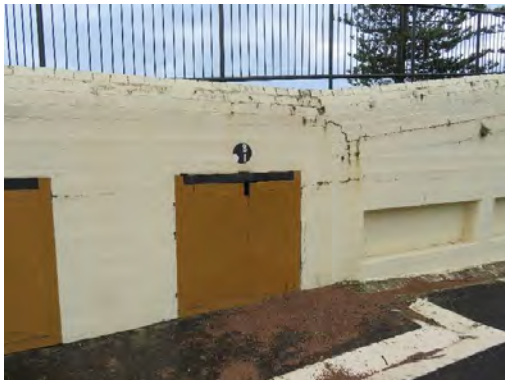
Figure 3.80 Former shell store recess located along the eastern edge of the exposed portion of Smiths Hill Fort.

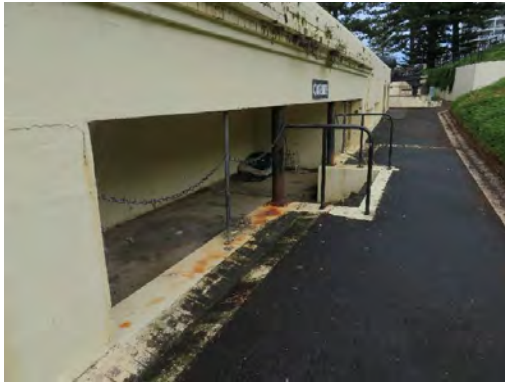
Figure 3.82 Looking south towards the bombproof shelter.

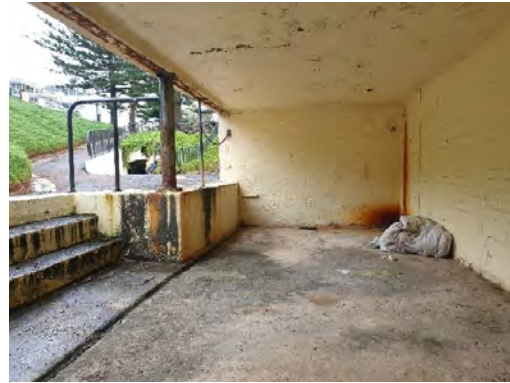
Figure 3.83 Looking north through the bombproof shelter.

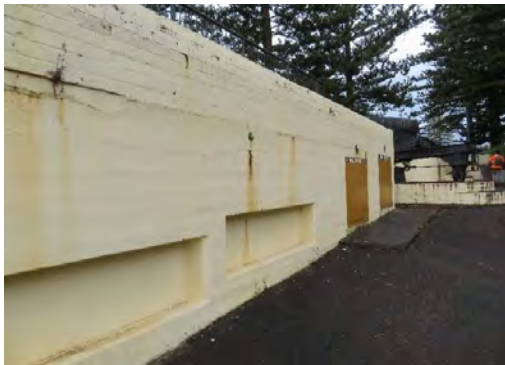
Figure 3.84 Niches located along the eastern wall that surrounds the exposed portions of the Smiths Hill Fort.

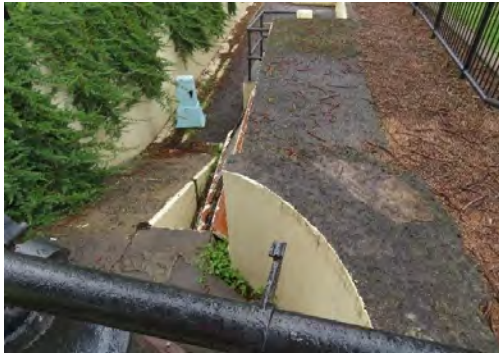
Figure 3.88 Looking down towards the ramp that leads up to the gun located at the southern end of the Smiths Hill Fort.

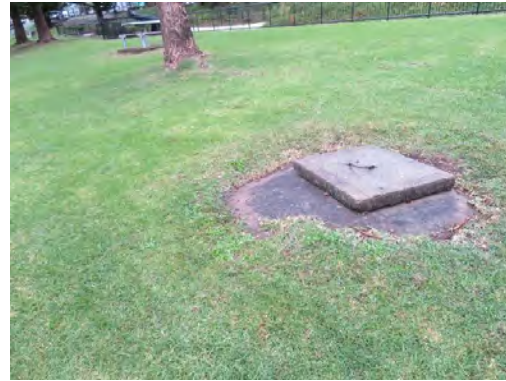
Figure 3.93 Covered pit (likely the cap over one of the underground tanks) located along the grassed area towards the eastern portion of the study area.

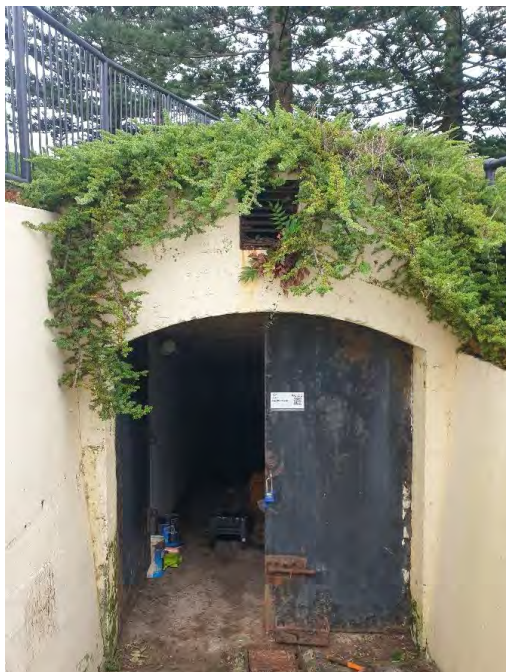
Figure 3.97 Entry into underground area of Smiths Hill Fort.

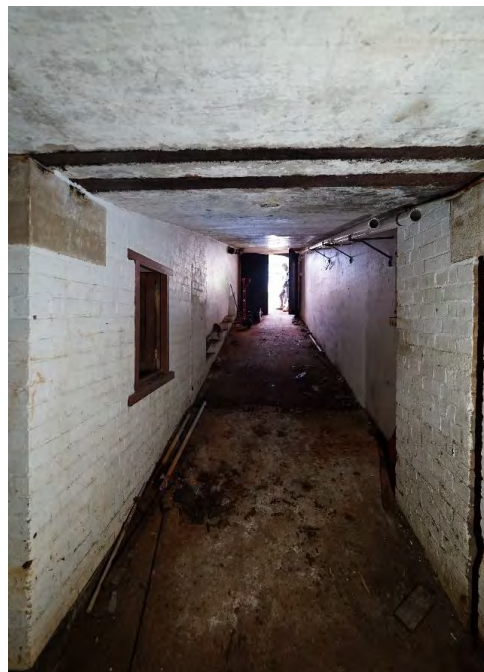
Figure 3.98 Gallery with a ramp to ground level.

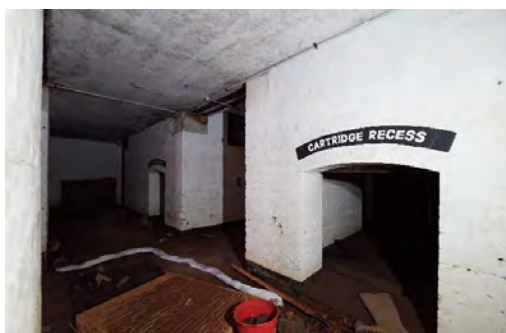
Figure 3.99 Passageway showing the ammunition and cartridge room.

Ammunition	<ul style="list-style-type: none"> <li>• Same materials and openings as cartridge store with a mirrored layout.</li> <li>• New timber door and frame.</li> </ul>
Lamps	<ul style="list-style-type: none"> <li>• Brick walls, concrete ceiling and floor.</li> <li>• Timber door frame, no door.</li> <li>• Small opening on the west wall to the artillery room.</li> </ul>
Artillery	<ul style="list-style-type: none"> <li>• Brick walls, concrete ceiling and floor.</li> <li>• Openings to the lamps room and on the west wall to the gallery with a timber frame and shutters.</li> </ul>

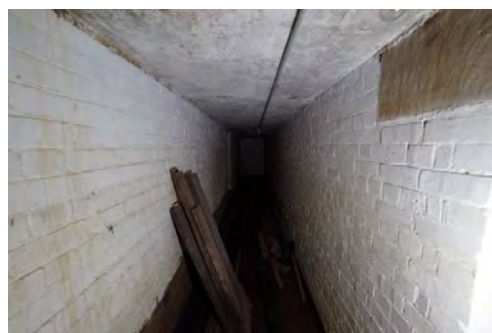
Figure 3.100 Passageway showing brick walls, concrete ceiling and a stone corner.

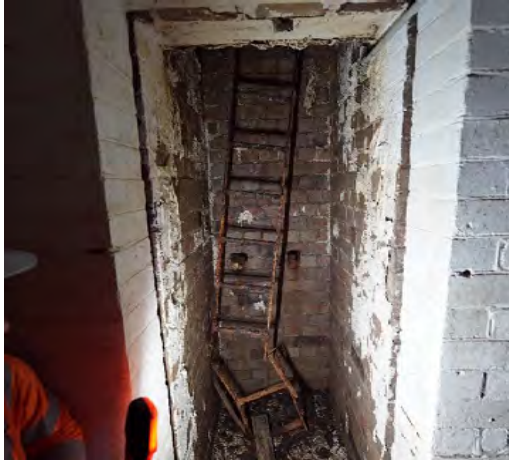
Figure 3.101 Ladder to the DRF area.

Area	Description
	<ul style="list-style-type: none"> <li>• Drainage channel along the perimeter.</li> <li>• Ladder to the DRF section.</li> </ul>
Shifting lobby	<ul style="list-style-type: none"> <li>• Lobby located between the ammunition room and cartridge store.</li> <li>• Painted brick walls, double barrel vault ceiling of brick, stone corners, concrete floor.</li> <li>• High lamp recess and doorway with brick lintel on either wall.</li> </ul>
Cartridge store	<ul style="list-style-type: none"> <li>• Brick walls, double barrel vault ceiling, concrete floor.</li> <li>• Timber door frame, no attached door.</li> <li>• A cartridge recess opening on the south wall. Brick arch lintel and additional timber support lintel. Evidence of a structure fixed to this wall around the opening.</li> <li>• Two small openings on the west wall and one on the east wall, circular ceiling vent.</li> <li>• A painted sign above the brick lintel on the outer side reads 'CARTRIDGE RECESS'.</li> </ul>

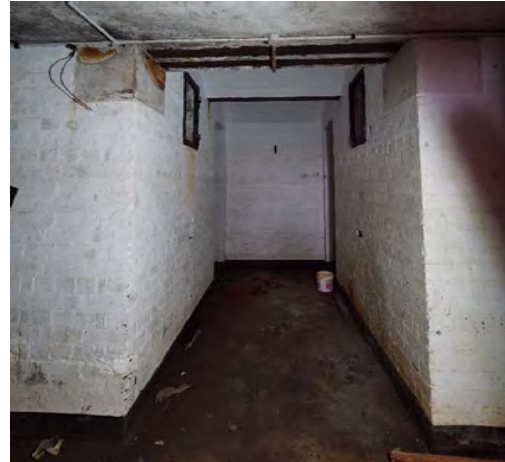
Figure 3.102 Shifting lobby.

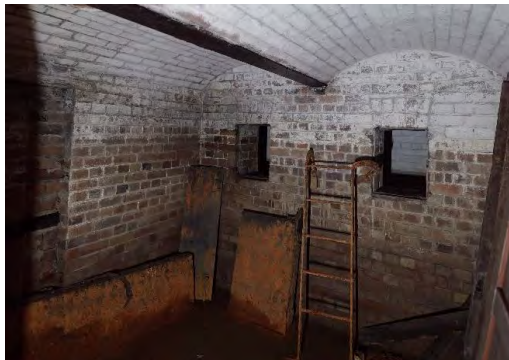
Figure 3.103 Cartridge store.

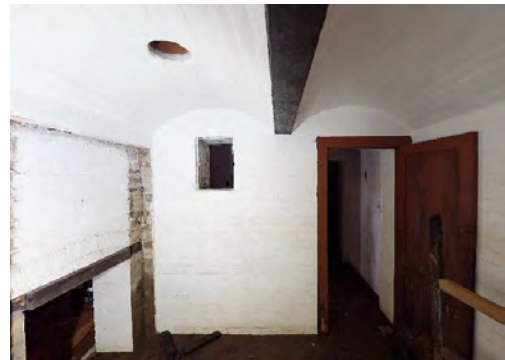
Figure 3.104 Ammunition room.

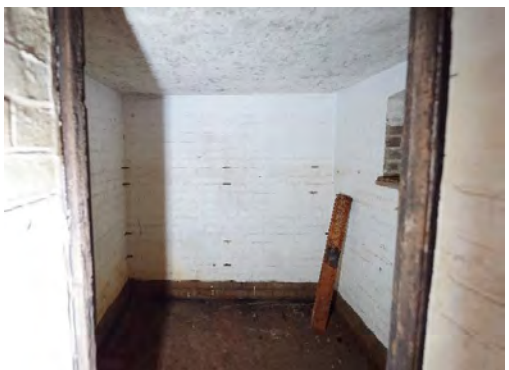
Figure 3.105 Lamps room.

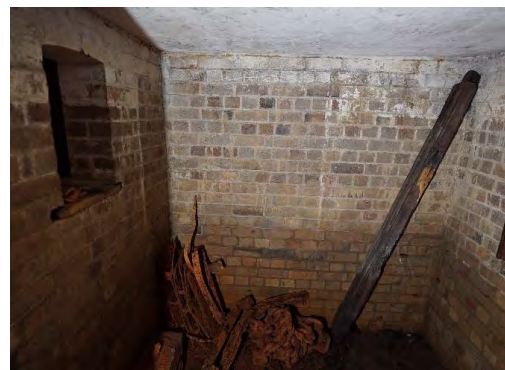
Figure 3.106 Artillery room.

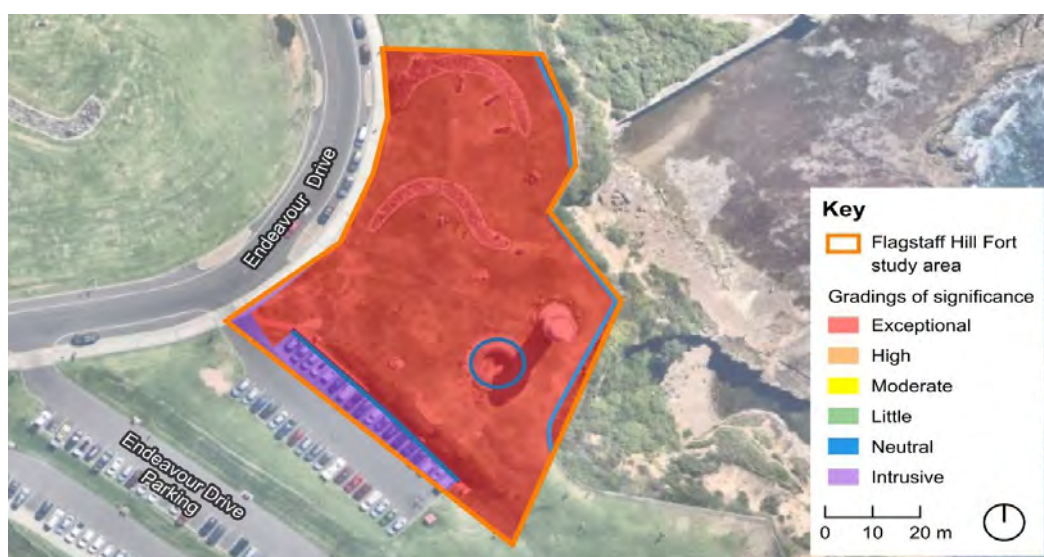
Figure 4.1 Significance grading of above-ground elements. (Source: Nearmap 2024 with GML overlay)

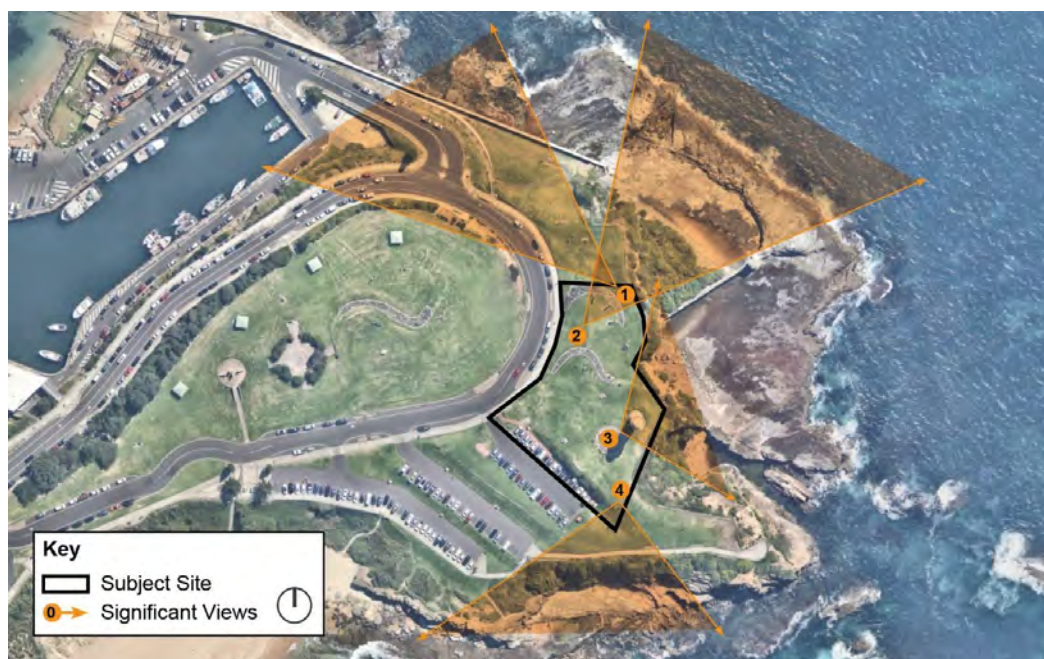
Figure 4.3 Aerial view of Flagstaff Hill Fort showing significant views. (Source: Nearmap 2024 with GML overlay)

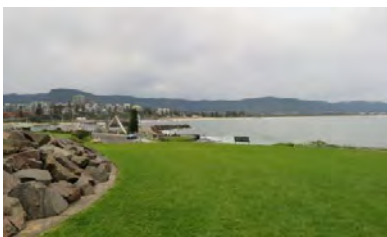
View	Description	Image	Significance
<b>View 1</b>	Sweeping panoramic view from Flagstaff Hill out towards the ocean, North Wollongong and Wollongong Harbour (including Battery Park) reflects the historical relationship of Flagstaff Hill with Wollongong Harbour and the wider Wollongong township. This view highlights this area of Wollongong Harbour as being a strategic point in the original fortification of the colony.
