## PUBLIC EXHIBITION - FLAGSTAFF HILL AND SMITHS HILL FORTS CONSERVATION MANAGEMENT PLAN

A draft Conservation Management Plan has been prepared for the Flagstaff Hill and Smith's Hill Fortifications. This report seeks Council's endorsement of the draft Conservation Management Plan for public exhibition to allow stakeholders and the community feedback.

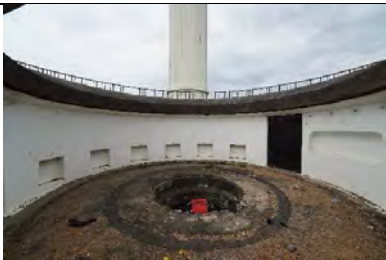
Exceptional
<b>View 3</b>	View from the gun pit demonstrating the historical function of the disappearing gun, which laid hidden before rising above the walls to fire. The view is partially obscured by the addition of the lighthouse.  The 1937 Wollongong Head Lighthouse is located within the boundaries of the study area and of Flagstaff Hill Fort's heritage curtilage. Construction of the lighthouse occurred between 1935 and 1937, shortly before the large gun in the Flagstaff gun pit was removed. Although the lighthouse is listed as a heritage item on the Wollongong LEP 2009, its location disrupts the historic line of fire from the gun pit and impacts the interpretability of the fort's original function.

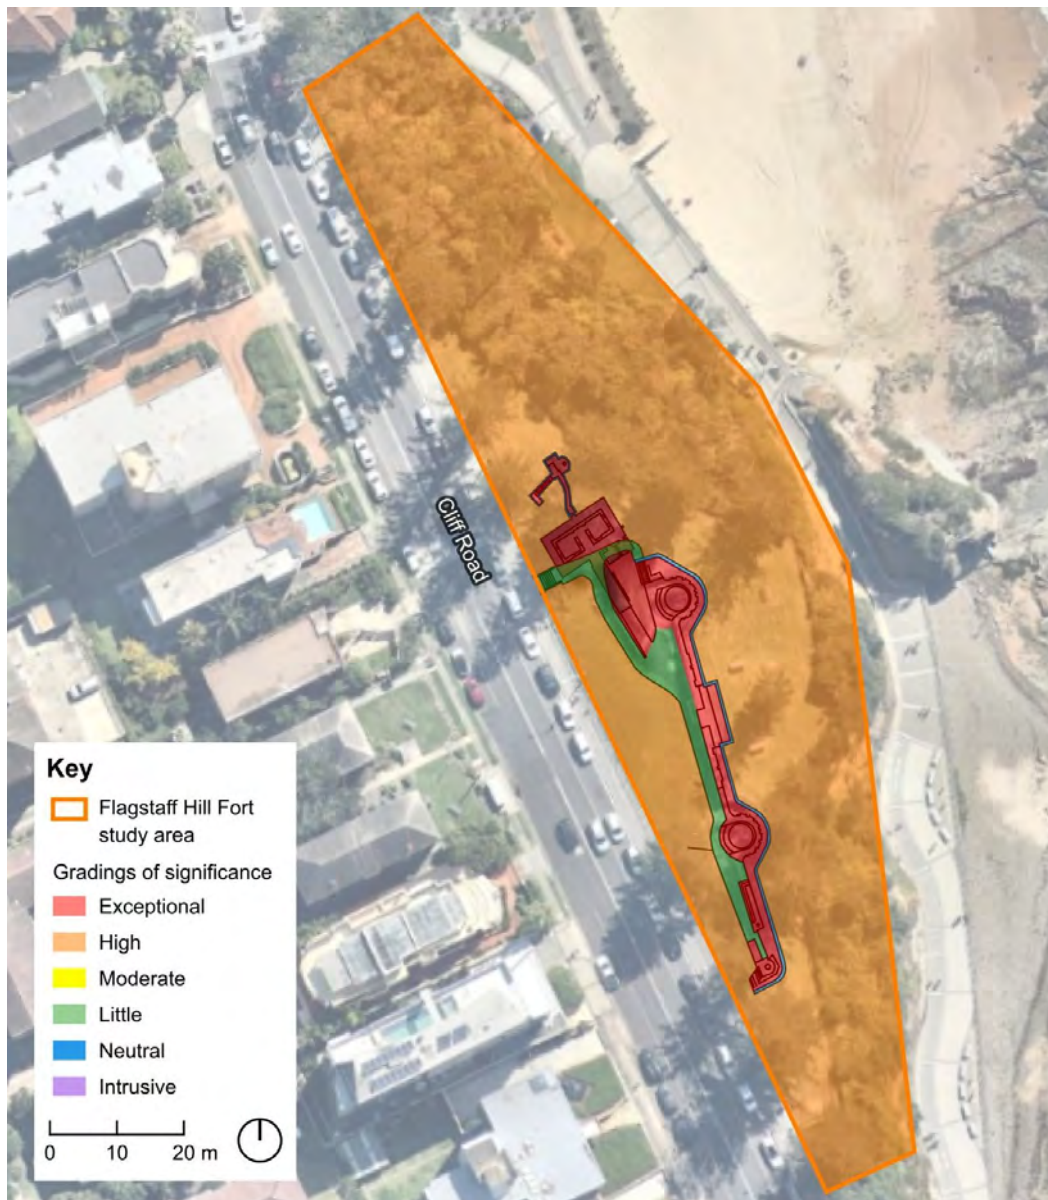
Figure 4.4 Significance grading for the built and landscape components of Smiths Hill Fort. Note, however, some vegetation impacts the interpretability of the defensive function of the fort (see discussion of views below). (Source: Wollongong Design and Technical Services 2024, Nearmap 2024 with GML overlay)

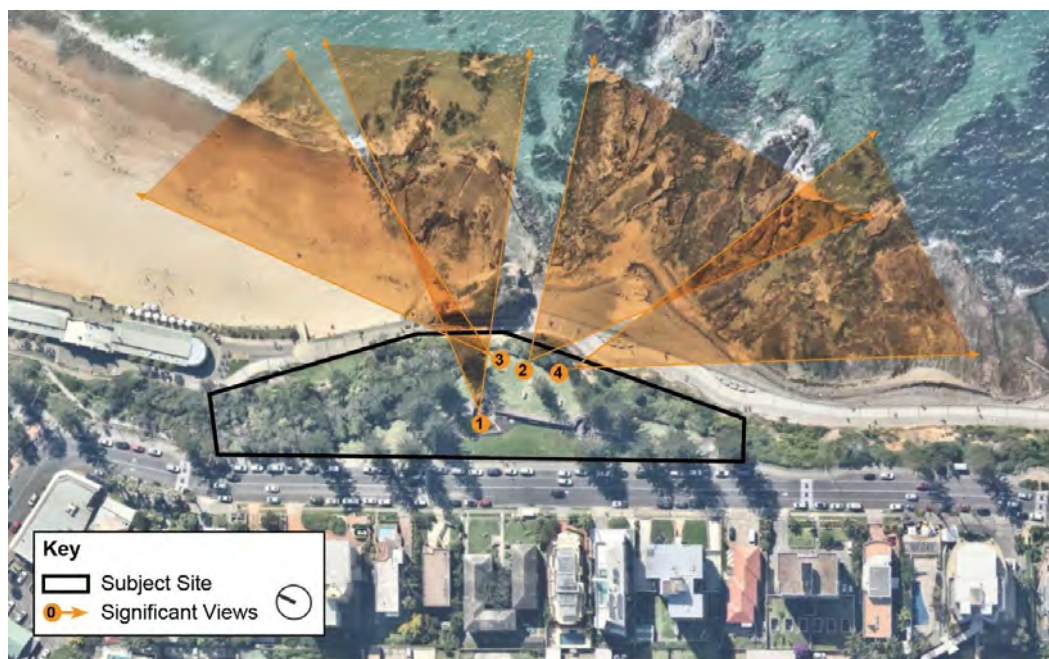
Figure 4.6 Aerial view of Smiths Hill Fort showing significant views. (Source: Nearmap 2024 with GML overlay)

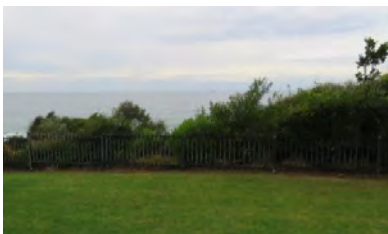
View	Description	Image	Significance
View 2	View from the park area looking east out towards the ocean. Though obscured by plantings, it is significant in demonstrating the fort's role in surveillance and protection from potential attacks from the sea in the Illawarra region.

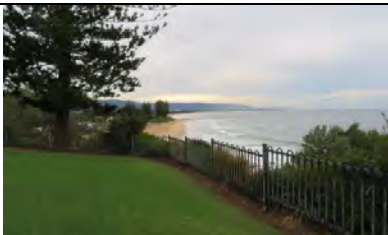
Exceptional
View 3	View looking north towards the Wollongong coastline from the eastern portion of the park. It demonstrates the height of this area above the surrounding coastline, which would have supported the fort's operations, particularly the DRF.

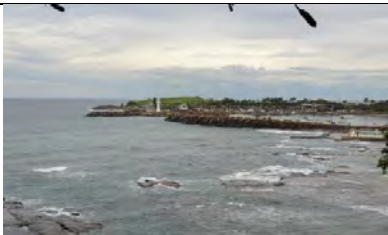
Exceptional
View 4	View looking southeast from the eastern portion of the park towards Wollongong Harbour and Flagstaff Hill Fort. This view highlights the visual relationship that has been retained between Flagstaff Hill Fort and Smiths Hill Fort and their combined efforts in protecting the Wollongong coastline.

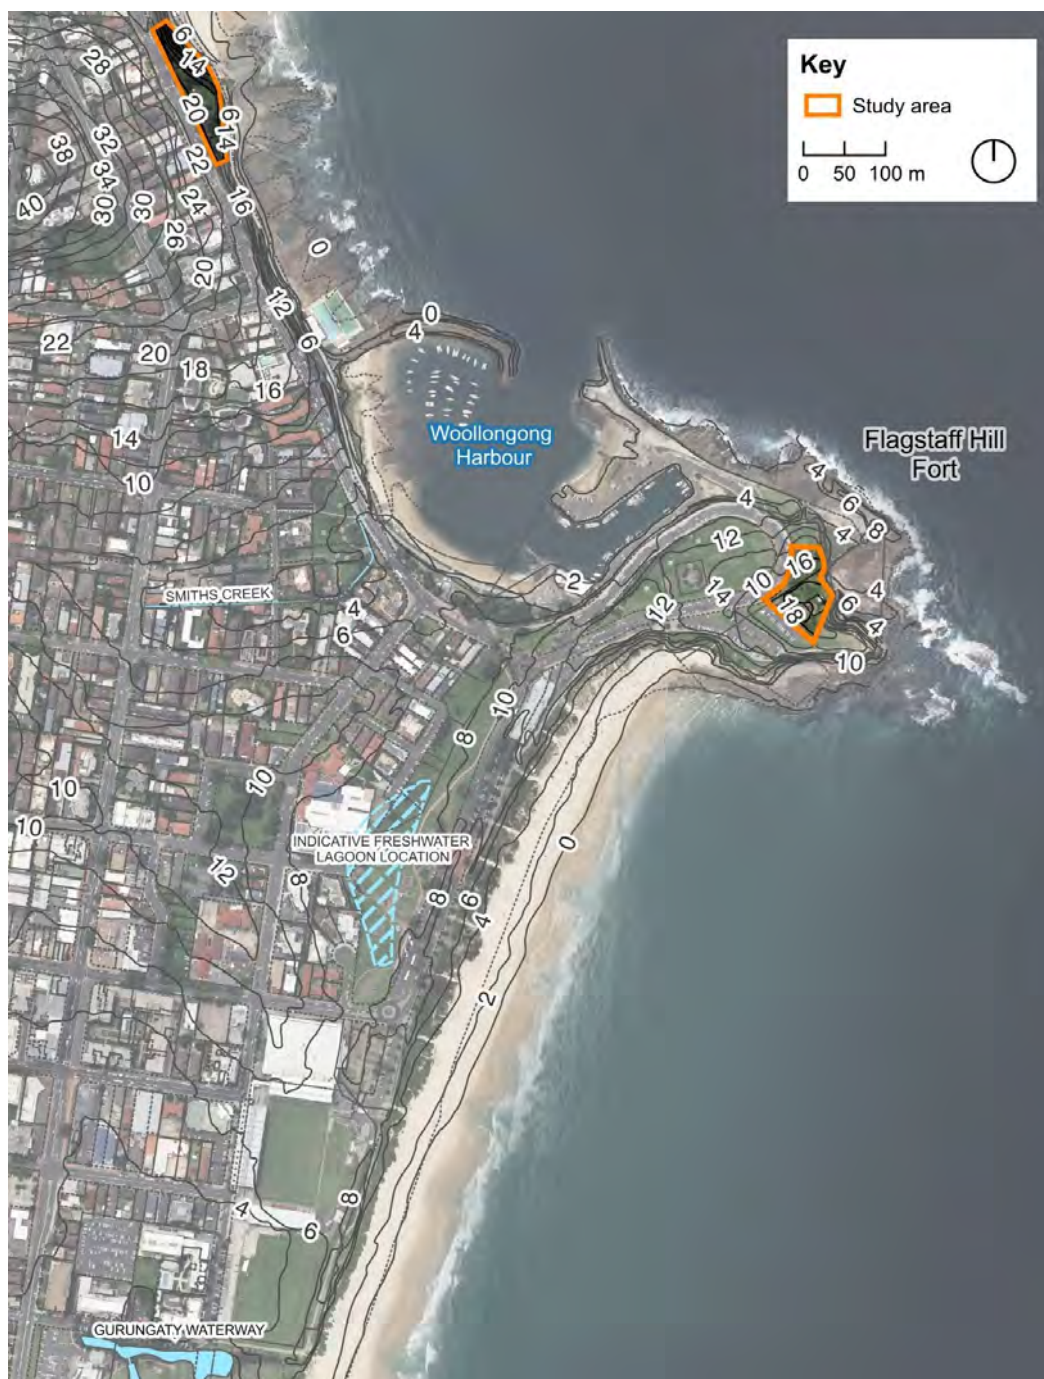
Figure 4.10 Hydrology and contours across and surrounding the Flagstaff Hill Fort. (Source: SIX Maps with GML overlay, 2024)

The coastal locations, proximity to freshwater and the known proximity of registered sites make these study areas probable locations for Aboriginal occupation. However, both sites contain an overall low potential for evidence of Aboriginal archaeology. The significant impacts caused by the construction of the forts, including removal of natural soil horizons, are likely to have had significant impacts across both sites.

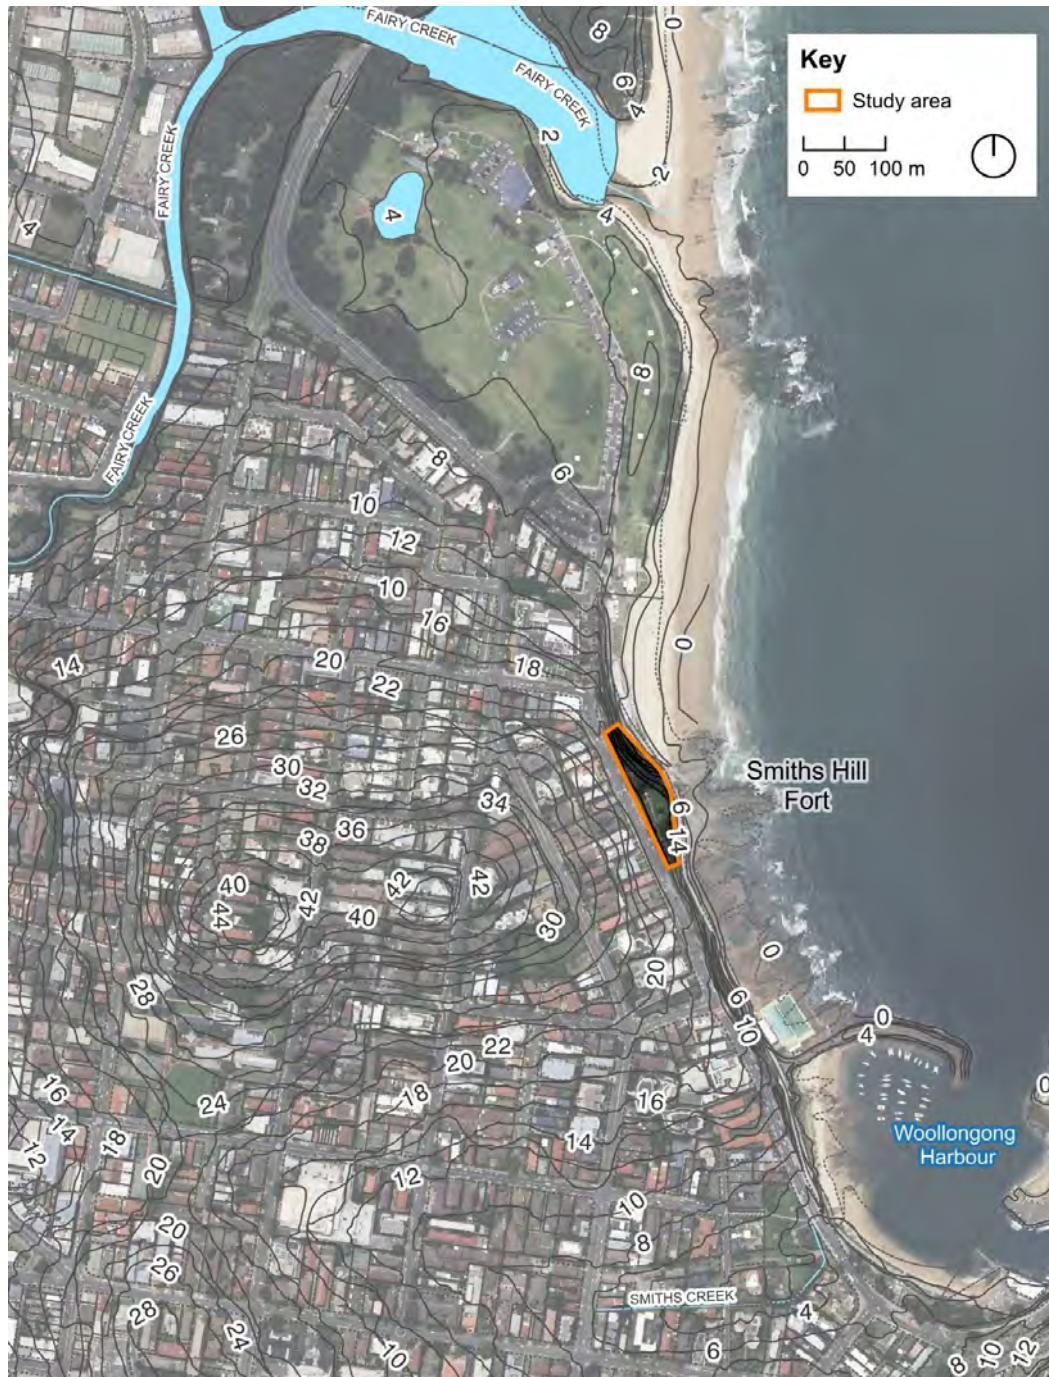
Figure 4.11 Hydrology and contours across and surrounding the Smiths Hill Fort. (Source: SIX Maps with GML overlay, 2024)

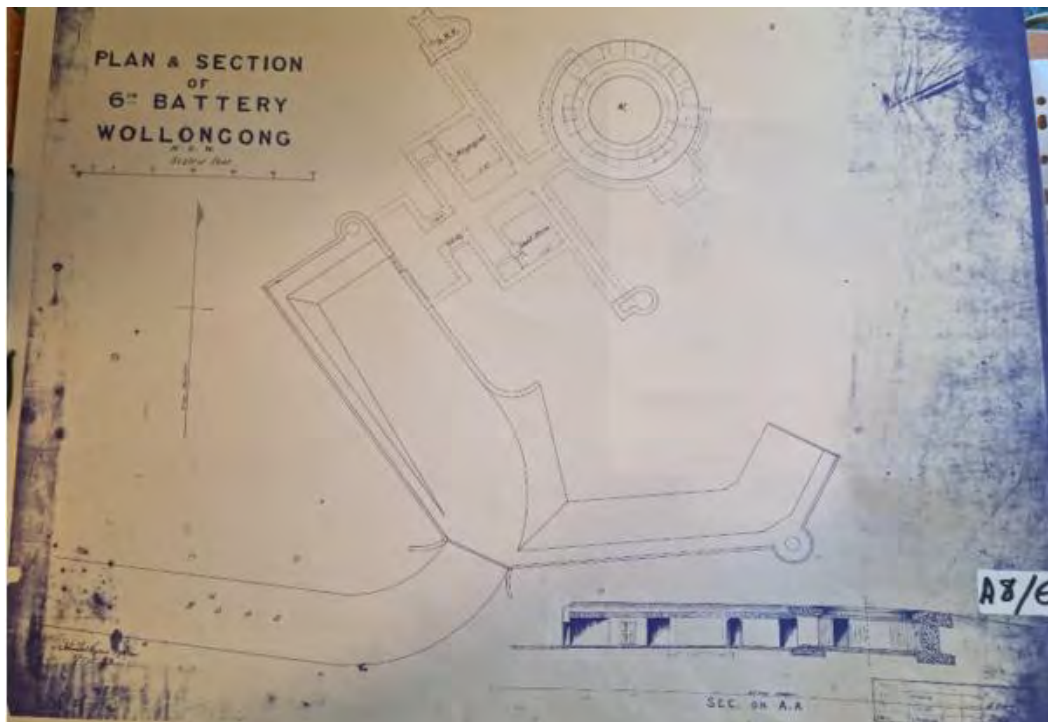
Figure 5.3 Engineering drawing showing the original extent of the Flagstaff Hill Fort. (Source: Royal Australian Artillery Historical Company archives)

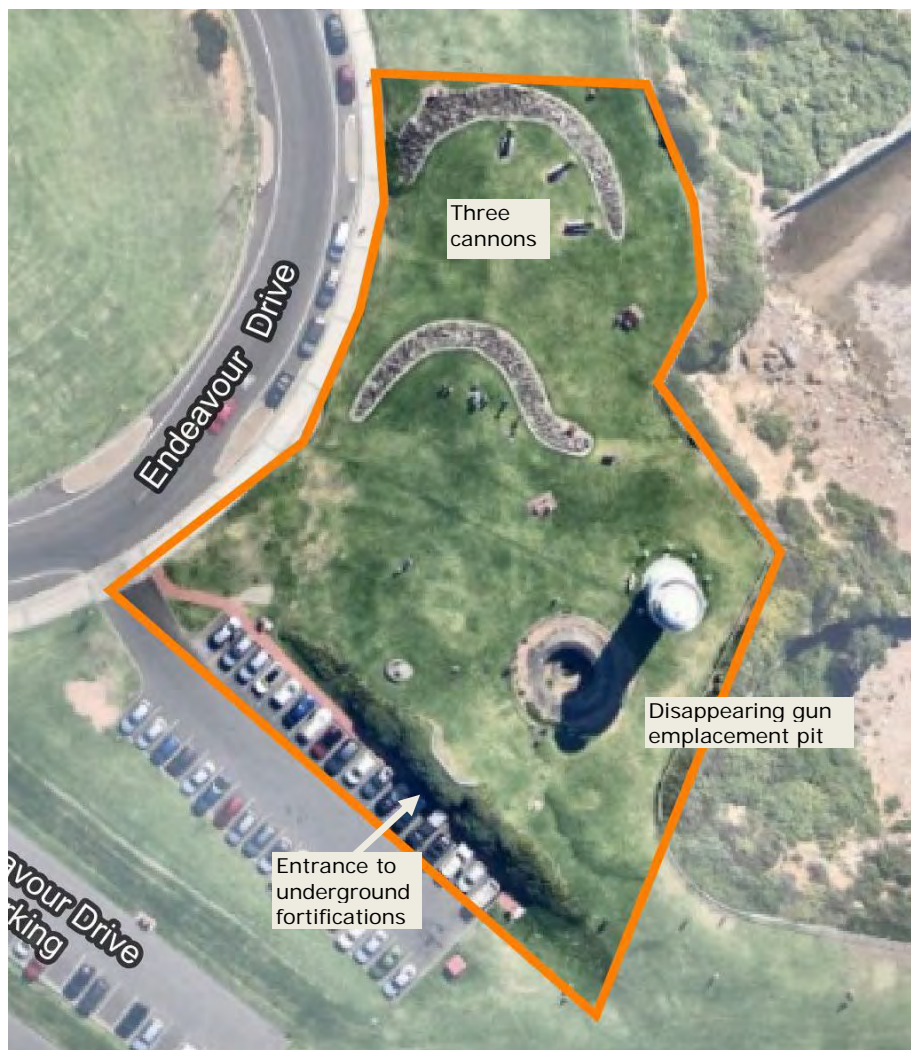
Figure 3.1 Flagstaff Hill Fort site showing boundaries and key above-ground elements. (Source: Nearmap, with GML overlay)

The structures and elements of the Flagstaff Hill Fort are identified in Figure 3.1 and Figure 3.2.

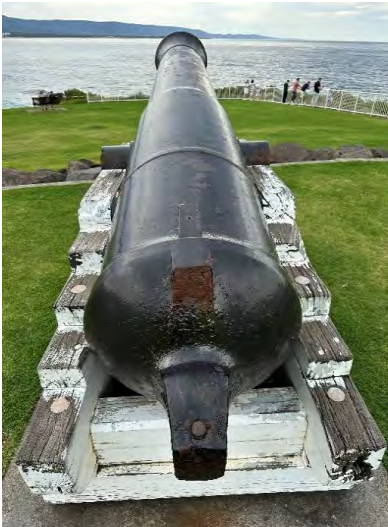
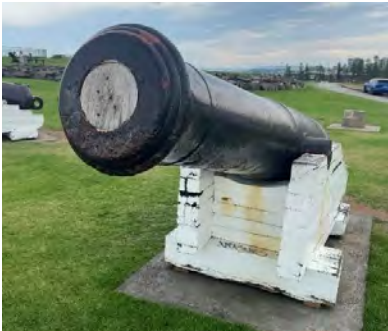
Item, image and significance	Description of works	Priority
<b>1861 guns and carriages</b>		
<p><b>1861 68-pounder guns</b></p> <p>Guns are of exceptional significance.</p>

<ul style="list-style-type: none"> <li>Carefully remove fixings and lift cannons out of gun carriages using a soft sling. Refer to methodology provided by OHM Consultants in Appendix C.</li> <li>Take cannons to workshop for cleaning, rust removal, rust treatment and repainting as specified, in black.</li> <li>Once works are complete and carriages have been repaired, return guns to carriages and refix.</li> <li>Provide a new tompson to detail for each gun to prevent water entry. Prepare and paint in black.</li> </ul>

The 1861 cannons were restored in the 1980s and remain in good condition, although the paintwork has deteriorated significantly. Two of the gun barrels are open to the air and subject to water entry.

The third is fitted with a timber tampion that is showing some signs of decay.

The timber gun carriages, which are held together with galvanised steel bolts, are also showing significant signs of decay; several timbers need repair or replacement. The concrete plinths are in good condition.

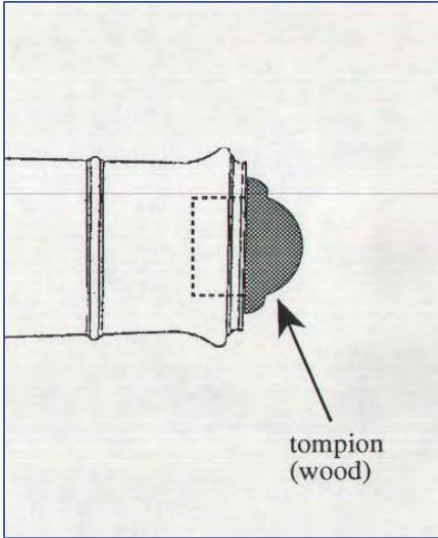
<p>tompson (wood)</p>	<p><b>Medium</b> priority.</p> <p>Complete within 3–5 years.</p>
<p><b>Timber gun carriages—stage 1: temporary repairs</b></p> <p>Gun carriages are reconstructions and of low significance. However, they are important to supporting and interpreting the guns.</p>	<ul style="list-style-type: none"> <li>If cannons are not to be restored off site within 3 years, undertake temporary repairs as follows:             <ul style="list-style-type: none"> <li>Check over timber for signs of decay and rot.</li> <li>Remove soft, unsound timber.</li> <li>Fill larger cavities with epoxy resin.</li> <li>Fill surface fissures with wood filler.</li> </ul> </li> </ul>	<p><b>High</b> priority.</p> <p>Complete within 1–3 years.</p>

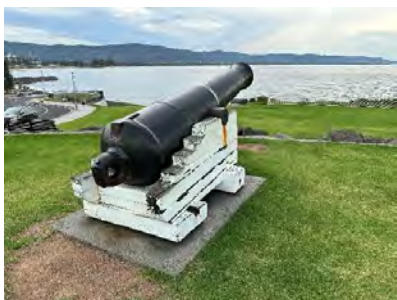
<p><b>Concrete gun plinths</b></p> <p>Gun plinths are of low significance.</p>

<ul style="list-style-type: none"> <li>The existing concrete plinths are in good condition. No works proposed.</li> <li>However, the plinths are not correctly oriented. If it is proposed to relocate and/or reorient the cannons, allow to remove existing plinths and provide new plinths to match the existing in the new locations identified on plan.</li> </ul>	<p><b>Low</b> priority.</p>
<b>Circular gun emplacement pit</b>		
<p><b>Fence around circular gun emplacement pit</b></p> <p>The fence is of low significance.</p>

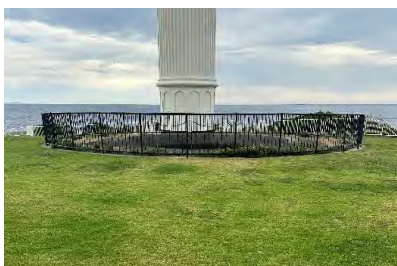
<ul style="list-style-type: none"> <li>Check over fence surrounding gun pit for peeling paint finish, broken joints or members (none currently obvious).</li> <li>Prepare and paint areas where paint is missing. Colour to match existing.</li> </ul>	<p><b>Medium</b> priority for safety.</p> <p>Low priority for conservation.</p> <p>Check annually.</p>

The structure of the gun pit, including its concrete apron, appears to be in good condition, although there is a considerable amount of rubbish and water sitting in the bottom of the pit. The fence around the pit is generally in good condition.

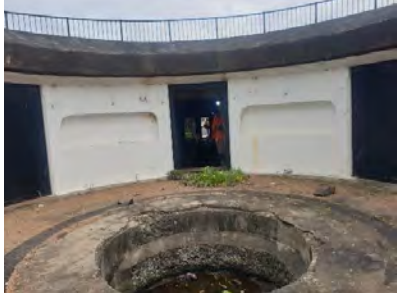
<ul style="list-style-type: none"> <li>Remove loose and decayed cement render.</li> <li>Patch repair inner edge of concrete apron to circular pit that once accommodated gun mount with compo mortar as specified.</li> <li>Fill cracks in concrete that are wider than 5mm with compo mortar as specified.</li> </ul>	Complete within 3–5 years. Remove weeds quarterly.
<p><b>Circular pit at centre of gun emplacement pit</b></p> <p>Pit for disappearing gun mechanism is of exceptional significance.</p>  	<ul style="list-style-type: none"> <li>Remove water from mechanical pit at centre of gun emplacement pit and check over surviving metalwork from former disappearing gun.</li> <li>Investigate and clean out drains from pit.</li> </ul>	<b>High</b> priority. Complete within 1–3 years.
<p><b>Metal fixtures and fittings in gun emplacement pit</b></p> <p>Gun fixtures and fittings are of exceptional significance.</p>	<ul style="list-style-type: none"> <li>Check over all metal fixtures and fittings.</li> <li>Remove corrosion back to a clean, bright surface. Treat metal with rust inhibitor.</li> <li>Prepare and paint as specified.</li> </ul>	<b>Medium</b> priority. Complete within 3–5 years.

<p><b>Steel doors and panels to circular gun pit openings</b></p> <p>Doors are of exceptional significance.</p>	<ul style="list-style-type: none"> <li>Retain and conserve existing doors and panels in situ.</li> <li>Clean back corrosion to a clean, bright surface.</li> <li>Treat with rust inhibitor.</li> <li>Put doors in full working order.</li> <li>Prepare and paint as specified.</li> </ul>	<b>High</b> priority. Complete within 1–3 years.

The steel doors and panels across the openings into the gun pit are in fair condition. Corrosion prevents them from being easily opened.

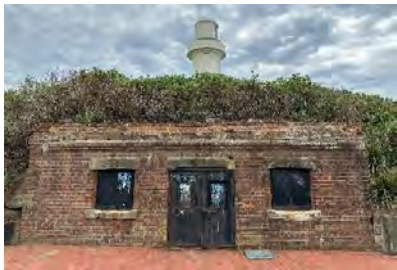
<p><b>Brick façade</b></p> <p>Brick façade is of exceptional significance.</p>

<ul style="list-style-type: none"> <li>Remove all vegetation and roots growing in brickwork.</li> <li>Allow to point up all open joints in the top course of brickwork.</li> <li>Allow to point up open joints in brickwork below left (northern) window.</li> <li>Clean out all weep holes above string course.</li> <li>Re-bed and point up loose bricks in top section of wall and in ragged ends of wall left by demolition of surrounding walls.</li> </ul>	<p><b>High</b> priority.</p> <p>Complete within 1–3 years.</p>
<p><b>Entrance doors</b></p> <p>Steel doors and frames are not original and are of low significance. Opening is of exceptional significance.</p>

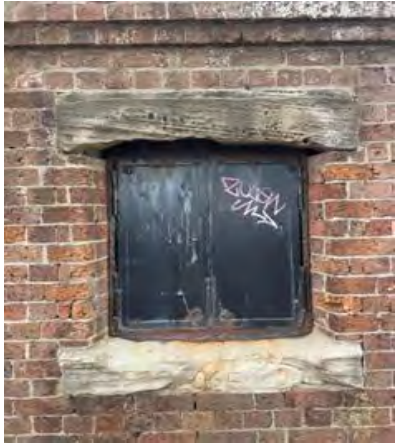
<p><b>Windows</b></p> <p>Steel window shutters and frames are of not original and are of low significance.</p> <p>Openings are of exceptional significance.</p> <p>Timber window elements and remains of iron strap and gudgeon hinges are original and of exceptional significance.</p>

<ul style="list-style-type: none"> <li>Remove steel shutters and frames from window openings. Make good fixing points in masonry using compo mortar.</li> <li>Conserve surviving timber window frame and retain in situ.</li> <li>Conserve remains of iron brackets/strap and gudgeon hinges from original shutters in situ. Clean back corroded material and treat with rust inhibitor. Prepare and paint metalwork.</li> <li>Provide new steel frame and shutters to detail.</li> </ul>	<p><b>Medium</b> priority.</p> <p>Complete within 3–5 years.</p>
<p><b>Stone sills and lintels</b></p> <p>Stone sills and lintels are of exceptional significance.</p>	<p>Door:</p> <ul style="list-style-type: none"> <li>Remove loose bricks from door threshold.</li> <li>Check over stone lintel. Provide temporary support for lintel until new lintel and/or steel doors are installed.</li> <li>If lintel has lost more than 50% of its depth, replace lintel stone in sandstone, detail to match the original prior to decay—including pointed pediment detail to top of stone and label mould to bottom edge.</li> </ul>	<p><b>High</b> priority.</p> <p>Complete within 1–3 years.</p> <p>Stone lintels and sills are in very poor condition and in danger of failing.</p>

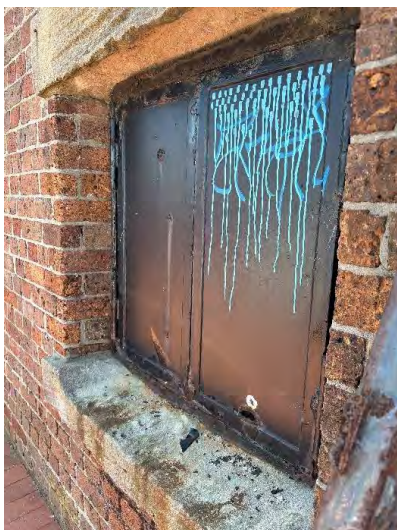
<p>Northern window.</p>	<ul style="list-style-type: none"> <li>If lintel has lost less than 50% of its depth, undertake the following repairs:           <ul style="list-style-type: none"> <li>Cut out decayed underside of stone to even surface, leaving external face of existing stone intact to minimum 100mm depth.</li> <li>Piece in new sandstone lintel beneath existing stone and pin it to the existing stone with stainless steel pins as specified.</li> <li>Pin broken corner of lintel back to lintel with stainless steel pins as specified.</li> <li>Patch repair underside of lintel where steel frame fixings have been removed using compo mortar as specified.</li> </ul> </li> <li>Northern window:           <ul style="list-style-type: none"> <li>Check over stone lintel and sill.</li> <li>Conserve sill in situ.</li> </ul> </li> <li>Gently brush back decayed surface of stone to sound surface.</li> <li>Piece in section of stone to fill hollow beneath sill.</li> <li>Southern window:           <ul style="list-style-type: none"> <li>Replace stone lintel in sandstone; detail to match the original prior to its decay—including pointed pediment detail to top of stone (refer to lintel over door) and flat bottom to bottom of stone.</li> <li>Replace stone sill in sandstone; detail to match the original prior to its decay—including curved slope to top surface of sill (refer to above instructions for northern window) and inclusion of recessed drip to underside of sill.</li> </ul> </li> </ul>

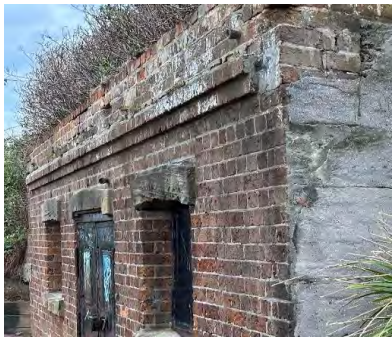
<p>Southern window.</p>		
<p><b>Steel ventilation pipes</b></p> <p>Ventilation pipes are of exceptional significance.</p>

<ul style="list-style-type: none"> <li>Clean out vent pipes projecting from façade.</li> <li>Investigate where pipes are connected using smoke test and fibre optic video camera (industrial endoscope).</li> </ul>	<p><b>High</b> priority.</p> <p>Complete within 1–3 years.</p> <p>Tests will assist in decision-making for internal works.</p>
<p><b>Former observation post and depression range finder</b></p>		
<p><b>Former observation post and depression range finder</b> (see Figure 1.13 in Appendix 3)</p>

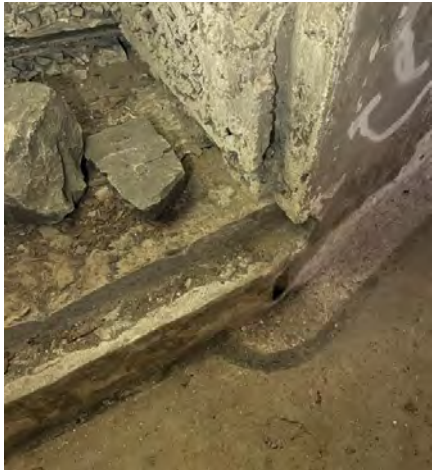
<p>reduce trip hazards.</p>
<p><b>Gravel floor</b></p> <p>Gravel is part of original floor to shell store and of exceptional significance.</p>

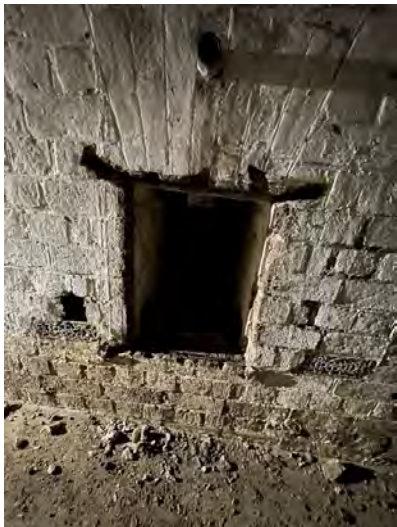
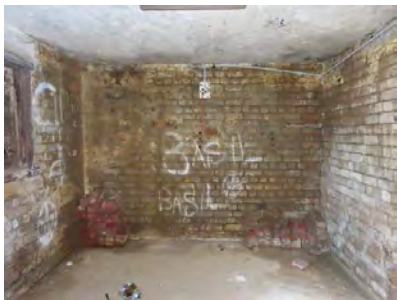
<p>Graffiti.</p>

Item, image and significance	Description of works	Priority
<p><b>Brick walls</b></p> <p>Brick walls are of exceptional significance, as is the original painted signage.</p>

<p>Mould.</p>	<ul style="list-style-type: none"> <li>• Brush walls with soft bristle brush to remove loose material—flaking paint, decaying surface of bricks and mortar. Collect debris and remove from site.</li> <li>• Be careful to conserve remnant painted signage and painted skirting detail.</li> <li>• Remove peeling or separated acrylic paint layers.</li> <li>• Retain and conserve limewash finish.</li> <li>• Remove modern graffiti from brickwork using approved materials and methodology. Ensure that method is selective to individual paint layers and does not remove earlier wall finishes, surface of bricks or mortar from between bricks.</li> <li>• Remove mould using approved materials and methodology. Avoid using bleach. If vinegar is used, gently spray onto surface and dab off. Avoid rubbing surface as this will remove limewash. Avoid contact with metals.</li> </ul>

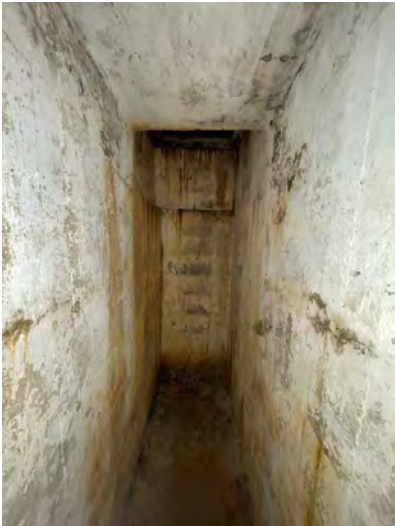
Item, image and significance	Description of works	Priority
<p><b>Concrete walls</b></p> <p>Concrete walls are of exceptional significance.</p>

<ul style="list-style-type: none"> <li>• Conserve evidence of formwork used to build walls.</li> <li>• Brush walls with soft bristle brush to remove loose material—flaking paint, decaying surface of bricks and mortar. Collect debris and remove from site.</li> <li>• Be careful to conserve remnant painted signage and painted skirting details.</li> <li>• Remove peeling acrylic paint layers.</li> <li>• Retain and conserve limewash finish.</li> <li>• Remove modern graffiti from concrete walls using approved materials and methodology. Ensure that method is selective to individual paint layers and does not remove earlier wall finishes or impact surface of concrete.</li> <li>• Remove mould using approved materials and methodology. Avoid using bleach. If vinegar is used, gently spray onto surface and dab off. Avoid rubbing surface as this will remove limewash. Avoid contact with metals.</li> </ul>	<p><b>Medium</b> priority.</p> <p>Mould removal will be ongoing.</p> <p>For conservation of original fabric, but also for health and safety of visitors and staff.</p>

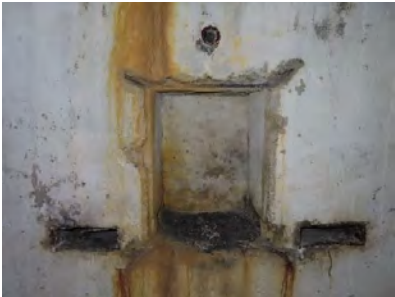
<p><b>Lamp niches</b></p> <p>Lamp niches are of exceptional significance.</p>

<ul style="list-style-type: none"> <li>• Conserve all lamp niches in situ, including ventilation pipes and openings in wall (above and to each side of each niche).</li> <li>• Conserve metal surrounds to wall vents.</li> <li>• Conserve lamp housing in the shelf of each niche.</li> <li>• Conserve all evidence of the framing for fireproof glass enclosures to the lamps. This includes scarring and remains of metalwork left in wall surrounding the recesses.</li> </ul>	<p><b>Medium</b> priority.</p> <p>Ongoing.</p> <p>To conserve original fabric.</p>

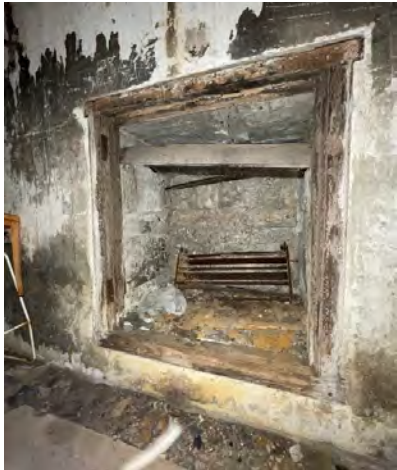
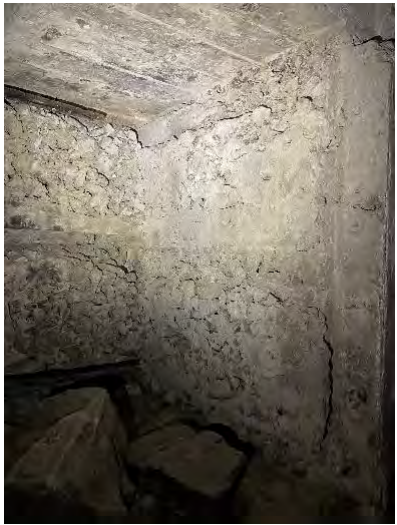
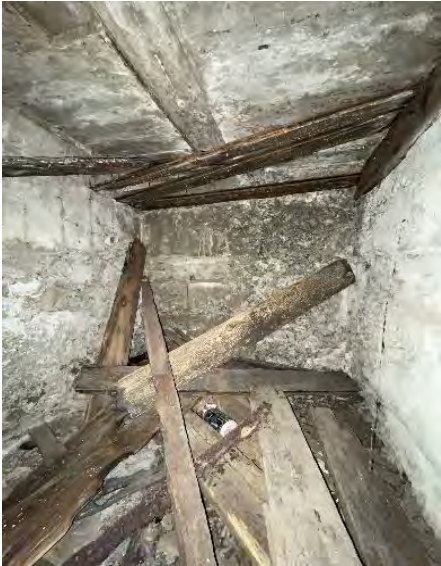
<p><b>Wall recesses</b></p> <p>Wall recesses are of exceptional significance.</p>

<ul style="list-style-type: none"> <li>Retain and conserve all wall recesses in their existing state.</li> <li>Conserve all evidence of how recesses were constructed.</li> <li>Conserve remnant framing and timber elements that originally formed linings to recesses in situ.</li> <li>Remove rubbish and decayed material from openings.</li> <li>Conserve metal fixtures and fittings in situ.</li> </ul>

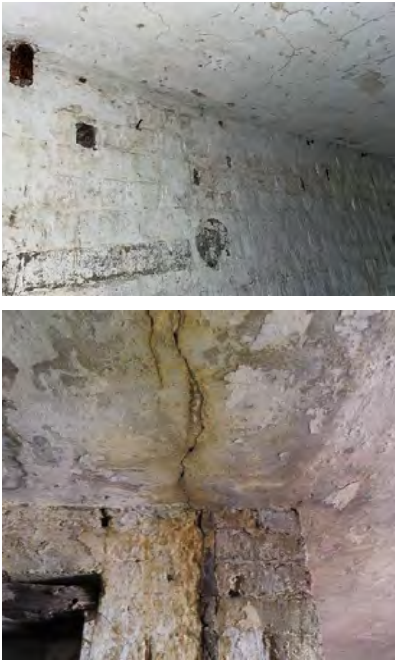
Item, image and significance	Description of works	Priority
<b>Ceilings</b> Ceilings are original and of exceptional significance.

<ul style="list-style-type: none"> <li>• Brush ceilings with soft bristle brush to remove loose material—flaking paint, decaying surface of bricks and mortar. Collect debris and remove from site.</li> <li>• Remove peeling acrylic paint layers.</li> <li>• Retain and conserve limewash finish.</li> <li>• Remove modern graffiti from ceiling using approved materials and methodology. Ensure that method is selective to individual paint layers and does not remove earlier ceiling finishes, surface of bricks or mortar from between bricks.</li> <li>• Remove mould using approved materials and methodology. Avoid using bleach. If vinegar is used, gently spray onto surface and dab off. Avoid rubbing surface as this will remove limewash. Avoid contact with metals.</li> </ul>	<b>Medium</b> priority. Mould removal will be ongoing. For conservation of original fabric, but also for health and safety of visitors and staff.

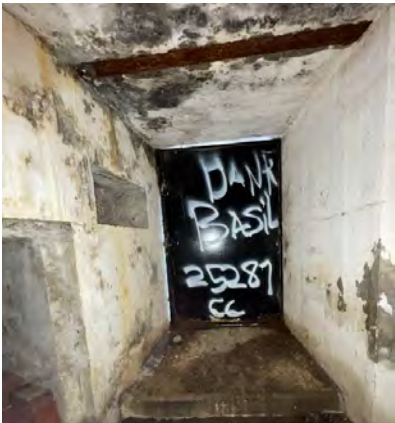
<b>Iron rails/beams in ceilings</b> Iron rails/beams are original fabric and of exceptional significance.

<ul style="list-style-type: none"> <li>• Carefully remove any loose and spalling concrete from around iron rails.</li> <li>• Remove any loose rusted material from surface of rails.</li> <li>• Investigate structural integrity of iron rails and concrete around them.</li> <li>• Clean and treat with rust inhibitor.</li> </ul>	<b>High</b> priority. Complete within 1–3 years. Important to maintaining structural stability.
<b>Metal ceiling vents</b> Ceiling vents are original fabric and of exceptional significance.	<ul style="list-style-type: none"> <li>• Retain existing ceiling vents in situ.</li> </ul>	<b>High</b> priority.

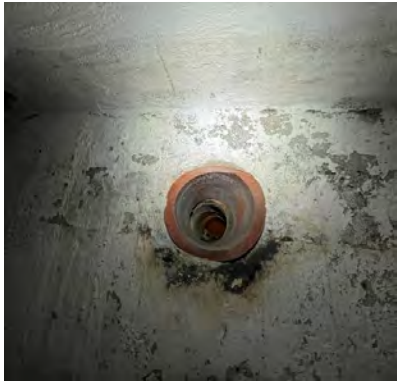
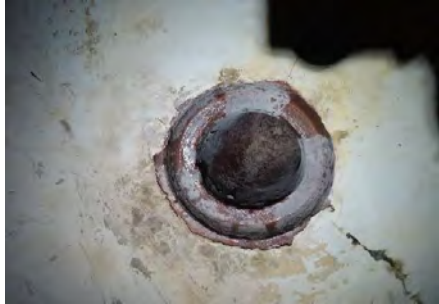
<p>Complete within 1–3 years.</p> <p>Important to maintaining air quality as well as conservation of significant fabric.</p>
<p><b>Terracotta ceiling vent</b></p> <p>Terracotta vent is introduced fabric and of moderate significance.</p>

<ul style="list-style-type: none"> <li>Conserve terracotta vent pipes in situ.</li> <li>Investigate vent's connection with the original ventilation system—assumed to have been installed when roof vents blocked up.</li> </ul>

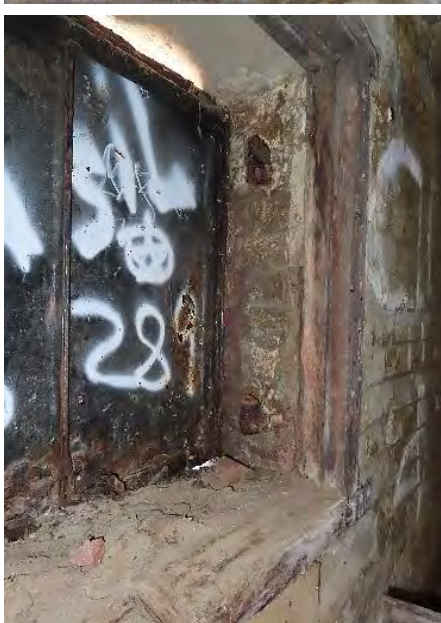
<p>Northern window of front façade showing timber frame for casement sashes and strap and gudgeon shutter hinges.</p>

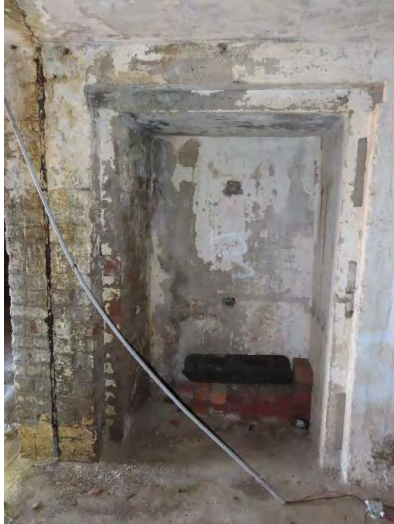
<p>Evidence of door frame around store.</p>		
<p><b>Internal steel doors and frames</b></p> <p>Remains of steel doors and frames are of exceptional significance</p> <p>Note: Bombproof covering materials are missing</p>

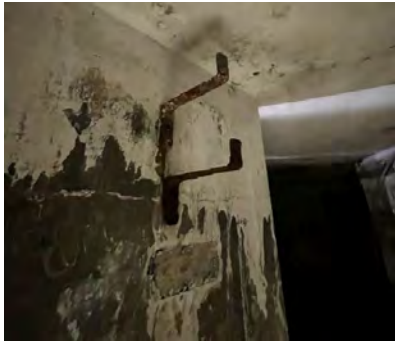
<p><b>Iron/steel fixtures and fixings</b></p> <p>All early fixings are of exceptional significance.</p>

<ul style="list-style-type: none"> <li>Retain and conserve original fixtures and fittings in situ.</li> <li>Retain and conserve strap hinges on corners of passages in situ.</li> <li>Clean and treat all ironwork with rust inhibitor.</li> </ul>	<p><b>Medium</b> priority.</p> <p>Complete within 3–5 years.</p> <p>Ongoing.</p> <p>To conserve original fabric.</p>
<p><b>Shaft to former observation post</b></p> <p>Shaft is of exceptional significance.</p> <p>Structure supporting shaft is of low significance.</p>	<ul style="list-style-type: none"> <li>Investigate integrity and stability of structure holding fill in shaft leading up to former observation post.</li> <li>Record existing iron structure in photographs and drawings.</li> <li>If shaft is to be reopened in the future, construct timber frame beneath shaft to support structure and fill above.</li> <li>Install temporary safety barricade across passage to prevent entry to area below shaft.</li> </ul>	<p><b>High</b> priority.</p> <p>Complete within 1–3 years.</p> <p>For safety.</p>

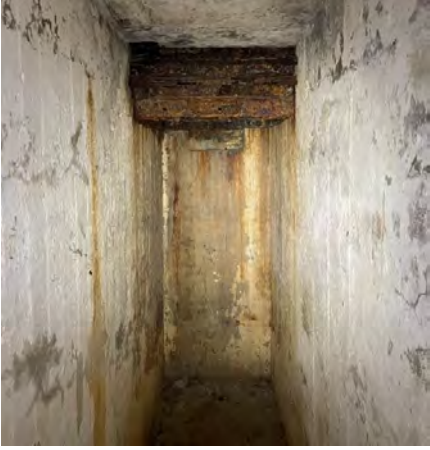
<p><b>Shaft to former depression range finder</b></p> <p>Shaft is of exceptional significance.</p> <p>Structure supporting shaft is of low significance.</p>

<ul style="list-style-type: none"> <li>• Investigate integrity and stability of structure holding fill in shaft leading up to former depression range finder.</li> <li>• Record existing iron structure in photographs and drawings.</li> <li>• If shaft is to be reopened in the future, construct timber frame beneath shaft to support structure and fill above.</li> <li>• Install temporary safety barricade across passage to prevent entry to area below shaft.</li> <li>• Monitor condition of shaft closely.</li> <li>• If shaft is not to be reopened, construct new structural support to replace existing steel grate. The support structure should not obscure evidence of the shaft and ladder from view.</li> </ul>	<p><b>High</b> priority.</p> <p>Complete within 1–3 years.</p> <p>For safety.</p>

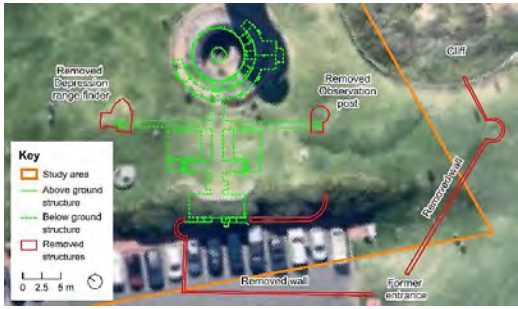
Item, significance	Description of works	Priority
<b>Exterior works to underground complex</b>		
<b>Entrance forecourt to underground fortifications</b>  Existing footpath and carpark are of low significance.	<ul style="list-style-type: none"> <li>Remove parking spaces from immediately in front of main entrance to underground fortifications.</li> <li>Develop design for new forecourt in front of main entrance to interpret former nineteenth-century walled compound area. Possibly build low walls and seating around original (southern) walled entrance to underground fortifications. Refer to original plans for fortifications.</li> </ul>

<ul style="list-style-type: none"> <li>Install bollards to prevent vehicular access and entry to new forecourt area.</li> <li>Use paving to define area that is pedestrianised zone only.</li> </ul>	<b>Bollards—high priority.</b> Complete within 1–3 years. For protection of site. Forecourt development— <b>medium priority.</b> Complete within 3–5 years. To improve safety and interpretation of site.

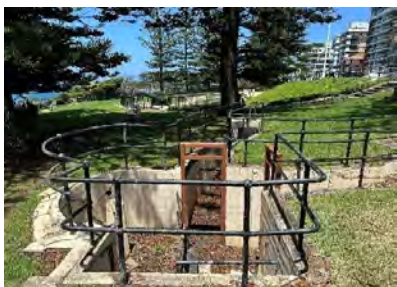
Item, image and significance	Description of works	Priority
<b>Tree removal</b>		
<p><b>Norfolk Island Pines</b></p> <p>Trees are <b>significant</b> to the park and are listed as significant landscape items by Council.</p>

<p>Tree over underground fortifications.</p> <p><b>Issue:</b> damage to structures caused by trees.</p>	<ul style="list-style-type: none"> <li>Refer to arborist's report (Appendix D) on trees at northern end of fortifications.</li> <li>Carefully remove tree from top of underground fortifications. Grind out stump if possible without damaging structure.</li> <li>Engage arborist to investigate tree up the hill from the Nordenfelt gun to determine its impact on the fortifications.</li> <li>Cut back invasive roots of trees that are impacting the fortification structures.</li> <li>Install a tree root barrier behind the fortification walls.</li> <li>Continue to monitor roots.</li> </ul>	<p><b>High</b> priority.</p> <p>Complete within 1–3 years.</p> <p>Essential to protect and limit damage to heritage structures.</p>

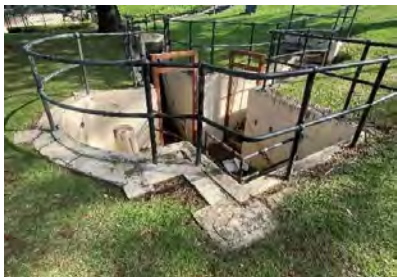
Item, image and significance	Description of works	Priority
<b>Depression range finder</b>		
Photographic record.	<ul style="list-style-type: none"> <li>Prior to undertaking repair and reconstruction works, photographically record the depression range finder—all elevations, floor and layout.</li> </ul>	<b>High</b> priority. Complete within 1–3 years.
<b>Fence</b> Fence is of low significance.

<ul style="list-style-type: none"> <li>Remove existing fence.</li> <li>Provide a new steel fence or other safety barrier outside the existing structure. It must be freestanding and not fixed to the structure.</li> </ul>	<b>High</b> priority. Complete within 1–3 years. Current fence has caused damage to structure.
<b>Vegetation</b> Grass is of low significance. (Fortification walls are of exceptional significance.)

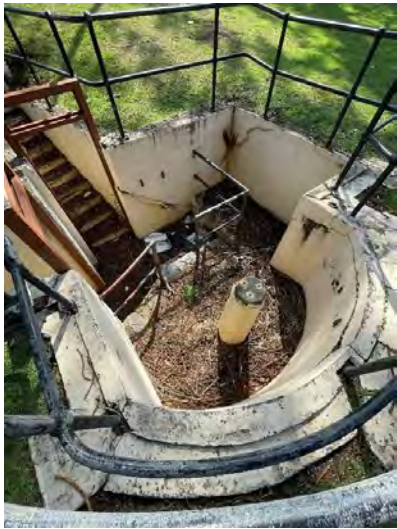
Item, image and significance	Description of works	Priority
	<ul style="list-style-type: none"> <li>Fill and returf this area so that the depression range finder continues to be set into the ground.</li> </ul>	
<p><b>Concrete floor and steps of depression range finder</b></p> <p>Concrete floor and steps are original fabric and are of exceptional significance.</p>

<ul style="list-style-type: none"> <li>Remove all debris from depression range finder.</li> <li>Conserve existing concrete floor and steps.</li> <li>Investigate area around slate tread, which does not appear to be original. Retain in situ.</li> </ul>	<p><b>High</b> priority.</p> <p>Complete within 1–3 years.</p> <p>Ongoing.</p>
<p><b>Grated drains</b></p> <p>Drain is original, of exceptional significance and important for removing water from site.</p> <p>Grates may not be original (age to be confirmed). However, grates were included over the drains in the original design. The hinged grates allow easy access to clean out drains.</p>

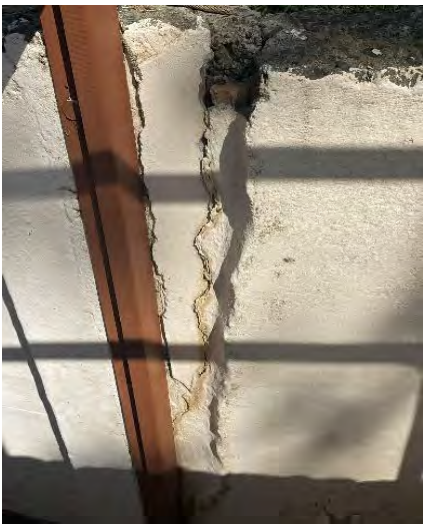
<ul style="list-style-type: none"> <li>Remove loose pieces of concrete and cement patching.</li> <li>Assess cracks and displacement.</li> <li>Stitch cracks in concrete walls using HeliBars or similar and fill gaps with cement mortar as detailed by engineer. Finish should match surrounding wall finish (markings from timber boarded formwork).</li> <li>Provide vertical control joints between concrete and brickwork where cracks exist.</li> <li>Fill cracks in top edge of depression range finder with cement mortar; finish to match surrounding surfaces.</li> <li>Patch top of concrete wall where balustrade removed with cement mortar.</li> </ul>

<p><b>High priority.</b></p> <p>Complete within 1–3 years.</p> <p>To stabilise and conserve significant structure.</p>

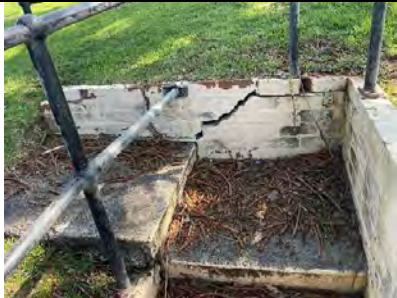
<p><b>Brick walls on uphill side of depression range finder</b></p> <p>Red brickwork at top of stairs is not original and of low significance.</p>	<ul style="list-style-type: none"> <li>Brickwork of top section of wall appears to be single-skin only and inadequate to retain the embankment above it.</li> </ul>	<p><b>High priority.</b></p> <p>Complete within 1–3 years.</p>

<ul style="list-style-type: none"> <li>Rebuild damaged brickwork at top of stairs:               <ul style="list-style-type: none"> <li>Ensure new brickwork is bonded into existing brickwork.</li> <li>Incorporate strengthening elements as detailed by engineer (eg second skin of brickwork).</li> <li>Include subsurface drainage and weep holes or drainage holes in wall.</li> </ul> </li> </ul>	To stabilise structure.
<p><b>Brick walls between shaft and depression range finder</b></p> <p>Brick walls are original and of exceptional significance.</p>

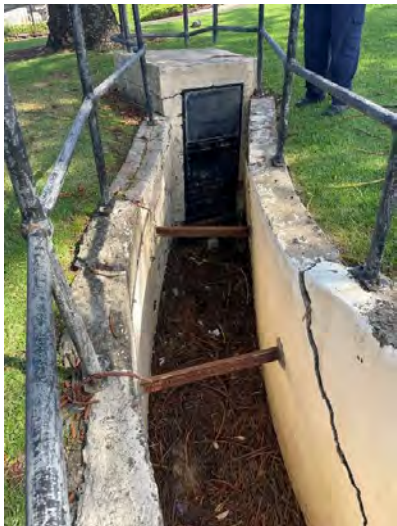
<ul style="list-style-type: none"> <li>With the exception of the top courses, brickwork appears to be original. Salvage original bricks from collapsing walls.</li> <li>Rebuild brick walls as detailed by structural engineer:               <ul style="list-style-type: none"> <li>Re-use original bricks for the exposed front face of the walls.</li> <li>Note that face brickwork is currently laid in stretcher bond. If stretcher bond is to be retained, include ties to bond inner and outer brick skins together.</li> <li>New bricks may be used for concealed brickwork and to complete the top of the walls.</li> <li>Include wall strengthening or external piers as detailed by engineer.</li> <li>Include weep holes or drainage holes to prevent build-up of water behind walls.</li> </ul> </li> <li>Provide subsurface drainage behind walls as detailed by hydraulics engineer.</li> <li>Remove steel braces once repairs are complete, and make good, but only if drainage and strengthening of walls have been undertaken.</li> </ul>	<p><b>High priority.</b></p> <p>Complete within 1–3 years.</p> <p>To stabilise and conserve significant structure.</p>

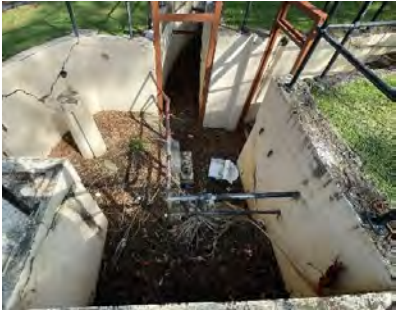
Item, image and significance	Description of works	Priority
<p><b>Handrails inside depression range finder</b></p> <p>Steel handrails are original and of exceptional significance.</p>

<ul style="list-style-type: none"> <li>Retain existing handrails.</li> <li>Treat handrails with rust inhibitor, prepare and paint.</li> </ul>	<p><b>Medium</b> priority.</p> <p>Complete within 3–5 years.</p> <p>To conserve significant fabric.</p>
<p><b>Stone pillar</b></p> <p>Stone pillar appears to be early and of exceptional significance.</p>

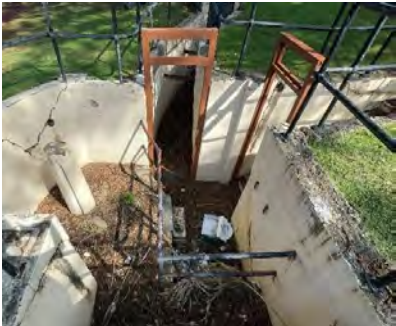
<ul style="list-style-type: none"> <li>Retain and conserve pillar.</li> </ul>	<p><b>Medium</b> priority.</p> <p>Complete within 3–5 years.</p> <p>Ongoing.</p>
<p><b>Timber door frames</b></p> <p>Timber door frames are modern fabric and of low significance.</p> <p>They assist in interpreting the depression range finder.</p>

<ul style="list-style-type: none"> <li>Retain existing timber door frames.</li> <li>Repair as necessary.</li> <li>Prepare and paint.</li> </ul>	<p><b>Medium</b> priority.</p> <p>Complete within 3–5 years.</p>

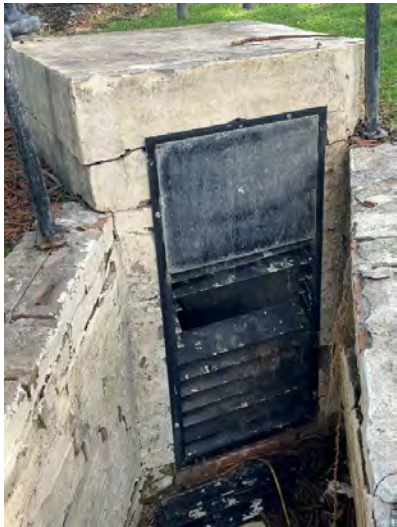
Item, image and significance	Description of works	Priority
<b>Metal ventilation panel to shaft</b> Metal panel is intrusive.

<ul style="list-style-type: none"> <li>Remove existing panel and frame.</li> <li>Replace with new louvred panel in same location; size to match existing.</li> </ul>	<b>High priority.</b> Complete within 1–3 years. Work to be undertaken in conjunction with work to access shaft.
<b>Battery—generally</b>		
<b>Debris</b>  	<ul style="list-style-type: none"> <li>Remove all loose gravel and other debris from floor of battery.</li> </ul>	<b>High priority.</b> Complete within 1–3 years. Ongoing.
<b>Concrete paving</b> Early concrete paving is of exceptional significance.

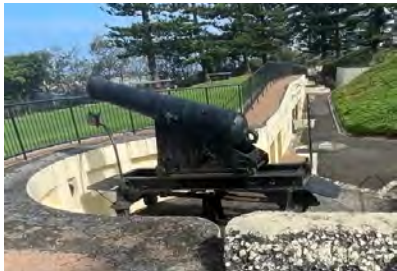
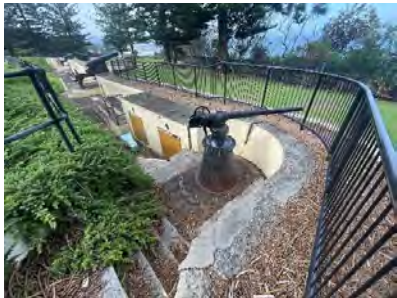
Item, image and significance	Description of works	Priority
<b>Gun emplacements</b>		
<p><b>Guns and gun carriages</b></p> <p>Guns and carriages are of exceptional significance.</p>

<ul style="list-style-type: none"> <li>Carefully remove fixings and lift guns out of gun carriages using a soft sling. Refer to methodology provided by OHM consultants in Appendix C.</li> <li>Take guns to workshop for cleaning, rust removal, rust treatment and repainting as specified, in black.</li> <li>Once works are complete and carriages have been repaired, return guns to carriages and reinstate on site.</li> <li>Provide a new tompion to detail for each gun to prevent water entry. Prepare and paint in black.</li> </ul>	<p><b>High priority.</b></p> <p>Complete within 1–3 years.</p> <p>To conserve significant fabric and to reduce risk of cuts to visitors.</p>
<p><b>Raised concrete plinths</b></p> <p>Raised concrete plinths are original and of exceptional significance.</p>

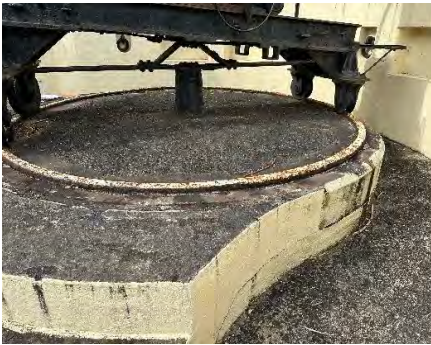
<p><b>Stone ring to plinths</b></p> <p>Stone capping is of exceptional significance.</p>	<ul style="list-style-type: none"> <li>Retain and conserve stone edges to plinths.</li> <li>Remove debris from drains and ensure they are functional.</li> <li>Remove loose and decayed stone debris using a soft bristle brush.</li> <li>Check over joints and cracks in stones.</li> </ul>	<p><b>High priority.</b></p> <p>Complete within 1–3 years.</p> <p>Undertake works at same time as repairs to guns.</p>

Item, image and significance	Description of works	Priority
 	<ul style="list-style-type: none"> <li>• Check over previous patch repairs. Remove loose patching material.</li> <li>• Point up open joints with lime compo mortar. Do not widen joints.</li> <li>• Patch repair stones only where there is a recess in the top of the stone to hold water—greater than 5mm deep.</li> </ul>

<p><b>Steel rails for guns</b></p> <p>Steel rails supporting guns are of exceptional significance.</p>  	<ul style="list-style-type: none"> <li>• Clean rails back to clean, bright metal.</li> <li>• Treat rails with rust converter.</li> </ul>	<p><b>High priority.</b></p> <p>Complete within 1–3 years.</p> <p>Undertake works at same time as repairs to guns.</p>
