## PUBLIC EXHIBITION - FLAGSTAFF HILL AND SMITHS HILL FORTS CONSERVATION MANAGEMENT PLAN

A draft Conservation Management Plan has been prepared for the Flagstaff Hill and Smith's Hill Fortifications. This report seeks Council's endorsement of the draft Conservation Management Plan for public exhibition to allow stakeholders and the community feedback.

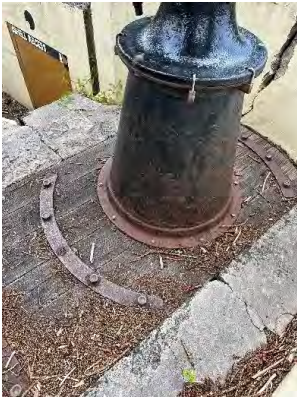
Item, image and significance	Description of works	Priority
<p><b>Timber deck under Nordenfelt gun</b></p> <p>Timber deck is not original and is of low significance, although the iron straps and bolts securing the timbers are of moderate significance.</p>

<ul style="list-style-type: none"> <li>Remove debris and check over timber deck.</li> <li>Replace decayed timbers.</li> <li>Oil deck to extend its life.</li> <li>Clean back metalwork to bright surface.</li> <li>Treat with rust inhibitor.</li> </ul>	<p><b>High</b> priority.</p> <p>Complete within 1–3 years.</p> <p>Undertake works at same time as repairs to guns.</p>
<b>Bombproof shelter</b>		
<p><b>Concrete floor</b></p> <p>Floor and steps of bombproof shelter are of exceptional significance.</p>

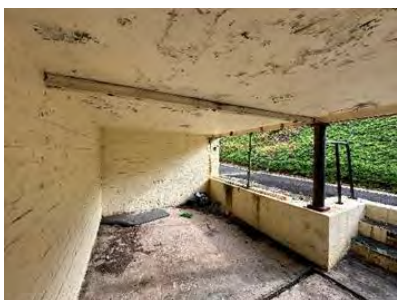
Item, image and significance	Description of works	Priority
<p><b>Concrete roof</b></p> <p>Roof of bombproof shelter is of exceptional significance.</p> <p>Evidence of former structure in southern half of casemate is of high significance.</p>

<ul style="list-style-type: none"> <li>Retain and conserve existing concrete roof.</li> <li>Retain timber plate fixed to underside of roof and evidence of timbers embedded in concrete at southern end of space.</li> <li>Remove peeling paint and spalling concrete from ceiling.</li> <li>Clean any exposed reinforcement and treat with rust inhibitor.</li> <li>Remove peeling paint. Prepare and paint ceiling.</li> </ul>	<p><b>High priority.</b></p> <p>Complete within 1–3 years.</p>

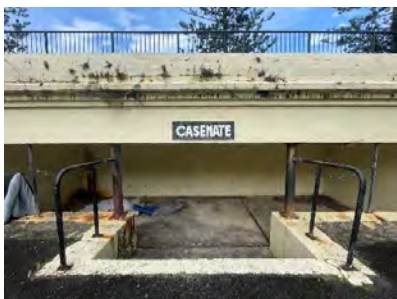
<ul style="list-style-type: none"> <li>Remove peeling paint. Prepare and paint walls.</li> </ul>	
<p><b>Original steel columns, beam and handrails</b></p> <p>Beam is original and of exceptional significance.</p> <p>Large diameter steel columns are original and of exceptional significance.</p> <p>Handrails are of exceptional significance.</p>

<ul style="list-style-type: none"> <li>Clean steelwork back to clean, bright surface.</li> <li>Treat with rust inhibitor.</li> <li>Prepare and paint.</li> </ul>	<p><b>High priority.</b></p> <p>Complete within 1–3 years.</p> <p>To conserve original fabric and maintain structural integrity.</p>

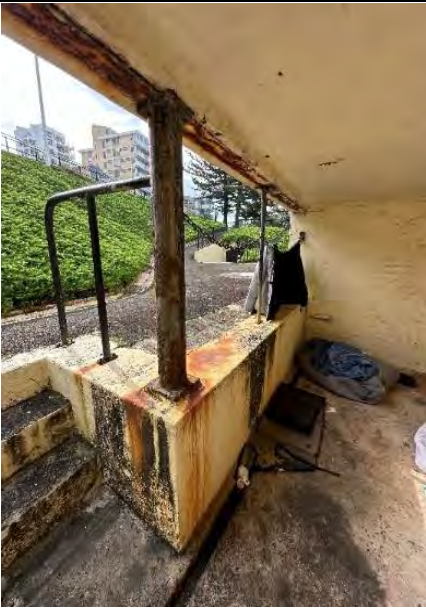
<p><b>Galvanised steel columns and chains</b></p> <p>Small diameter columns and chains are late twentieth-century and of low significance.</p>	<ul style="list-style-type: none"> <li>Investigate structural integrity of steel columns and temporary prop supports.</li> <li>Repair broken chain at southern end of space.</li> <li>Clean steelwork back to clean, bright surface.</li> <li>Treat with rust inhibitor.</li> <li>Prepare and paint.</li> </ul>	<p><b>Medium</b> priority.</p> <p>Complete within 3–5 years.</p>
<b>Entrance to underground magazine</b>		
<p><b>Brickwork</b></p> <p>Brickwork above entry is of exceptional significance.</p>	<ul style="list-style-type: none"> <li>Retain and conserve brickwork, including arch detail over door.</li> <li>Check over joints at top of wall and point up any open joints with compo mortar.</li> </ul>	<p><b>Medium</b> priority.</p> <p>Complete within 3–5 years.</p> <p>Undertake works at same time as other brick repairs to fortification.</p>

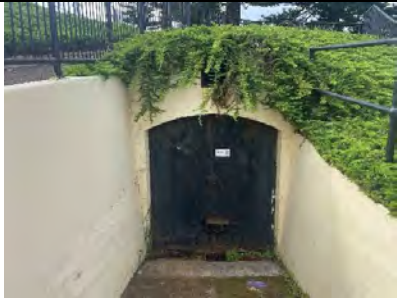
<p><b>Steel doors</b></p> <p>Steel doors appear to be early and of exceptional significance.</p>	<ul style="list-style-type: none"> <li>Retain and conserve steel doors.</li> <li>Ease doors and ensure they are in full working order.</li> </ul>	<p><b>High</b> priority.</p> <p>Complete within 1–3 years.</p>

<ul style="list-style-type: none"> <li>• Clean back metal to clean, bright finish.</li> <li>• Treat with rust inhibitor.</li> <li>• Prepare and paint.</li> </ul>	To conserve significant fabric.
<p><b>Louvred vent above doors</b></p> <p>Brick opening for vent is original and of exceptional significance.</p> <p>Louvred vent appears to have been replaced.</p>	<ul style="list-style-type: none"> <li>• Retain and conserve louvred vent.</li> <li>• Clean back metal to clean, bright finish.</li> <li>• Treat with rust inhibitor.</li> <li>• Prepare and paint.</li> </ul>	<p><b>High</b> priority.</p> <p>Complete within 1–3 years.</p>
<b>Landscape elements</b>		
<p><b>Steel fence</b></p> <p>Steel fence is modern and of low significance.</p>

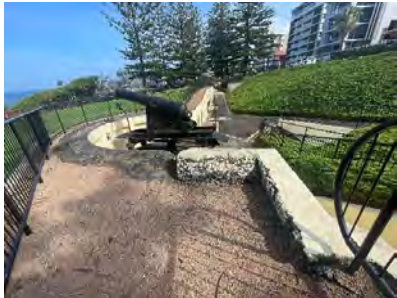
<p><b>Gravel</b></p> <p>Gravel is of low significance.</p>

<ul style="list-style-type: none"> <li>• Retain but manage gravel so that it does not constantly fall into battery.</li> </ul>	<p><b>Medium</b> priority.</p> <p>Complete within 3–5 years.</p> <p>Ongoing.</p>

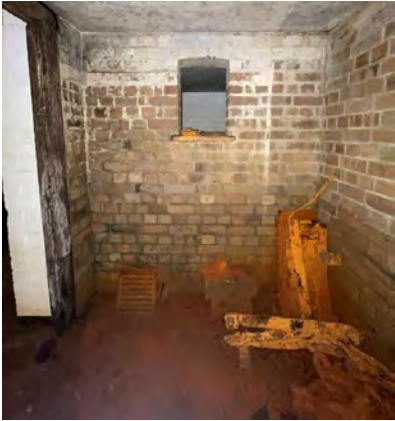
<p>Steel shutters and grates.</p>

<p>Steel panels.</p>	<ul style="list-style-type: none"> <li>Remove all rubbish and debris from interior of the complex.</li> <li>Check through stored metalwork with heritage consultant with expertise in fortification hardware and armaments. This includes large steel plates, shutters, brackets and grates, all of which appear to belong to the fortification complex.             <ul style="list-style-type: none"> <li>Remove items that are clearly modern and do not belong to the fortifications.</li> <li>Salvage all other items, brush off surface corrosion and remove areas of friable corrosion. Treat with rust inhibitor.</li> <li>Record, label and inventory items and, if possible, identify their original functions and locations.</li> <li>Store items off the floor (on palette) and manage items in accordance with conservation policy for movable heritage—until detailed investigations can identify their original use, heritage significance, future viability and interpretation potential.</li> </ul> </li> <li>Check over stored timber items that appear to belong to the fortification complex (eg door frames, panel door leaves including replica doors, timbers with tenons, mortices or rebates).             <ul style="list-style-type: none"> <li>Salvage, inventory and store items for future/potential reinstatement.</li> </ul> </li> <li>Remove loose bricks and pile of loose timbers.</li> <li>Undertake hazardous materials investigation.</li> <li>Investigate mould treatment options that will not impact original surfaces eg UV-C light.</li> </ul>	<p><b>High</b> priority.</p> <p>Complete within 1–3 years.</p> <p>To conserve significant elements to enable their future reinstatement where appropriate.</p>

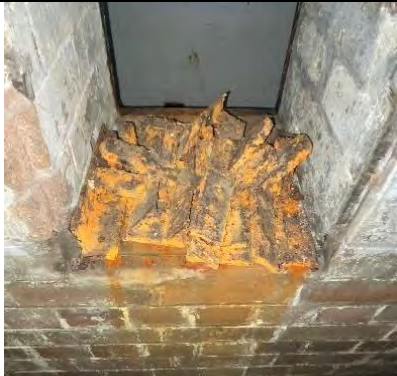
<p>Metal brackets.</p>

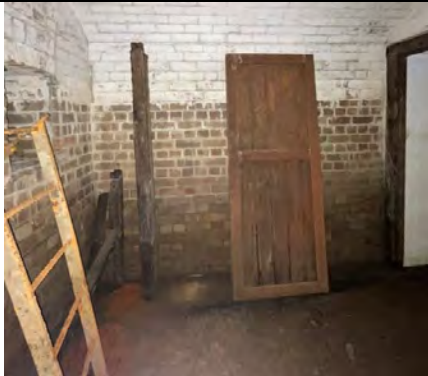
<p>Timber door frames and doors.</p>

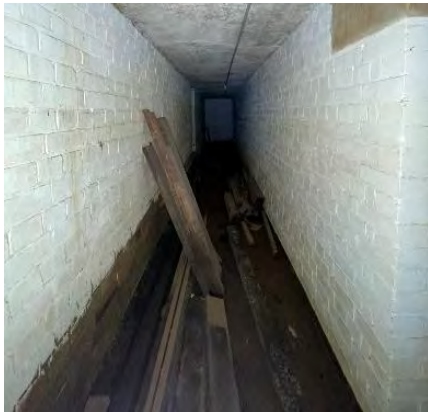
<p>Timber framing.</p>	
<p><b>Concrete floor</b></p> <p>Concrete floor is original and of exceptional significance.</p>

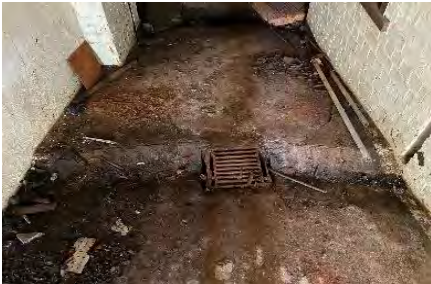
<p>Dish drain.</p>

<p>Pit with grate.</p>	<ul style="list-style-type: none"> <li>• Clear all floor drains of debris.</li> <li>• Conserve open channels and dish drains.</li> <li>• Clean out all drainage pits and sumps.</li> <li>• Clean existing grates and treat with rust inhibitor.</li> <li>• If grates are too fragile, provide new steel grates to pits/sumps. Grates are to match existing and are to be removable to enable cleaning.</li> </ul>

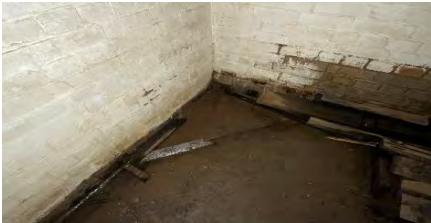
<p>Channel drain.</p>	<p><b>High priority.</b></p> <p>Complete within 1–3 years.</p> <p>Maintenance of drains will be ongoing.</p>

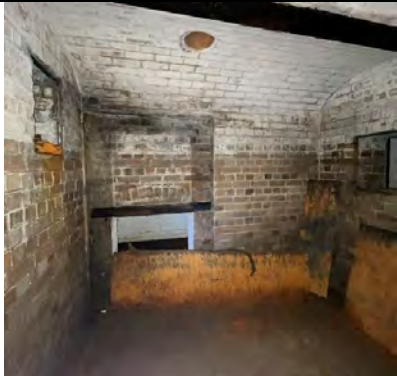
<p>Shadow left by shutter framing to opening from cartridge store.</p>	<ul style="list-style-type: none"> <li>Do not block wall cavities—doing so contributes to the lack of ventilation of the underground spaces.</li> </ul>

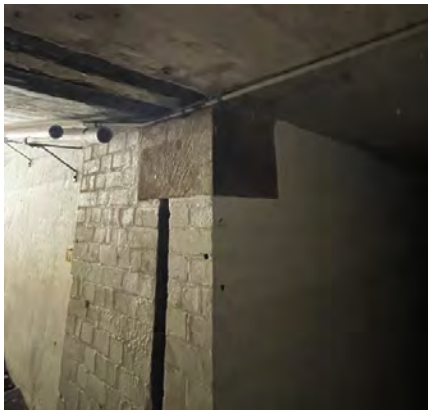
<p>Cavity in brickwork.</p>	
<p><b>Access shaft to depression range finder</b></p> <p>Shaft is of exceptional significance.</p> <p>Ladder is of exceptional significance.</p>

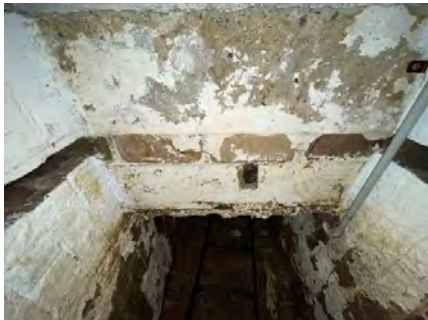
<p>Shadow of frame.</p>	<p><b>Medium</b> priority.</p> <p>Complete within 3–5 years.</p> <p>Ongoing.</p>
<p><b>Lamp niches</b></p> <p>Lamp niches are of exceptional significance.</p>	<ul style="list-style-type: none"> <li>Conserve all lamp niches in situ, including ventilation pipes and openings in wall (above and to each side of each niche).</li> <li>Conserve metal frames and lamp housings.</li> </ul>	<p><b>Medium</b> priority.</p> <p>Complete within 3–5 years.</p> <p>Ongoing.</p>

<ul style="list-style-type: none"> <li>Retain remnant limewash on walls.</li> <li>Retain and conserve metal ladder in situ.</li> <li>Retain and conserve shadow of frame above opening to shaft.</li> <li>Replace ventilation fan when needed.</li> </ul>

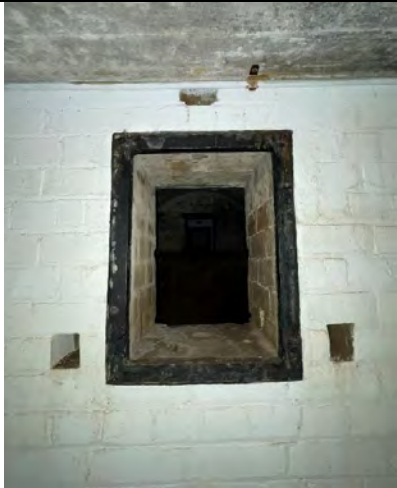
<p>Framed lamp niche with ventilation holes on each side and at top of niche.</p>	<ul style="list-style-type: none"> <li>Conserve lamp housing in the shelf of each niche.</li> <li>Conserve all evidence of the framing for fireproof glass enclosures to the lamps.</li> </ul>

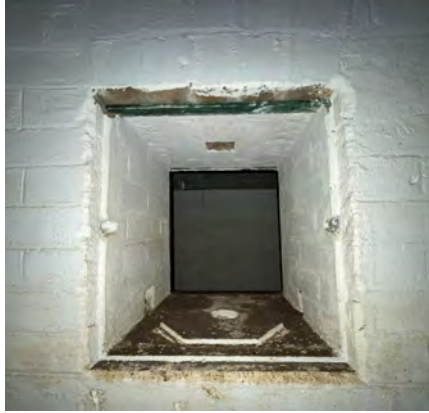
<p>Lamp housing.</p>	
<p><b>Concrete ceiling</b></p> <p>Concrete ceiling is original and of exceptional significance.</p>

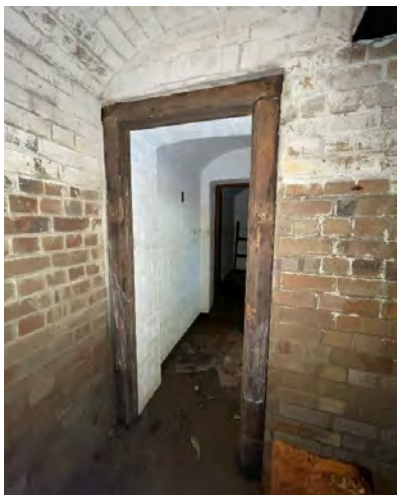
<p>Door frame.</p>	<ul style="list-style-type: none"> <li>• Retain and conserve brick arched heads and rendered sills to openings.</li> <li>• Retain and conserve all timber window and door frames in situ.</li> <li>• Retain and conserve timber lintels in situ.</li> <li>• Retain window shutters and replica door in situ.</li> <li>• Retain all surviving window and door hardware in situ.</li> <li>• Clean and treat all surviving metalwork with rust inhibitor.</li> <li>• Retain and conserve all evidence of hardware where doors have been removed.</li> <li>• Where frames are missing, retain all evidence of where timber frames were originally fitted.</li> </ul>	<p><b>Medium</b> priority.</p> <p>Complete within 3–5 years.</p> <p>Ongoing.</p>

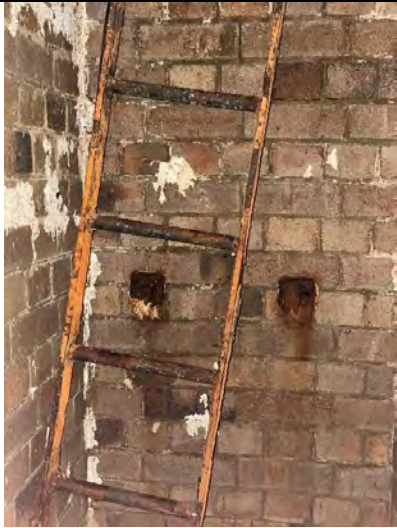
Ladder and fixings in shaft.

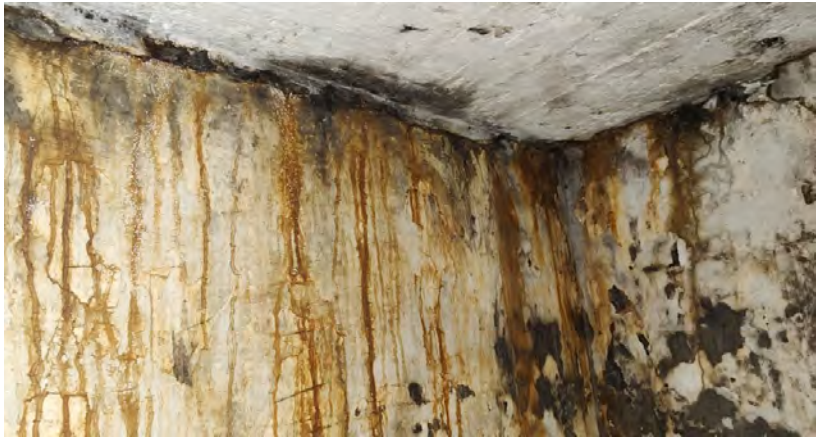
1
4	Cast in steel member	Severe corrosion of member, spalling and flaking of concrete along edges.

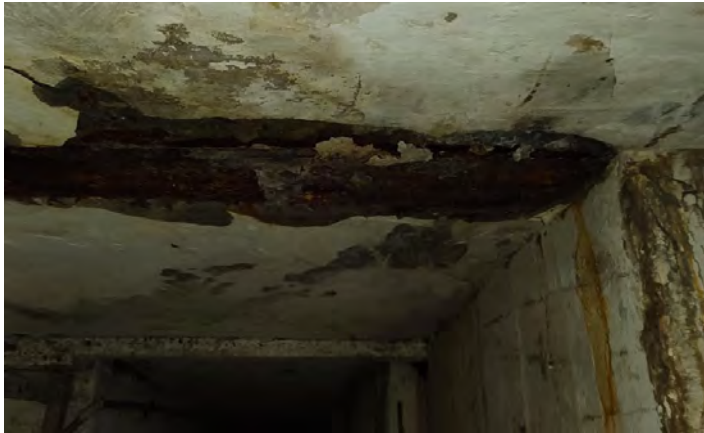
1
6	Vertical hatch	Extreme corrosion identified, risk of collapse

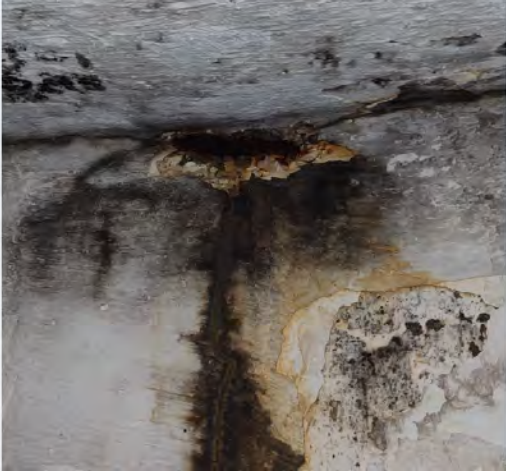
1
14	Cast in ventilation	Evidence of differential movement once pipe passes through wall, may make reopening of existing networks difficult

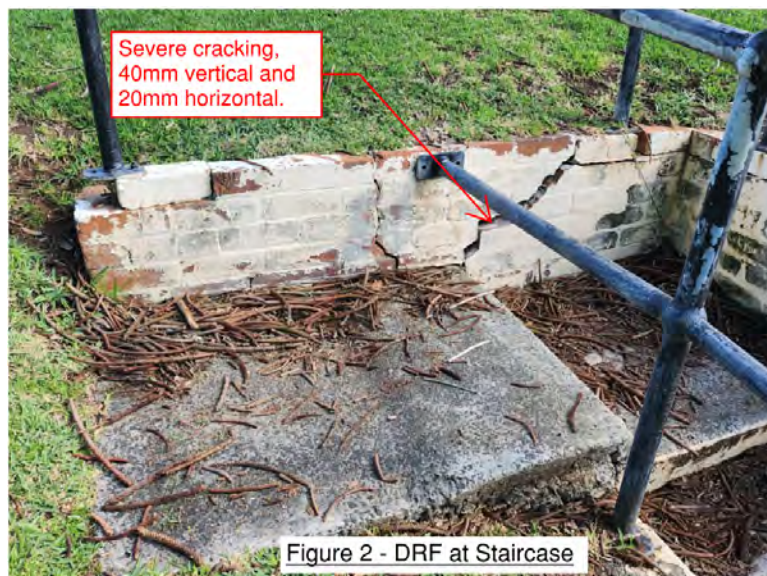
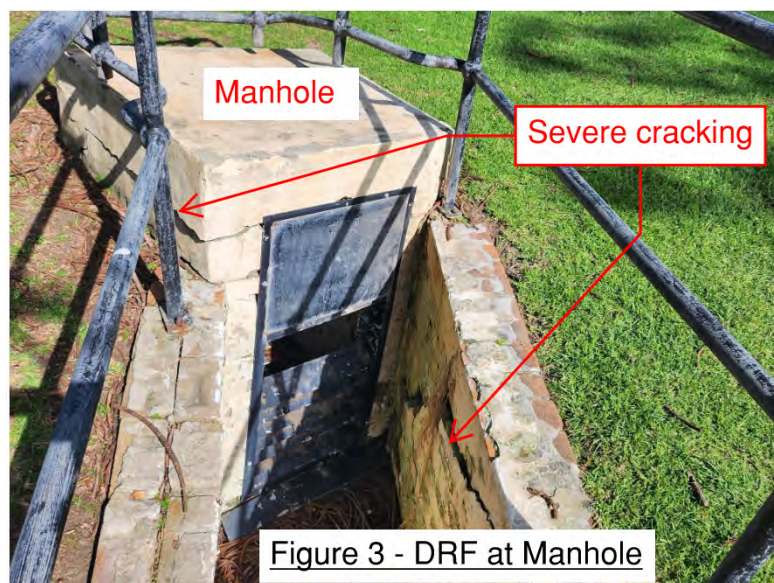
In our opinion the cracking to the brick walls is the result of the number of interacting influences, including the following: -

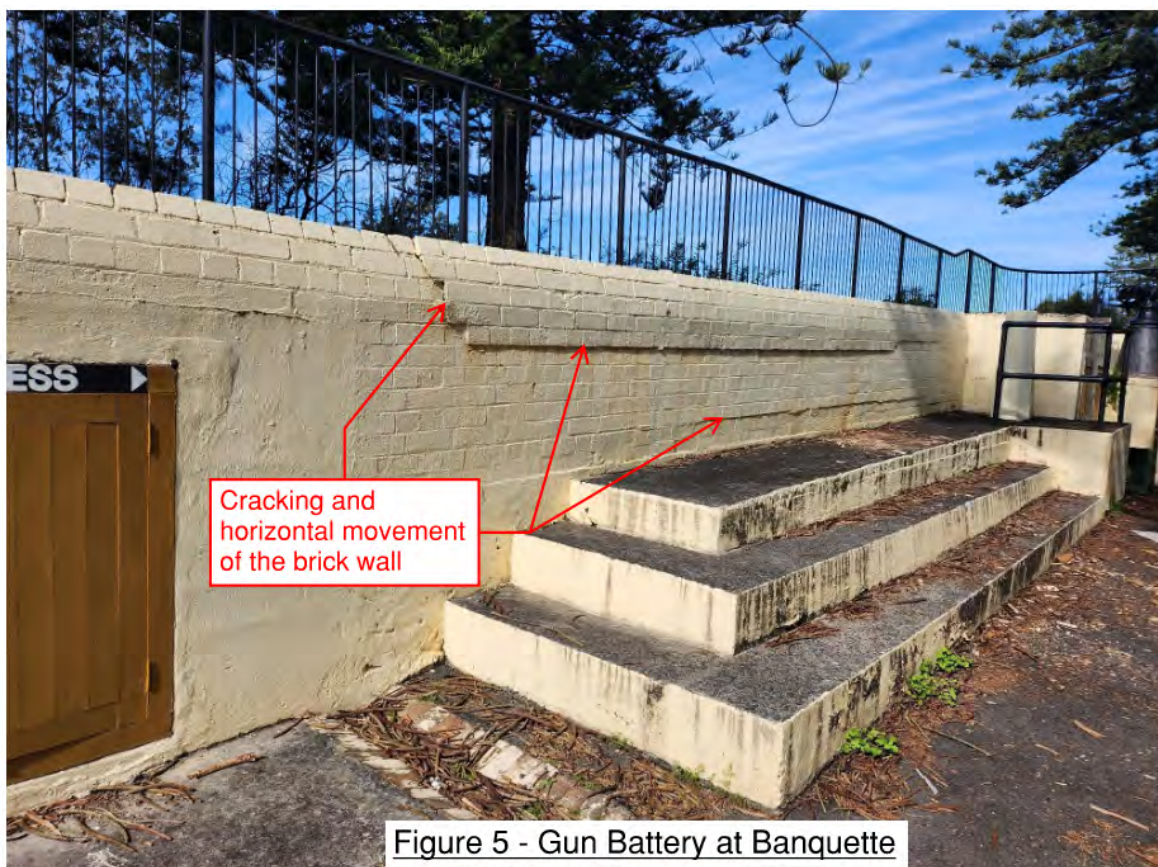
Figures 6 and 7 - Gun Battery at Bomb Proof Chamber

There is a slight cracking has occurred at the top right corner of the Bomb Proof chamber (refer to figures 6 and 7). The cause of the problem could be a slightly sagging of the steel lintel at the opening. There is evidence of repair work undertaken but the problem still occurs. However, it does not appear to be a major structural problem, the wall is still stable, and the capacity of the wall structure appears to be sound.

The steel posts and lintels supporting the brickwork walls at the Bomb Proof chamber show evidence of heavy corrosion. The corrosion could be the results from the following.

- 1) The steel components have met the end of their life span.
- 2) There were no steel protection methods such as galvanising and coating invented during the time of construction.
- 3) The steel elements are exposed to prolonged major storm events.
- 4) The site is located within the aggressive coastline environment.

5. If the slight cracks at the top corner of the Bomb Proof chamber (refer to figures 6 and 7) have no sign of further movement (after monitoring for a period of time), the cracks could be a cosmetic repair using patching mortar. This repair should be carried out after replacing the steel lintels as mentioned in the number 3 above.

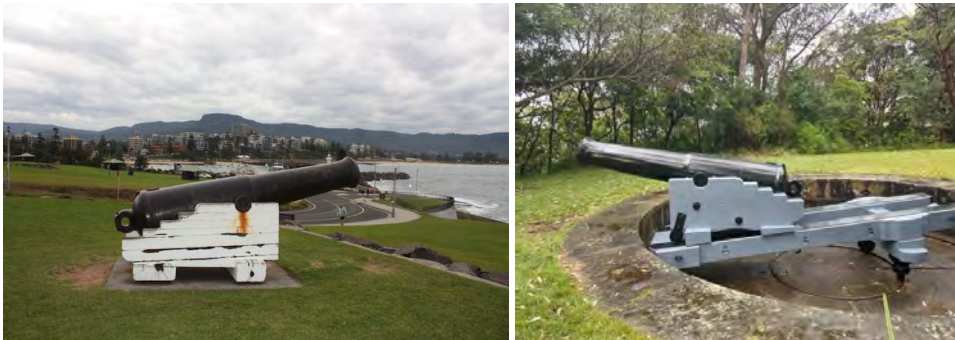
*One of the Flagstaff Hill 68lbs gun barrels with Standing & Bradleys Head gun with reproduction Standing and Slide*

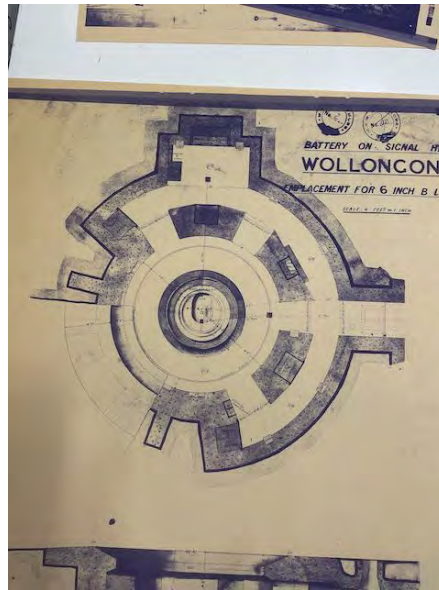
*Drawing Signal Hill Battery, RAAHC*

The 6-inch disappearing gun at Flagstaff Hill in Wollongong was a historically significant piece of military artillery. It was part of the coastal defence system in Australia, designed to protect the coastline from potential naval threats in the late 19th and early 20th centuries. The term "disappearing gun" refers to the gun's ability to retract or "disappear" behind a parapet or fortification after firing. This mechanism helped protect the gun and its crew from enemy fire by lowering the gun into a concealed position for reloading.

2. Firing Process: When the gun was fired, the recoil caused the carriage to move backward. This design had a counterbalance system that allowed the gun to disappear into its protected recess. This feature reduced the gun's visibility and vulnerability to return fire from enemy ships.

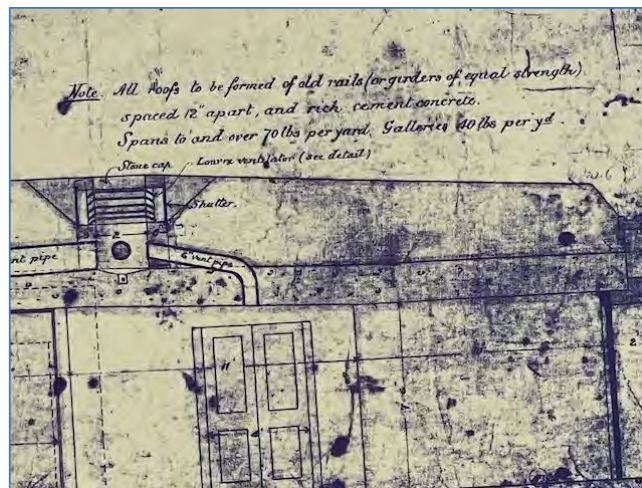
Layout drawings for Flagstaff Hill RAAHC

A major part of the fort's strength is in design of a roof using 70Lbs railway track set in concrete and overlaid with earth to form the casemate fort. A venting system was built into the structures roof to provide a dry aired space required to keep gun powder dry and a spark free environment for the light system of lanterns built into the walls of the tunnels.

Internally the casemate was fitted with timber framing and doors as part of the spark free design of forts from this period.

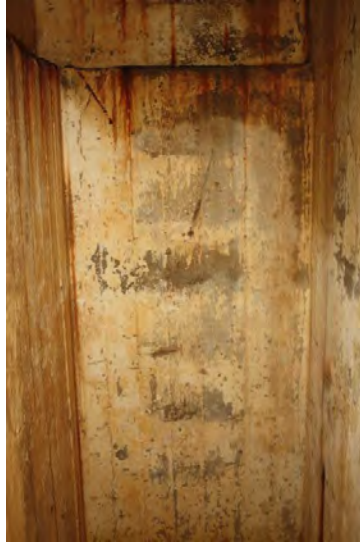
*Depression Range Finder access where a ladder was positioned.*

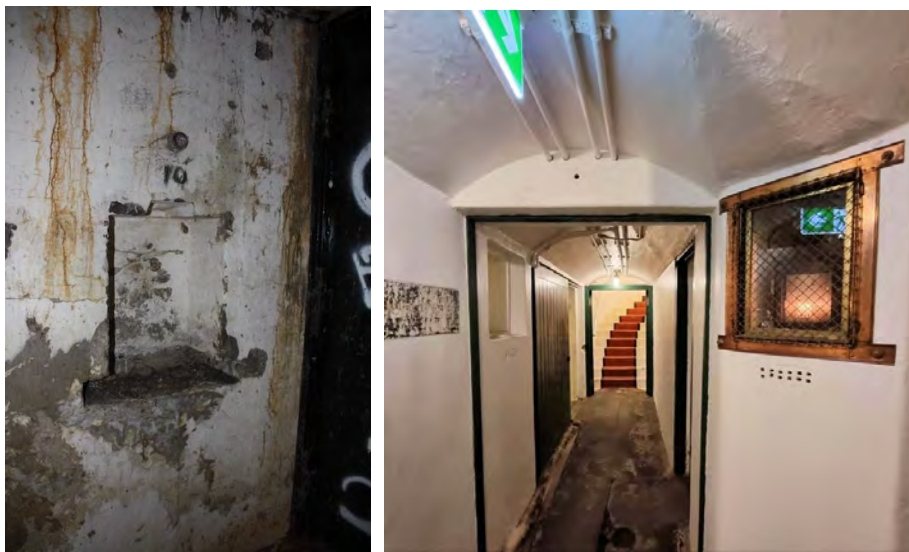
*Remnants of the lantern niches which featured a safety light casing. Similar safety lights at Fort Scratchley, Newcastle.*

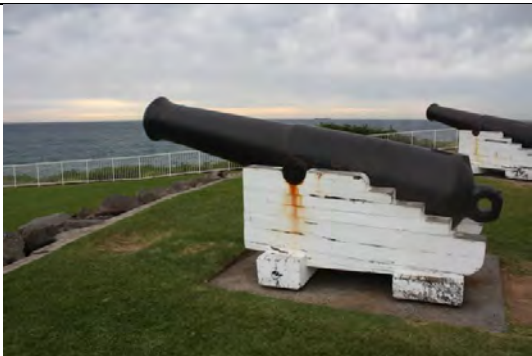
Date of manufacture	1861
Place of manufacture	Low Moor
<b>Condition</b> The gun barrel remain on an outline of the Standing carriage. The barrel is in a good condition but has a failing paint system that is not offering any corrosion protection. The barrel has a timber tampion possibly allowing water into its barrel. The Standing is in sound condition but will need to be renewed within 10 years. The paint condition is poor. Small amount of timber decay starting.	
<b>Recommendations</b> Paint the Standing carriage with timber primer oil-based paint and topcoat immediately to protect it until a replacement is produced. The barrel should be lifted and a new outline Standing carriage be designed and constructed within ten years with annual inspections of its condition. The external gun should be treated for corrosion and painted with a 2-pac zinc enriched paint system to protect it. It is recommended that a tampion be fitted that is weatherproof.

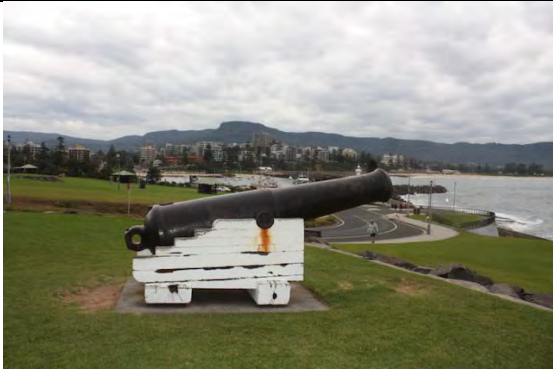
Date of manufacture	1861
Place of manufacture	Low Moor
<p>Condition</p> <p>The gun barrel remain on an outline of the Standing carriage.</p> <p>The barrel is in a good condition but has a failing paint system that is not offering any corrosion protection. The barrel has a timber tampion possibly allowing water into its barrel.</p> <p>The Standing is in sound condition but will need to be renewed within 10 years. The paint condition is poor. Small amount of timber decay starting.</p>	
<p>Recommendations</p> <p>Paint the Standing carriage with timber primer oil-based paint and topcoat immediately to protect it until a replacement is produced.</p> <p>The barrel should be lifted and a new outline Standing carriage be designed and constructed within ten years with annual inspections of its condition.</p> <p>The external gun should be treated for corrosion and painted with a 2-pac zinc enriched paint system to protect it.</p> <p>It is recommended that a tampion be fitted that is weatherproof.</p>

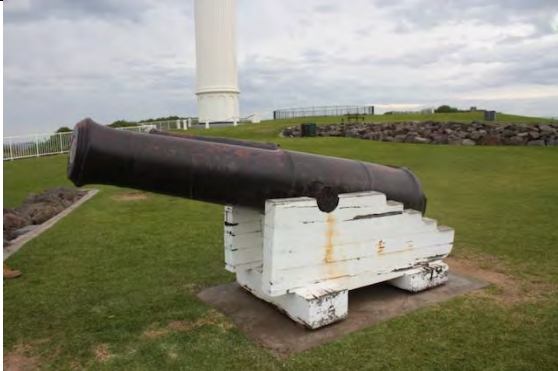
Date of manufacture	1861
Place of manufacture	Low Moor
<p>Condition</p> <p>The gun barrel remain on an outline of the Standing carriage.</p> <p>The barrel is in a good condition but has a failing paint system that is not offering any corrosion protection. The barrel has a timber tampion possibly allowing water into its barrel.</p> <p>The Standing is in sound condition but will need to be renewed within 10 years. The paint condition is poor. Small amount of timber decay starting.</p>	
<p>Recommendations</p> <p>Paint the Standing carriage with timber primer oil-based paint and topcoat immediately to protect it until a replacement is produced.</p> <p>The barrel should be lifted and a new outline Standing carriage be designed and constructed within ten years with annual inspections of its condition.</p> <p>The external gun should be treated for corrosion and painted with a 2-pac zinc enriched paint system to protect it.</p> <p>It is recommended that a tampion be fitted that is weatherproof.</p>

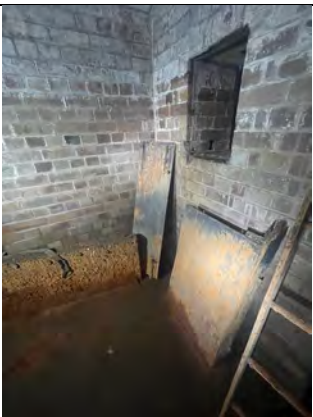
Recommended Action	See treatment pg. 27			
	Metal items	Internal	Assorted	
		A number of loose iron items are contained within the casemate and appear to have been collected when the fort was excavated and securely stored. These items provenance have not been identified.

Recommended Action	Store off the ground in a dry position.

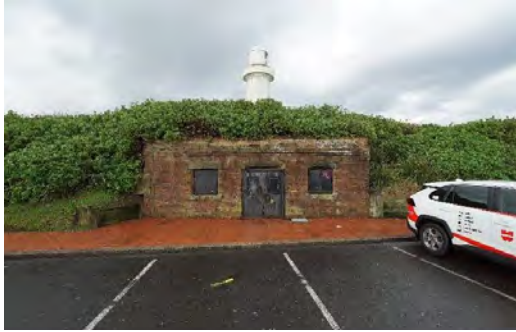
Figure 1.1 Front entrance as it appeared at the time of the site visit.

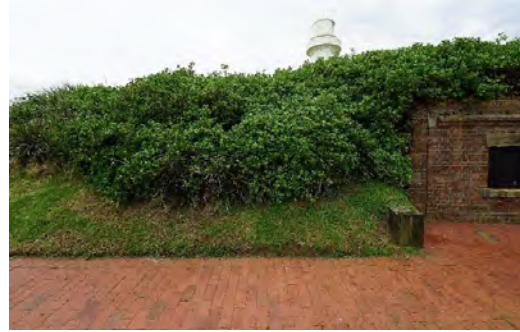
Figure 1.2 Evidence of the removal of brick walling to the south of the entrance. Any evidence has been obscured beneath more recent landscaping and overgrowth.

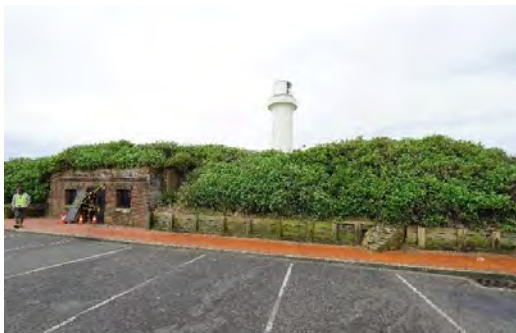
Figure 1.3 An extended portion of wall has been truncated to the south of the entrance with a truncated section visible at the right.

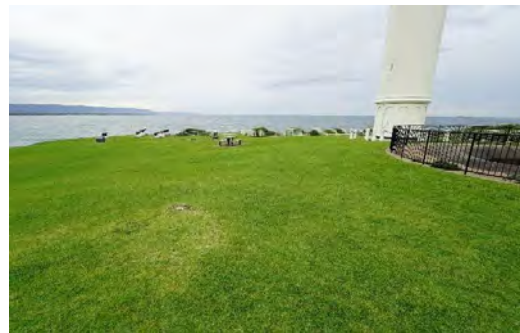
Figure 1.4 Landscaping in the approximate location of one of the former observation rooms to the north of the gun pit does not demonstrate any evidence of the former structure.

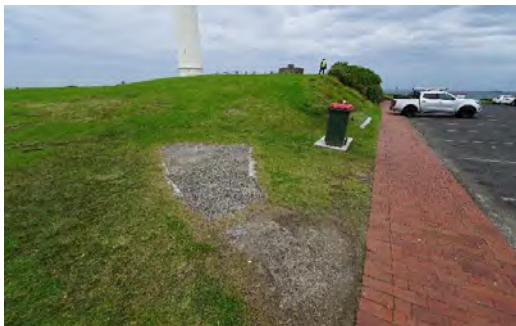
Figure 1.5 Concrete feature to the north of the entrance appears to be in line with former wall.

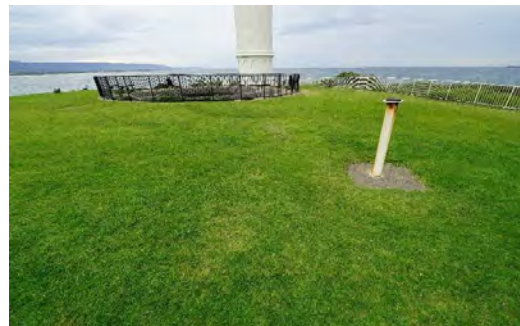
Figure 1.6 There have been minimal recent ground impacts above the fort substructure.

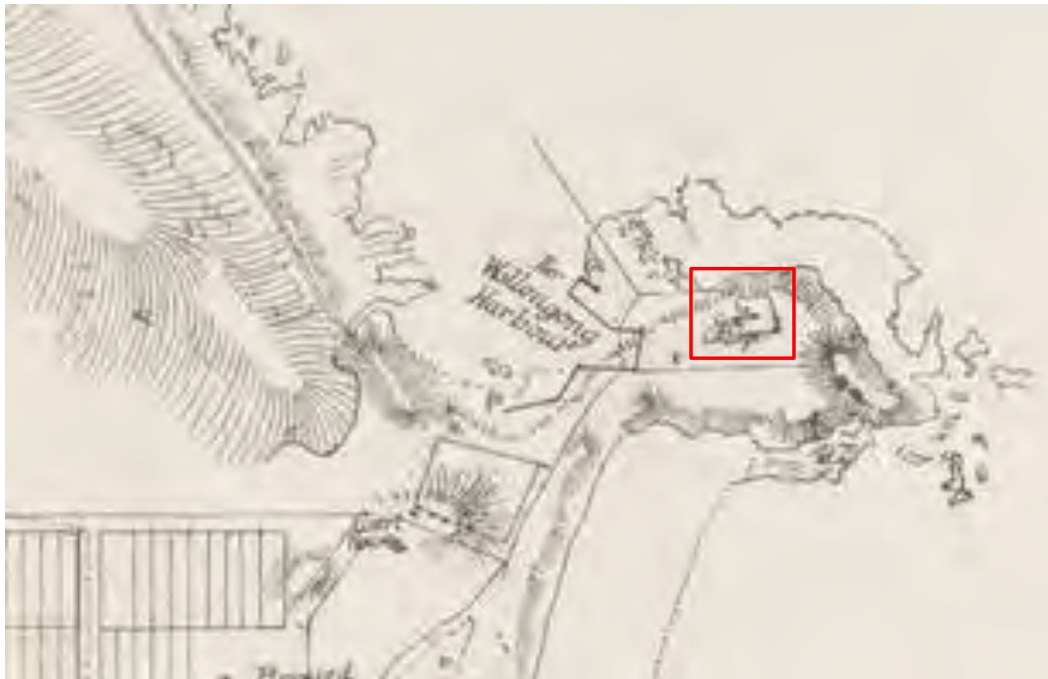
Figure 1.7 Detail of a 1855 sketch plan showing location of a built feature on the north part of the headland, indicated in area of the red box. The study area is located slightly to the south. (Source: SLNSW A 331A / 853567)

A sketch plan from 1855 appears to show a built feature about the centre of the headland, however nothing is shown in the approximate area of the site which is located further to the south. This suggests that by this stage no formal structures were present in this location of the headland, and there is no indication that anything was situated here until the construction of the fort.

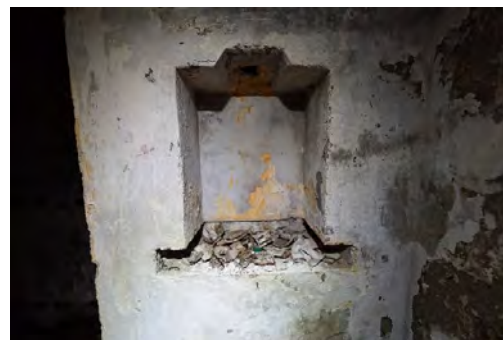
Figure 1.11 Gaps around wall insets provide space for artefacts to accumulate.

Visual inspection showed numerous gaps and crevices which may have collected and retained artefacts (Figure 1.10 and Figure 1.11) and there is a low-moderate potential for these artefacts to be present.

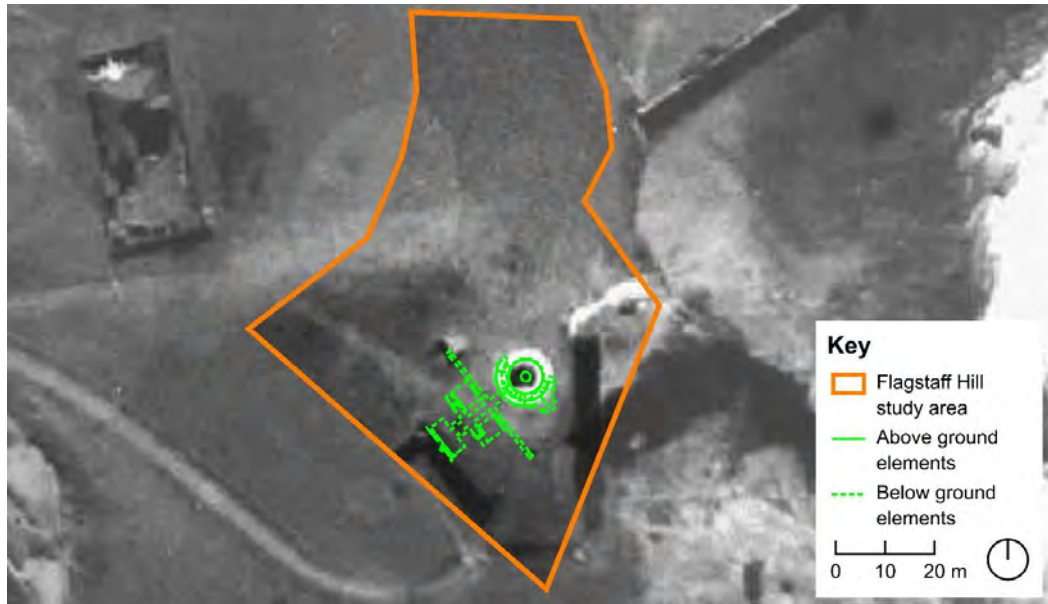
Figure 1.12 1938 aerial of study area with overlay indicating the location of observation rooms to north and south of gun pit, as well as a former path or roadway over the top of the below ground elements. A retaining wall can be seen extending to the south of the entry. (Source: Wollongong City Council 1938 with GML overlay)

An undated plan shows the location of the original extent of the fort structures (Figure 1.9) with these elements still faintly visible on the 1938 aerial (Figure 1.12). This includes the former observation and range finding rooms at the ends of the north and south corridors. There is a high potential for truncated structural remains of the former fort elements to be preserved in situ. These may include footings, surfaces, and evidence of how they interfaced with the below ground elements of the fort.

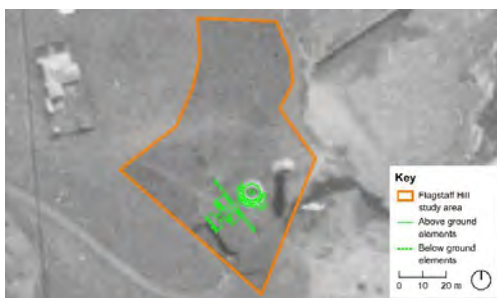
Figure 1.14 1941 aerial of study area showing above and below ground elements of Flagstaff Hill fort. The aerial shows minimal changes from the 1938 aerial. (Source: Wollongong City Council with GML overlay)

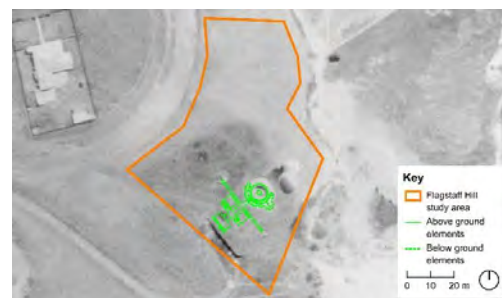
Figure 1.15 1948-51 aerial of study area showing above and below ground elements of Flagstaff Hill fort. (Source: Wollongong City Council with GML overlay)

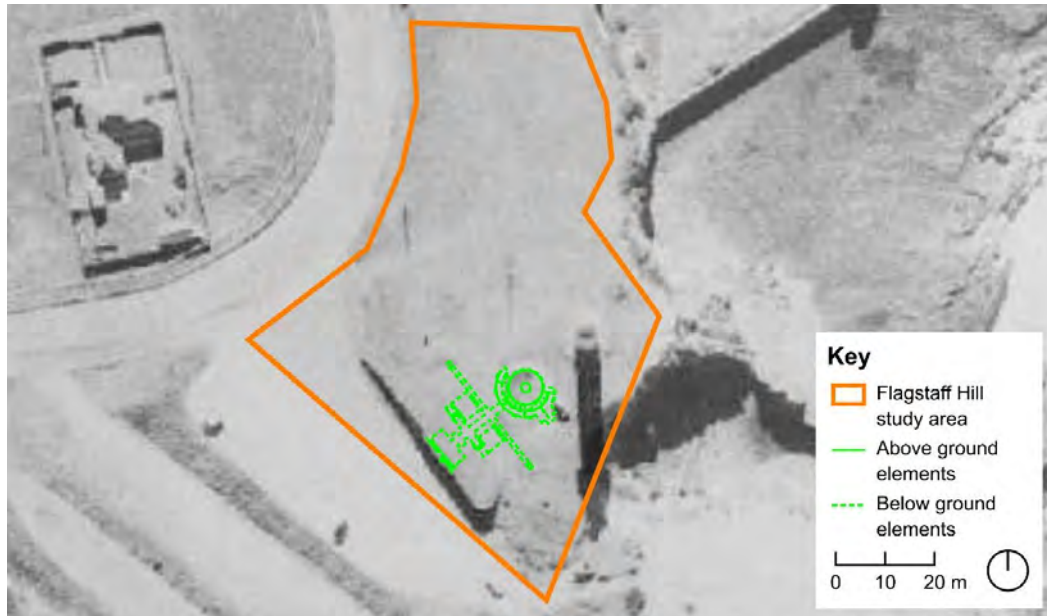
Figure 1.16 1961 aerial of study area showing above and below ground elements of Flagstaff Hill fort. A new retaining wall has been constructed to the north of the entrance and a new car park has been constructed to the south of the fort. (Source: Wollongong City Council with GML overlay)

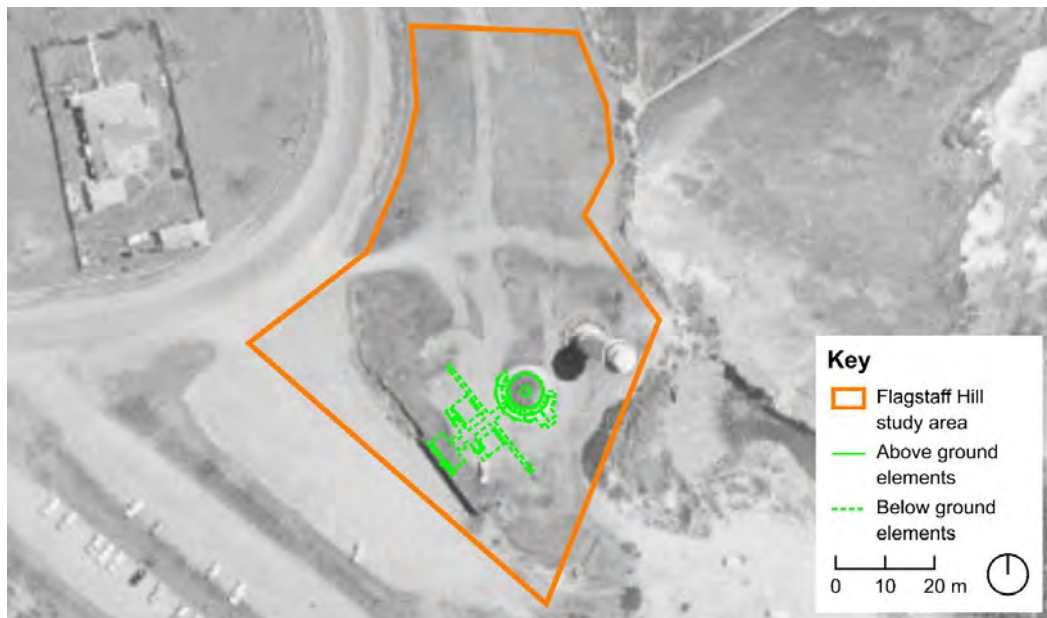
Figure 1.17 1966 aerial of study area showing above and below ground elements of Flagstaff Hill fort. More extensive roads or paths have been constructed above the fort. (Source: Wollongong City Council with GML overlay)

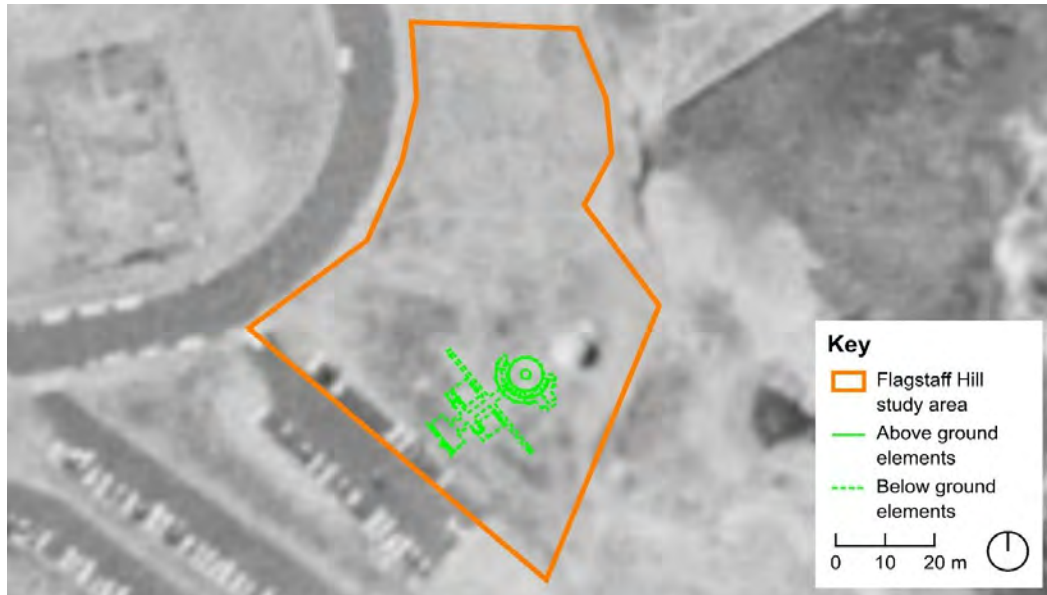
Figure 1.18 1975 aerial of study area showing above and below ground elements of Flagstaff Hill fort. The parking space to the front of the fort has been asphalted. (Source: Wollongong City Council with GML overlay)

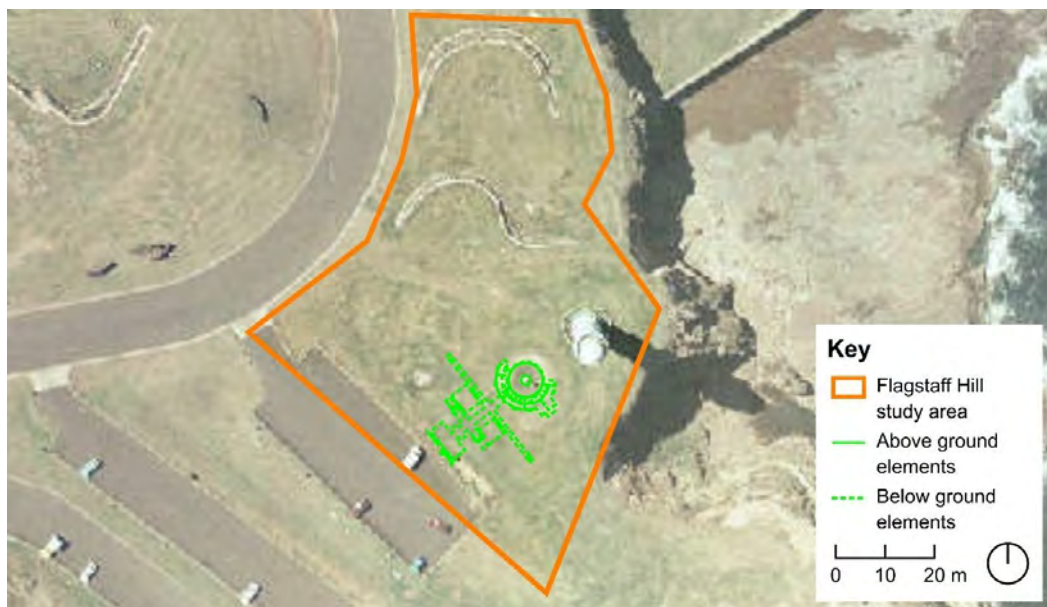
Figure 1.19 1977 aerial of study area showing above and below ground elements of Flagstaff Hill fort. The new landscaping to the north of study area has been excavated and by this time the retaining wall to the south of the entry has been removed. (Source: Wollongong City Council with GML overlay)

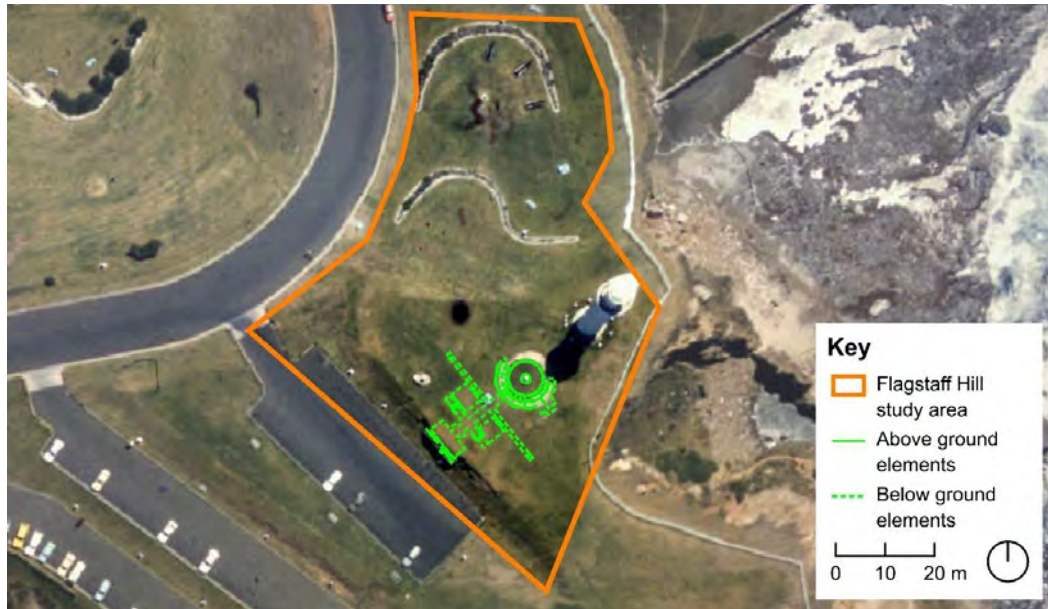
Figure 1.20 1986-87 aerial of study area showing above and below ground elements of Flagstaff Hill fort. Showing placement of the cannons at the north of the study area. (Source: Wollongong City Council with GML overlay)

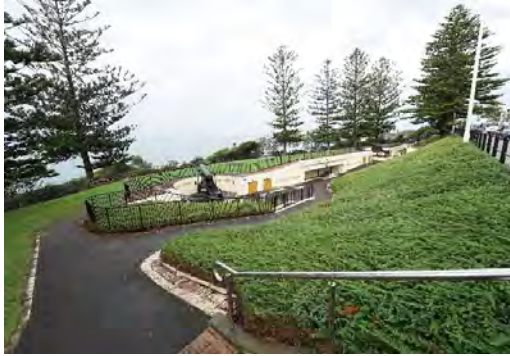
Figure 1.24 Modern accessibility upgrades to access the fort from Cliff Road include new stairways and hand rails.

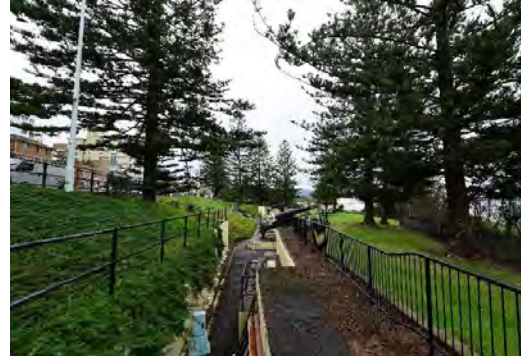
Figure 1.25 Landscaping and the fencing along the east side of the fort has been carried out since the fort was uncovered again in the late 1980s.

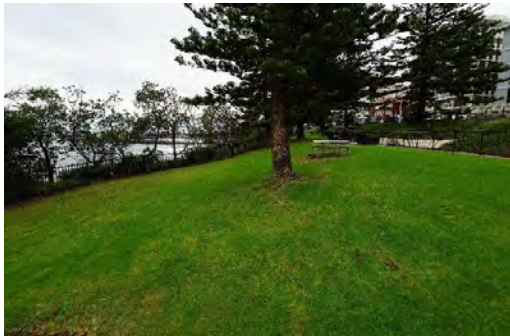
Figure 1.26 The grassed area to the east of the fort shows the twentieth century planting of Norfolk Island Pines but minimal evidence of other impacts to any potential archaeology in this area.

Any deposits which have accumulated in the water tanks (Figure 1.27) are likely to remain in situ but it is unclear if potential artefacts were accumulated stratigraphically. The planting of Norfolk Island Pines (Figure 1.24) may have had localised impacts on archaeological remains located beneath or adjacent them. If water remained or accumulated in the tanks it is possible that tree roots have permeated the structures and may have compromised their stability.

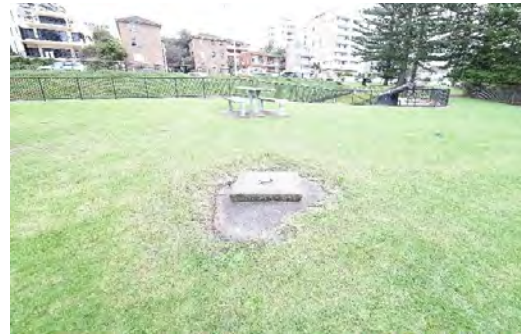
Figure 1.27 Potential evidence of one of the two underground tanks installed to the east of the fort structures.

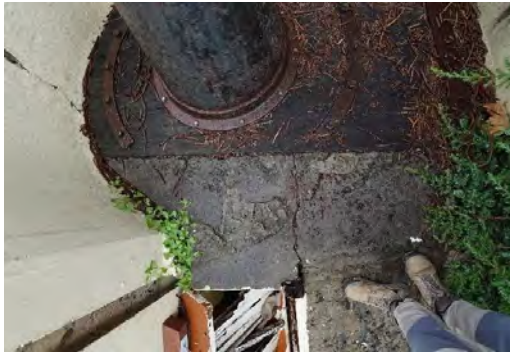
Figure 1.28 The swivel gun is situated on a butt-joint timber base which may conceal deposits dating from the occupation of the site.

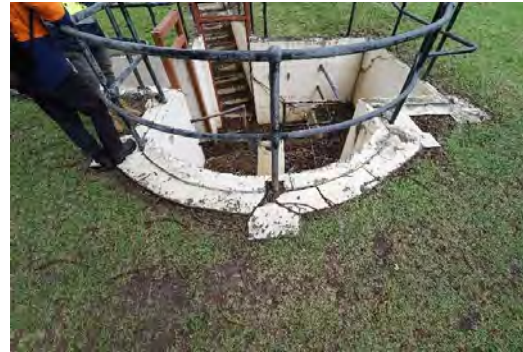
Figure 1.29 It is unclear if the Depression Range Finder Station may have originally had an overstructure, however this would have been located on top of the exposed built elements

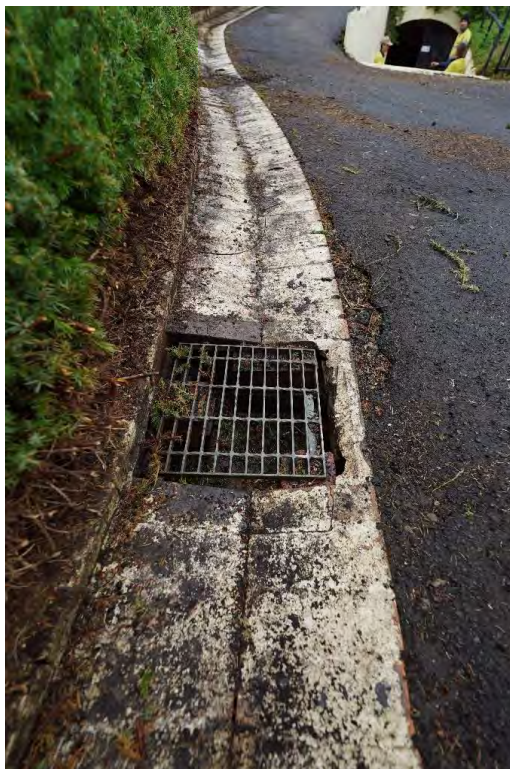
Figure 1.30 Modern drains have been installed which interface with the potentially original dish-drains. Their alignment is concealed by the asphalt surface.

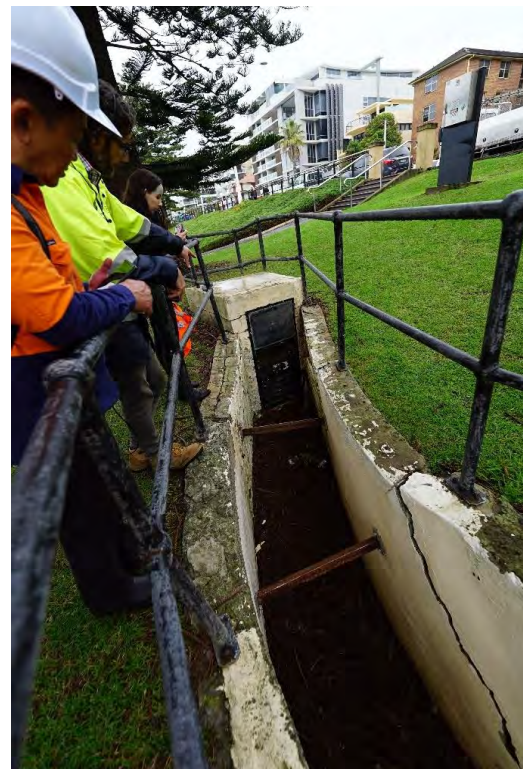
Figure 1.31 A pump room has been installed at the east end of the passage leading from the DRF station.
