# **Wollongong City Council Coastal Zone Study**

## **Volume 2 - Appendices**

# **WCC Geotechnical Data**

Re: **WOLLONGONG COASTAL HAZARDS STUDY  
GEOTECHNICAL INVESTIGATION**

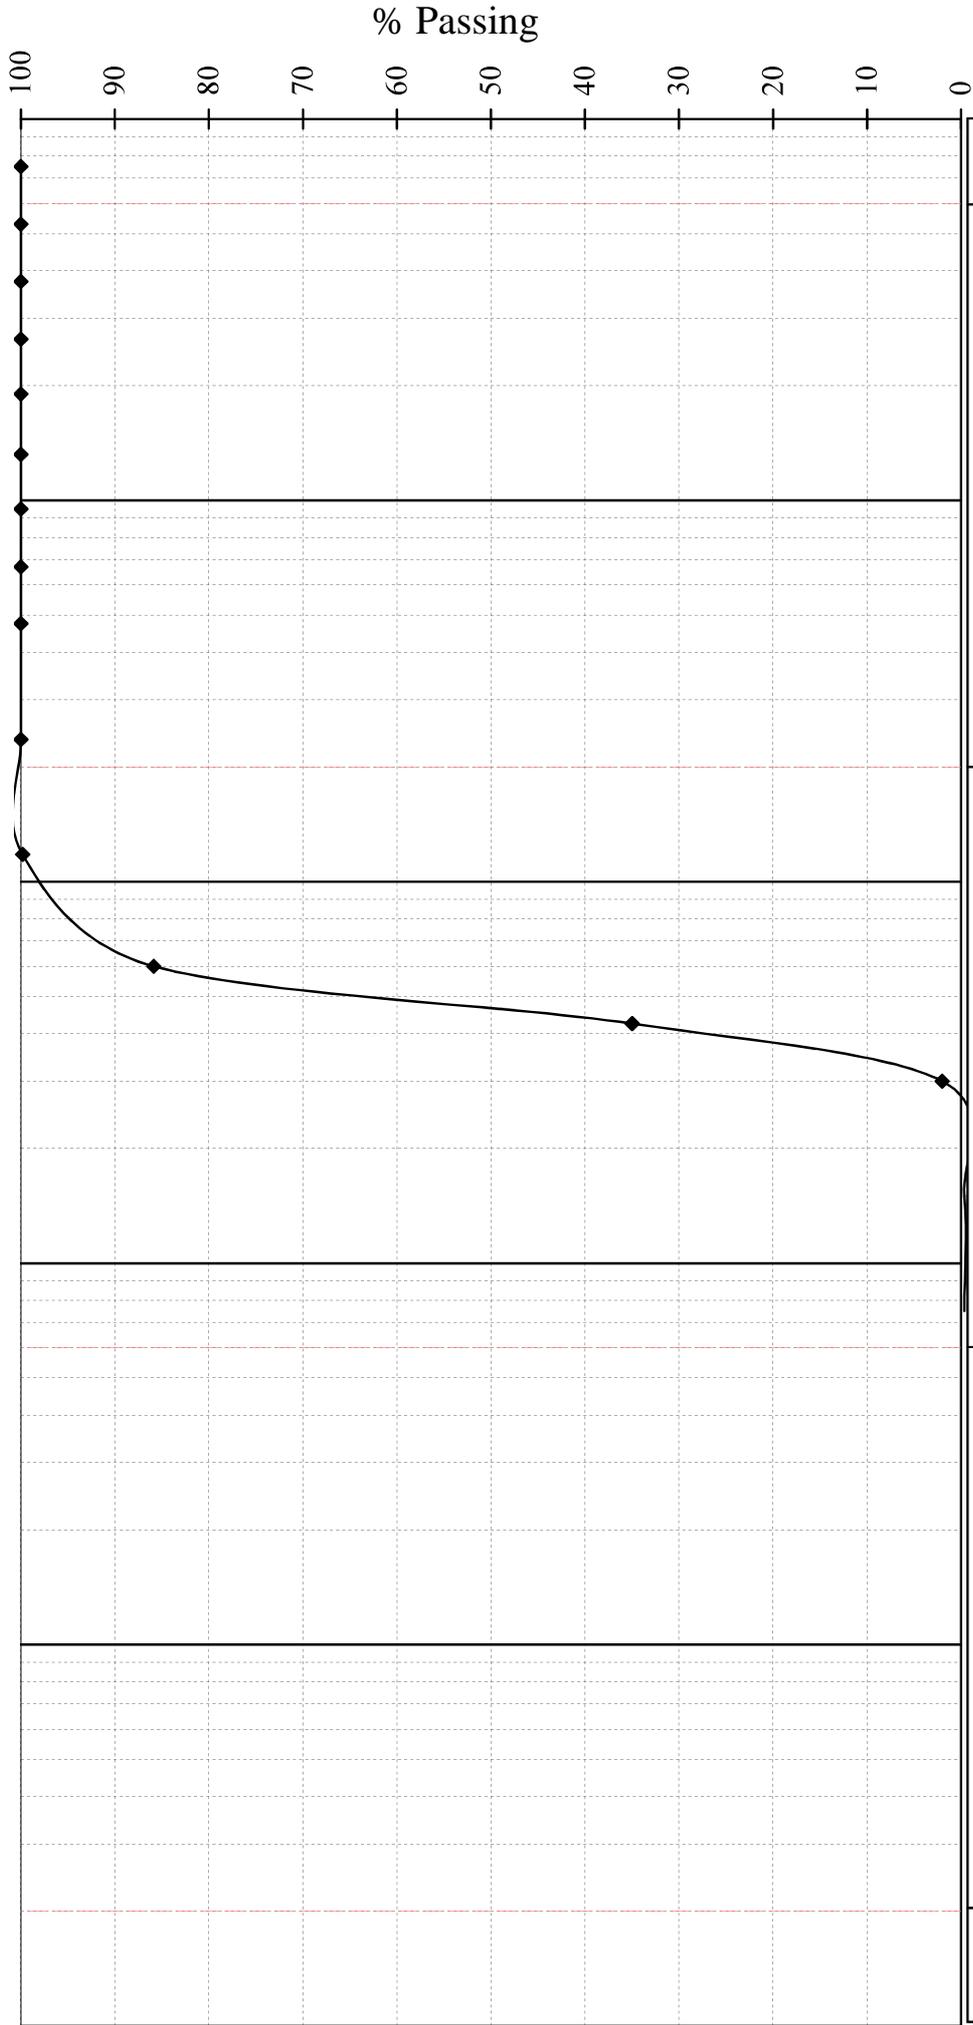
Sample No. .... TP1

Classification: *uniform sand*     $D_{10}$  (mm): 0.33     $D_{30}$  (mm): 0.40     $D_{50}$  (mm): 0.47     $D_{60}$  (mm): 0.50     $C_c = 1.0$      $C_u = 1.5$

<b>Location</b>	<b>Test Pit</b>	<b>D10</b>	<b>D30</b>	<b>D50</b>	<b>D60</b>	<b>Cc</b>	<b>Cu</b>
stanwell park	1	0.33	0.40	0.47	0.50	1.0	1.5
wombarra	3	0.26	0.34	0.39	0.42	1.1	1.7
coledale	5	0.20	0.31	0.36	0.39	1.3	1.9
sharkies	7	0.19	0.28	0.34	0.36	1.2	1.9
austinmer	9	0.22	0.32	0.36	0.38	1.2	1.8
sandon pt beach	11	0.19	0.30	0.35	0.37	1.3	2.0
bulli	12	0.21	0.32	0.36	0.39	1.2	1.8
woonona	13	0.18	0.28	0.33	0.35	1.2	2.0
bellambi	14	0.18	0.24	0.32	0.34	1.0	1.9
bellambi pt	15	0.17	0.24	0.31	0.34	0.9	2.0
east corrimal	16	0.18	0.27	0.35	0.39	1.1	2.1
towradgi	18	0.28	0.33	0.38	0.40	1.0	1.4
puckeys	19	0.31	0.35	0.40	0.43	0.9	1.4
south beach	20	0.31	0.35	0.41	0.44	0.9	1.4
coniston	21	0.22	0.32	0.36	0.38	1.2	1.8
port kembla	22	0.17	0.20	0.24	0.27	0.9	1.6
windang	23	0.17	0.21	0.27	0.30	0.9	1.8
<b>averages</b>		<b>0.22</b>	<b>0.30</b>	<b>0.35</b>	<b>0.38</b>	<b>1.1</b>	<b>1.8</b>

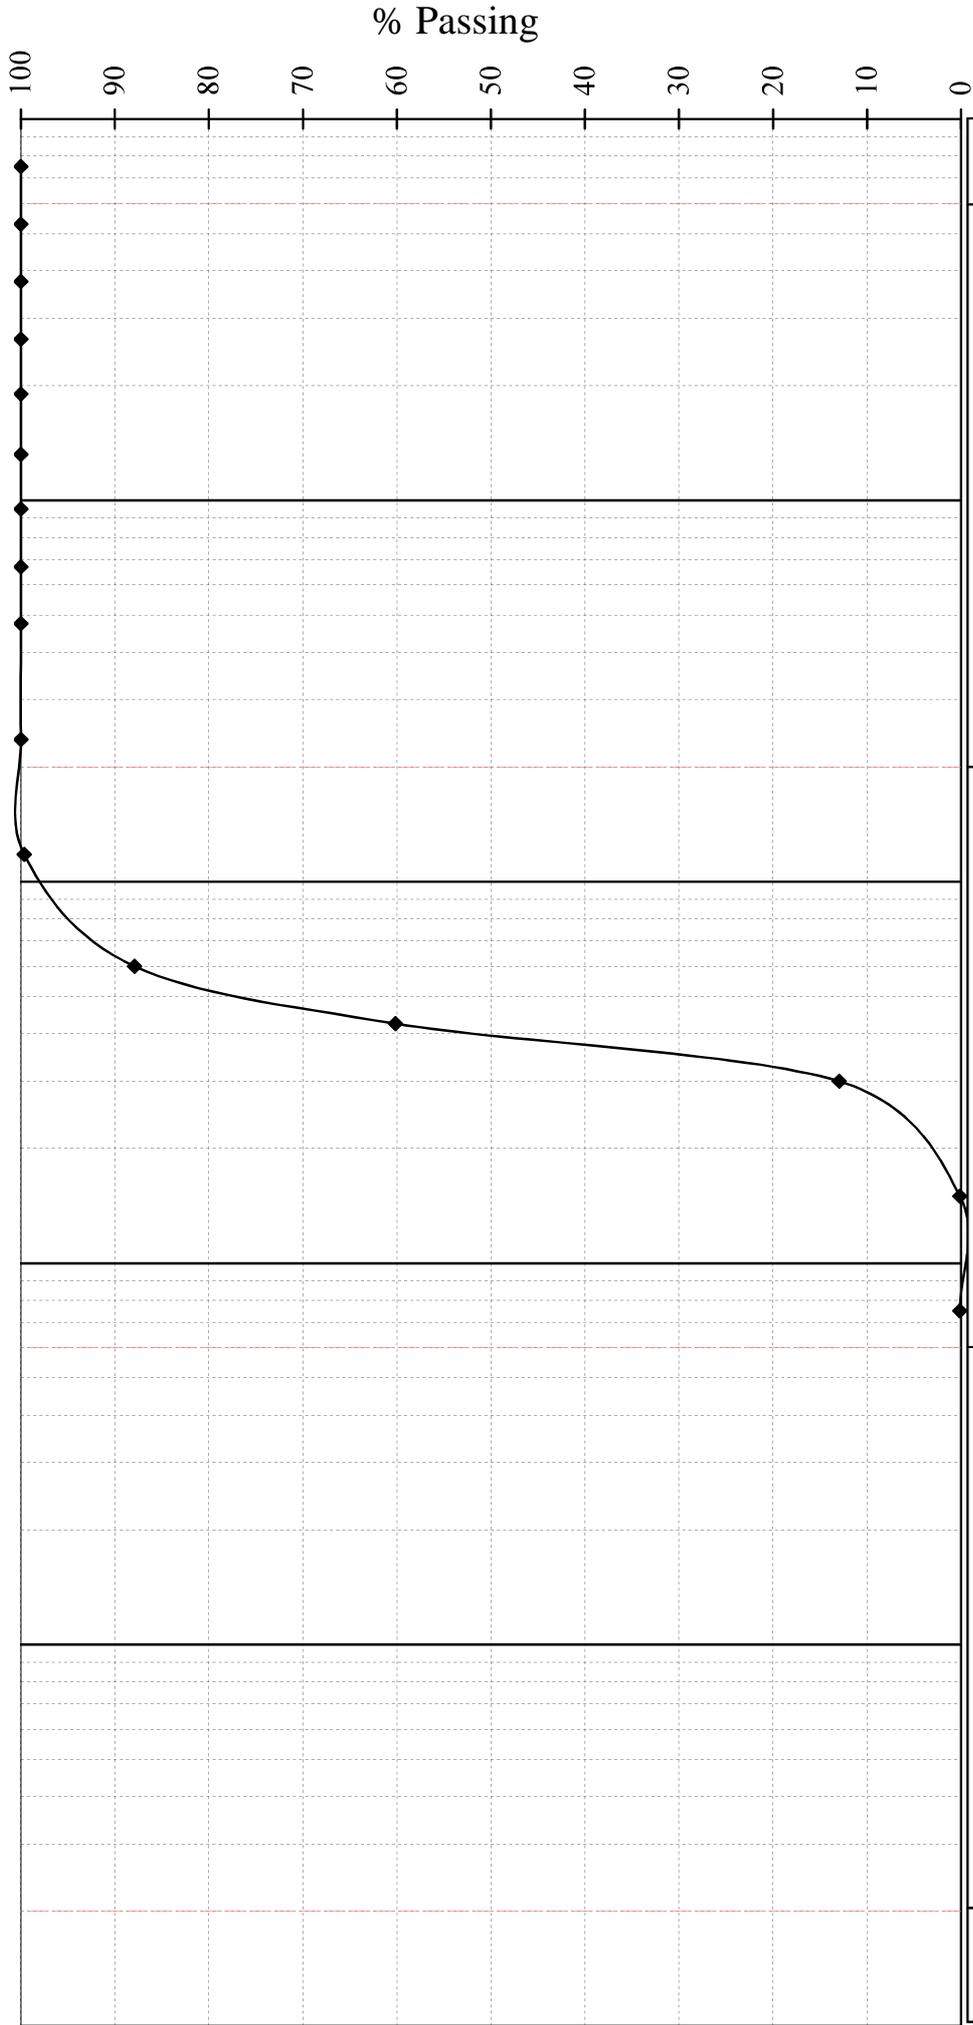
Job/Location ..... Wombarra Beach ..... Client WCC ..... Lab No. W10284 ..... Sample No. TP3 .....  
 ..... Environment.....

Classification: *uniform sand*     $D_{10}$  (mm): 0.26     $D_{30}$  (mm): 0.34     $D_{50}$  (mm): 0.39     $D_{60}$  (mm): 0.42     $C_c = 1.1$      $C_u = 1.7$   
 Form No. S04    Jan 2007

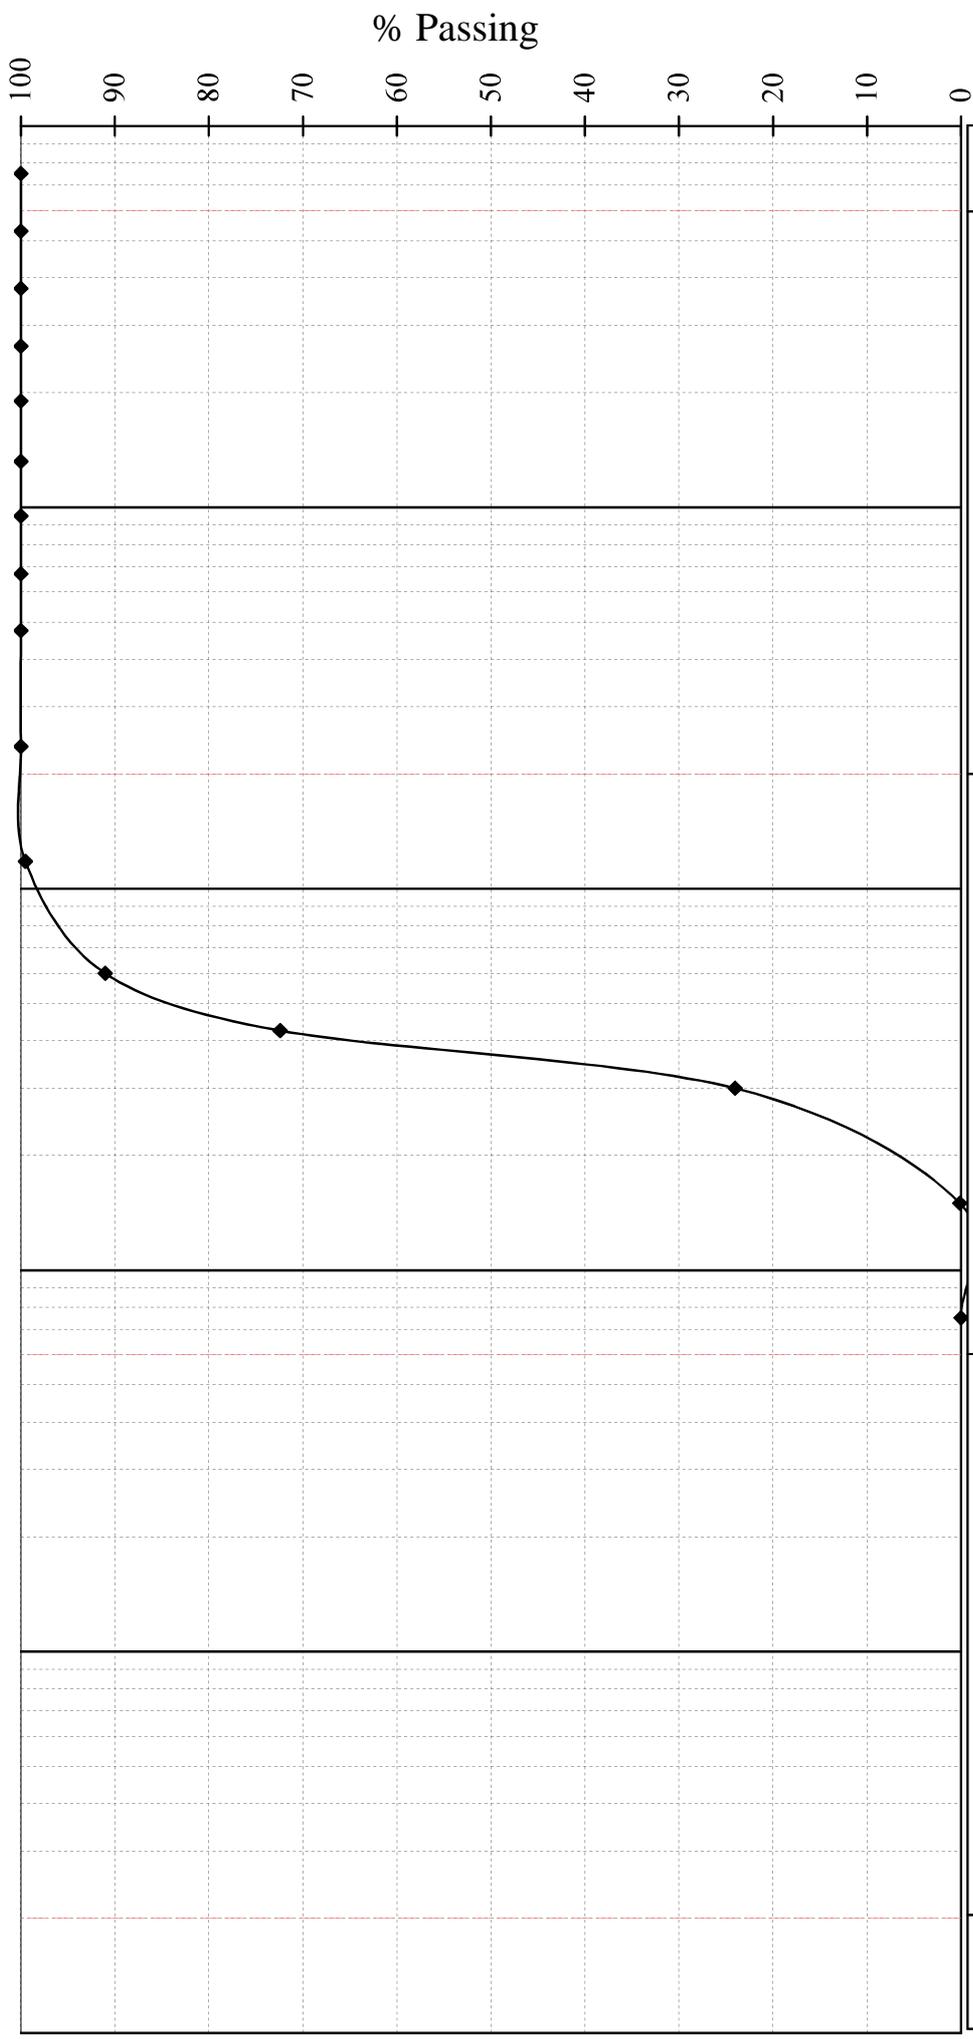
Job/Location ..... Coledale Beach ..... Client WCC ..... Lab No. W10284 ..... Sample No. TP5

Classification: *uniform sand*     $D_{10}$  (mm): 0.20     $D_{30}$  (mm): 0.31     $D_{50}$  (mm): 0.36     $D_{60}$  (mm): 0.39     $C_c = 1.3$      $C_u = 1.9$

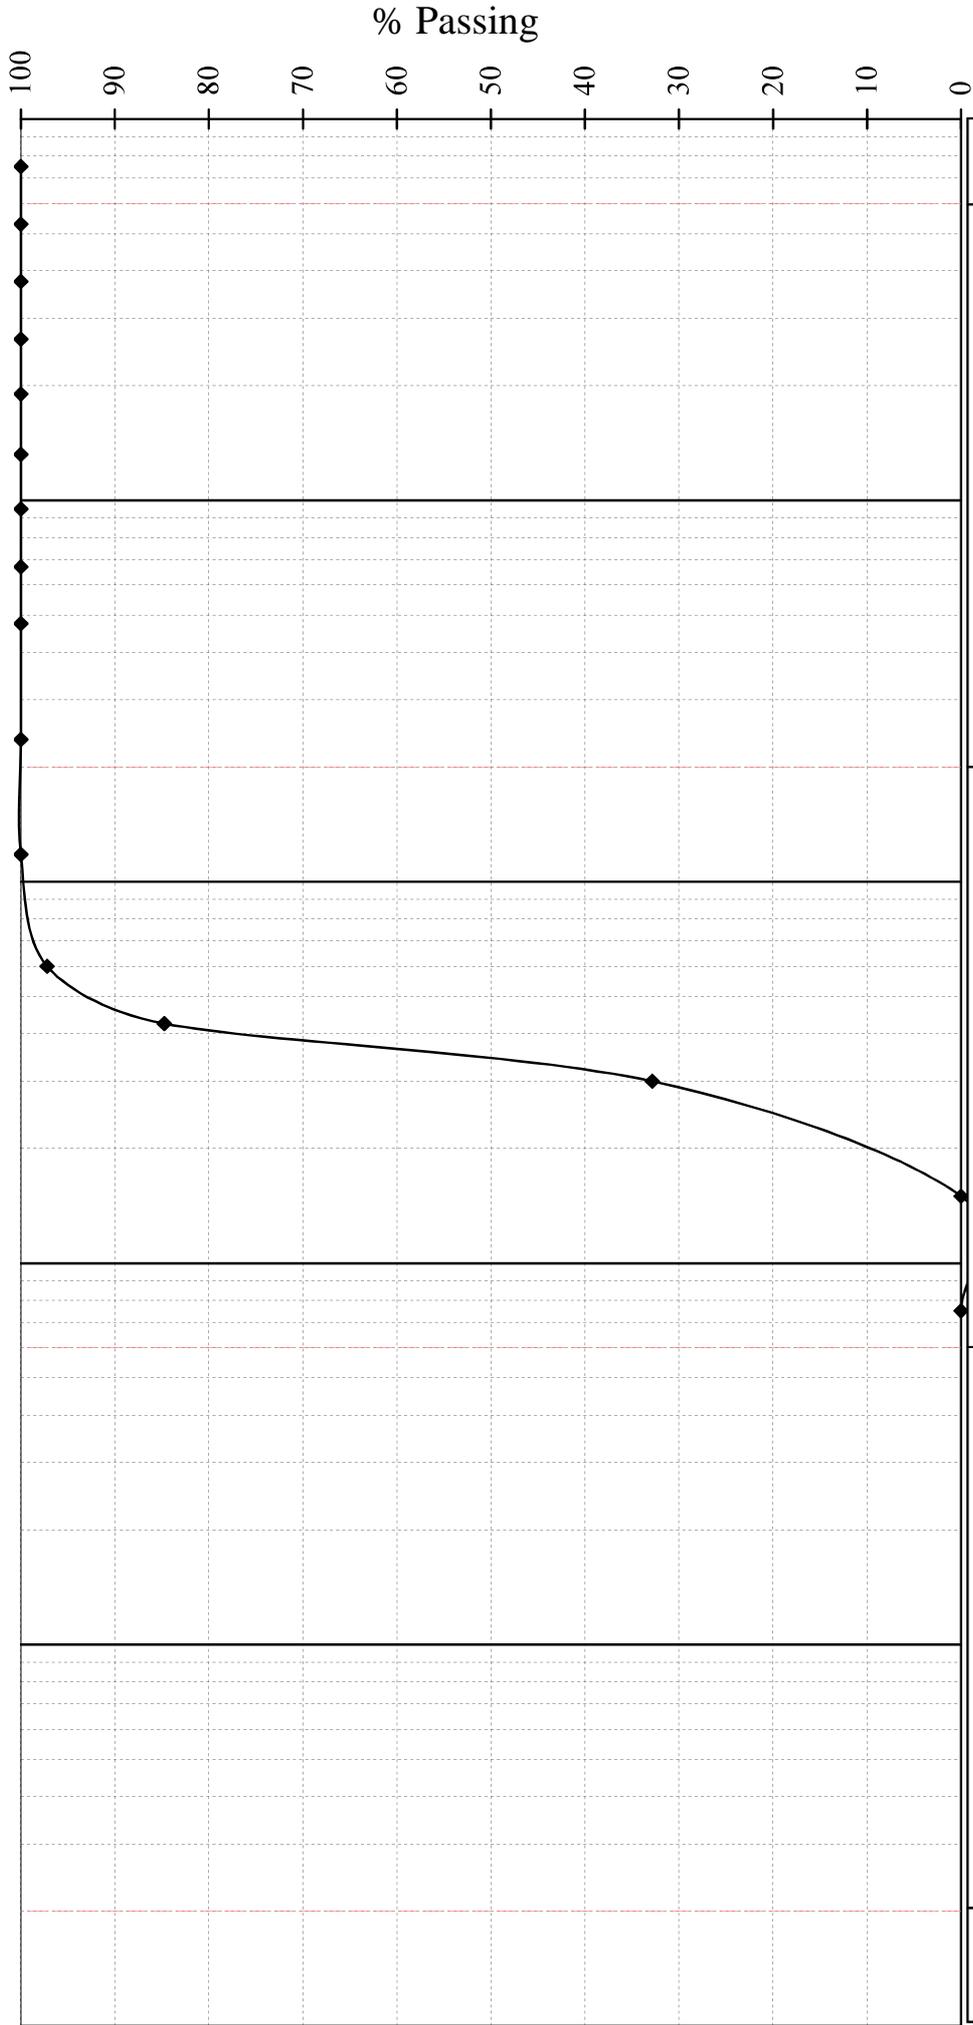
Job/Location: Sharkies Beach  
 Client: WCC Environment  
 Lab No.: W10284  
 Sample No.: TP7

Classification: *uniform sand*     $D_{10}$  (mm): 0.19     $D_{30}$  (mm): 0.28     $D_{50}$  (mm): 0.34     $D_{60}$  (mm): 0.36     $C_c = 1.2$      $C_u = 1.9$   
 Form No. S04    Jan 2007

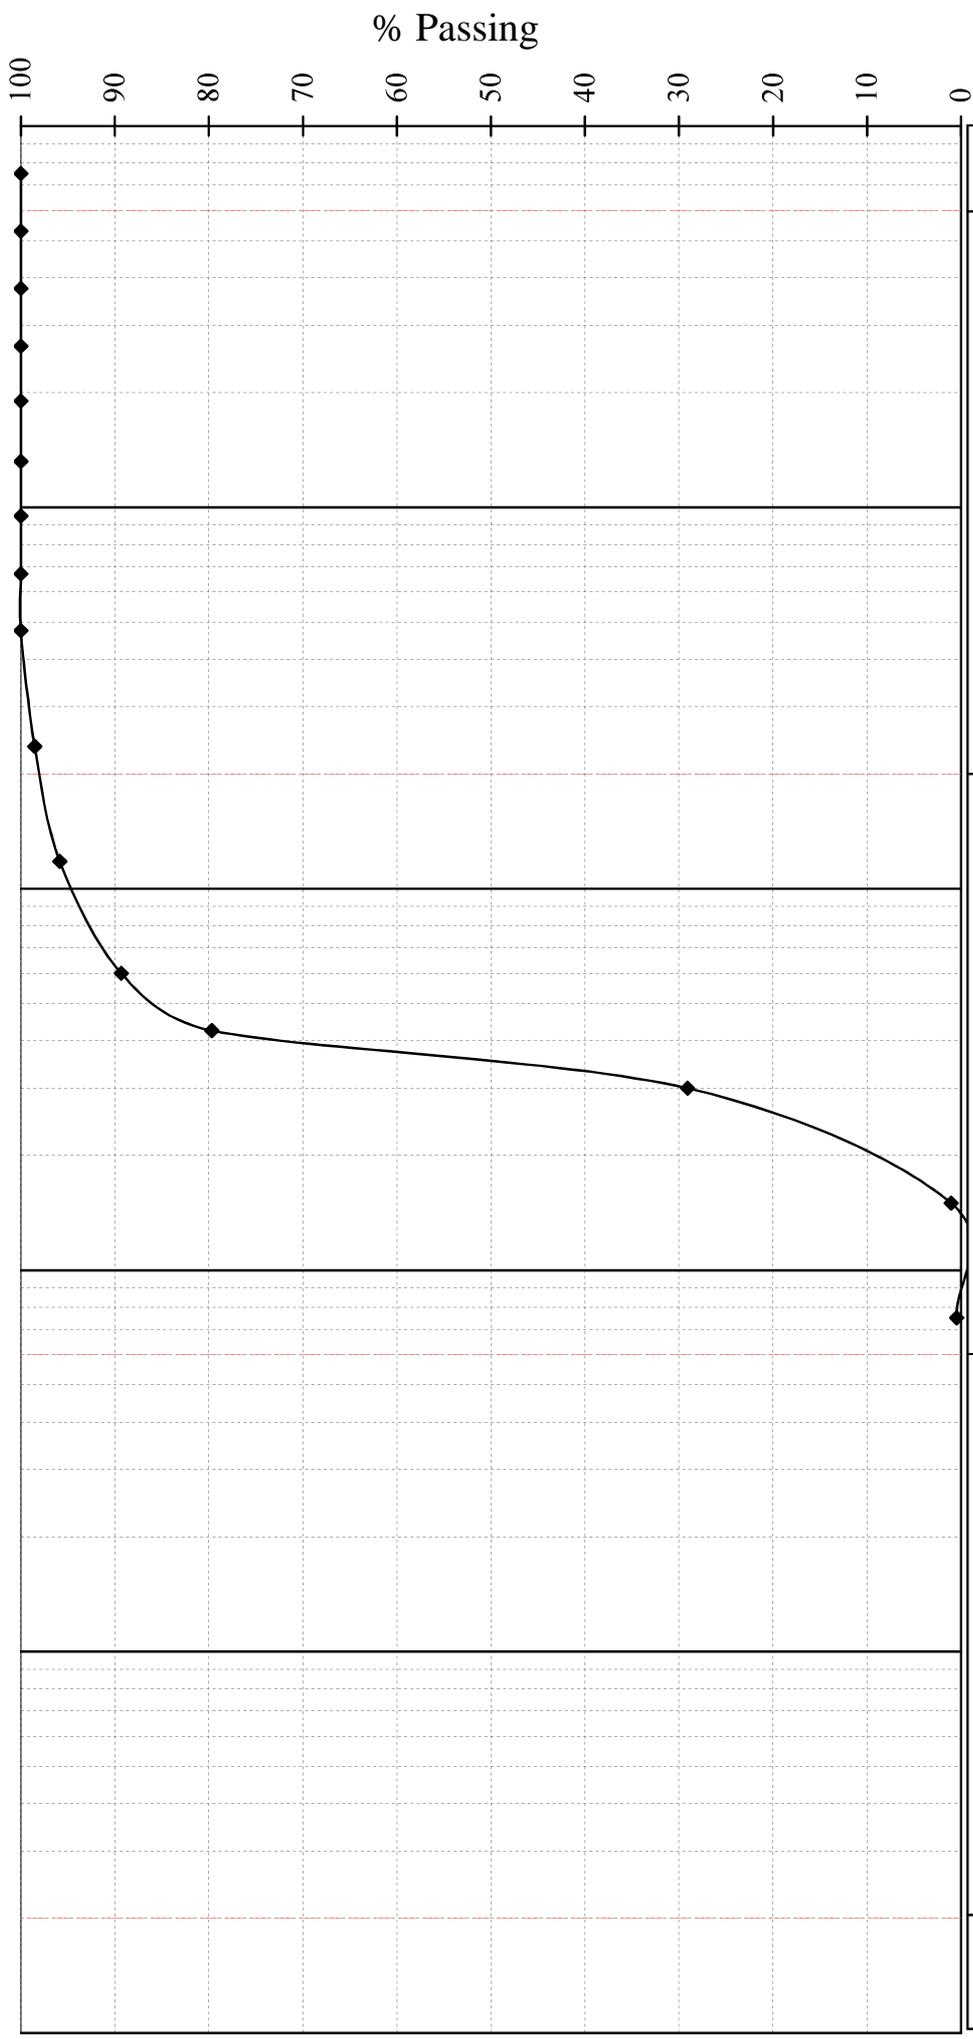
Job/Location ..... Sandon Point Beach ..... Client WCC ..... Lab No. W10284 ..... Sample No. TP11

Classification: *uniform sand*     $D_{10}$  (mm): 0.19     $D_{30}$  (mm): 0.30     $D_{50}$  (mm): 0.35     $D_{60}$  (mm): 0.37     $C_c = 1.3$      $C_u = 2.0$

Test Pit 11 located on Sandon Point Beach intercepted the underlying natural residual clay soils at 1.0m beneath the beach boulder armour at 0.6m depth. This sandy clay is a residual of sandstone and previous drilling at a site 50m south of this location shows that it can be in excess of 7m deep with some gravelly / rocky bands. This material is also prone to undercutting and collapse due wave run up during storm events, a consideration which led to the construction of a boulder armour seawall structure for the support of the cycleway to the south.

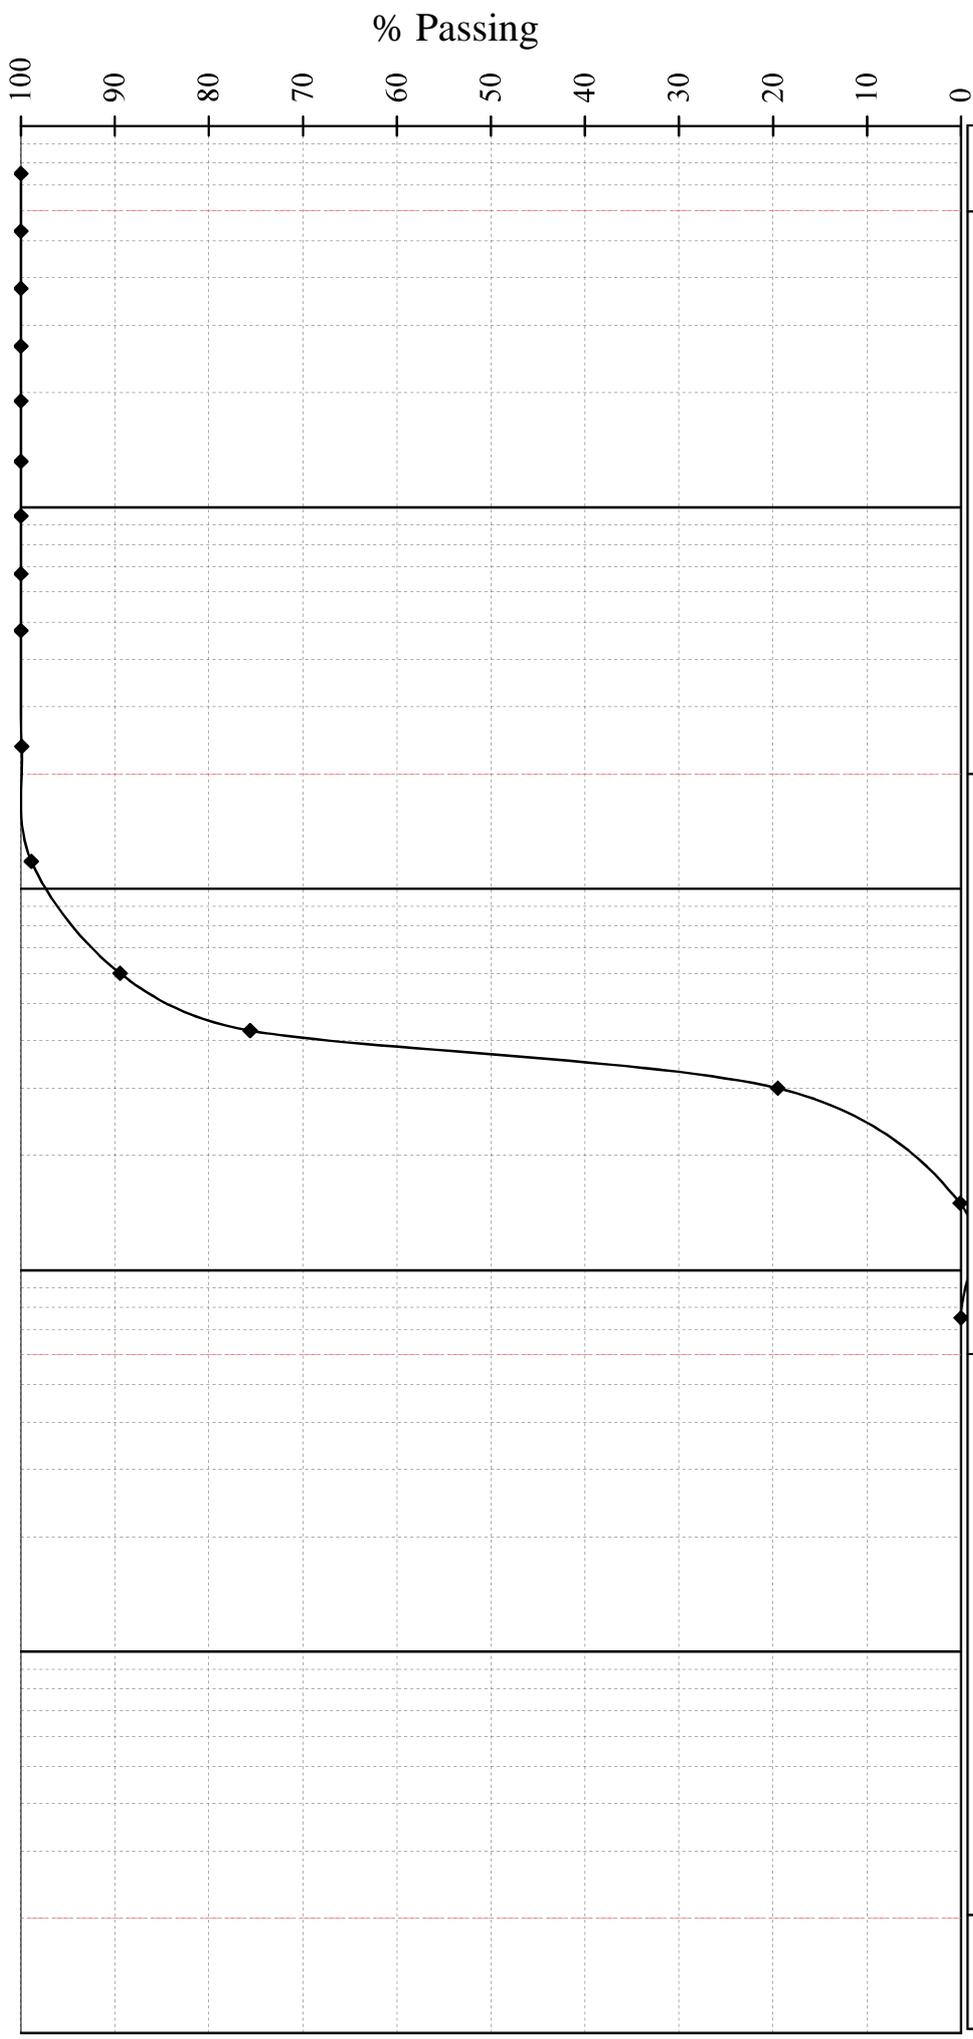
Job/Location ..... Bulli Beach ..... Client WCC ..... Lab No. W10284 ..... Sample No. .... TPI2 .....

Classification: *uniform sand*     $D_{10}$  (mm): 0.21     $D_{30}$  (mm): 0.32     $D_{50}$  (mm): 0.36     $D_{60}$  (mm): 0.39     $C_c = 1.2$      $C_u = 1.8$

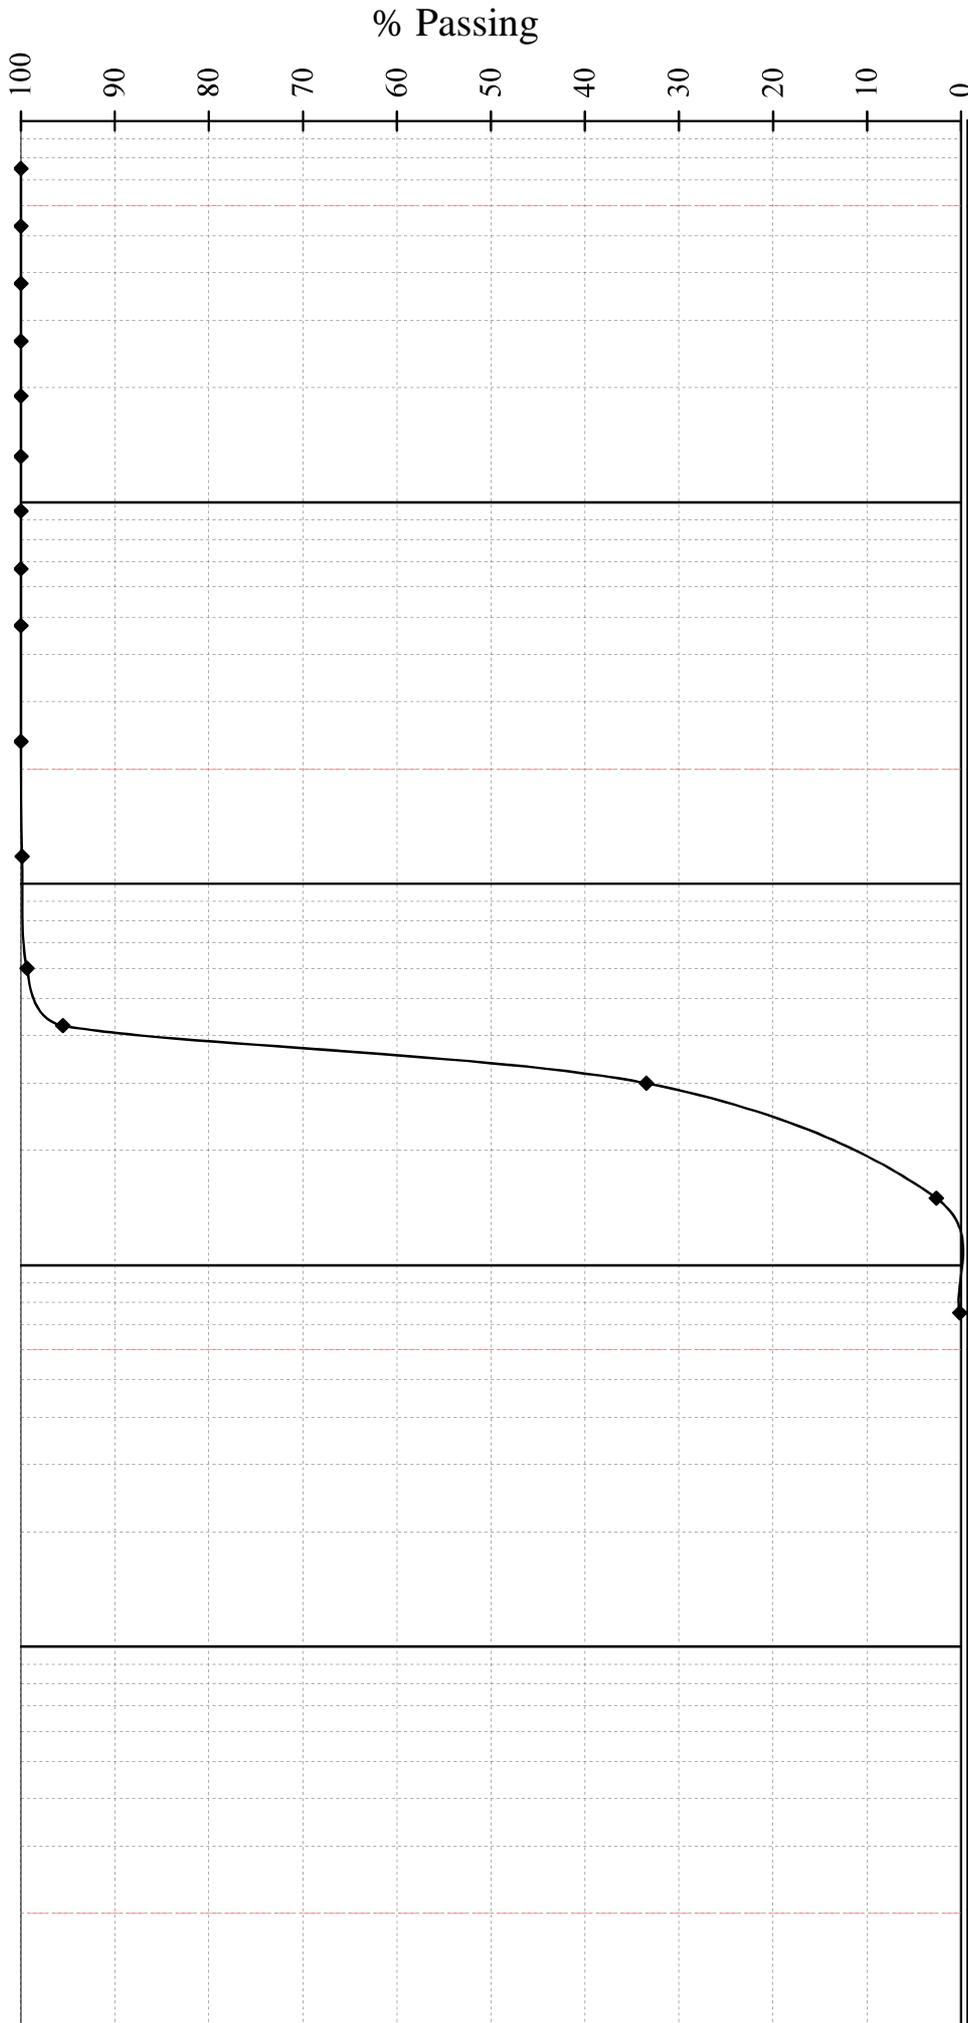
TPI13

Classification: *uniform sand*     $D_{10}$  (mm): 0.18     $D_{30}$  (mm): 0.28     $D_{50}$  (mm): 0.33     $D_{60}$  (mm): 0.35     $C_c = 1.2$      $C_u = 2.0$

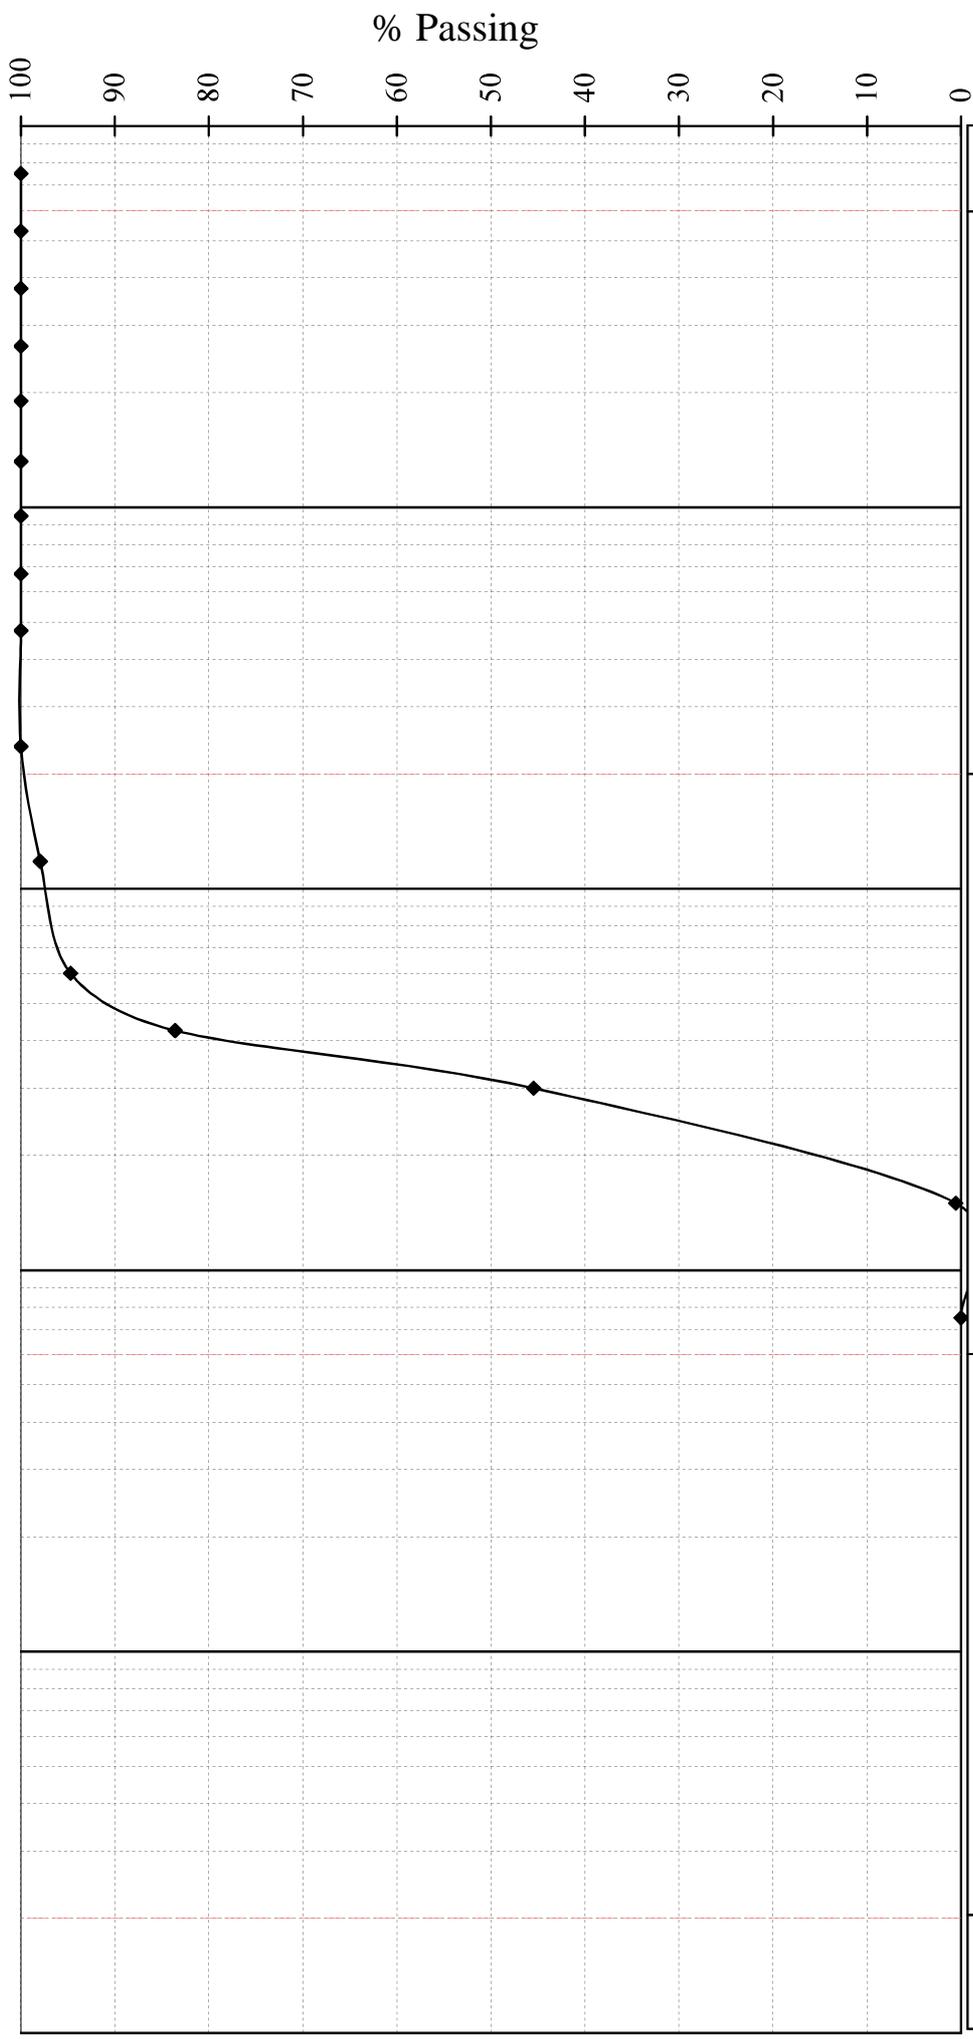
Job/Location: Bellambi Point  
 Client: WCC Environment  
 Lab No.: W10284  
 Sample No.: TPI5

Classification: *uniform sand*     $D_{10}$  (mm): 0.17     $D_{30}$  (mm): 0.24     $D_{50}$  (mm): 0.31     $D_{60}$  (mm): 0.34     $C_c = 0.9$      $C_u = 2.0$

Test Pit 15 located on Bellambi Point beach uncovered lithic sandstone bedrock at 1.0m depth located immediately beneath the beach sands which is consistent with the visual assessment of other outcrops at that beach.

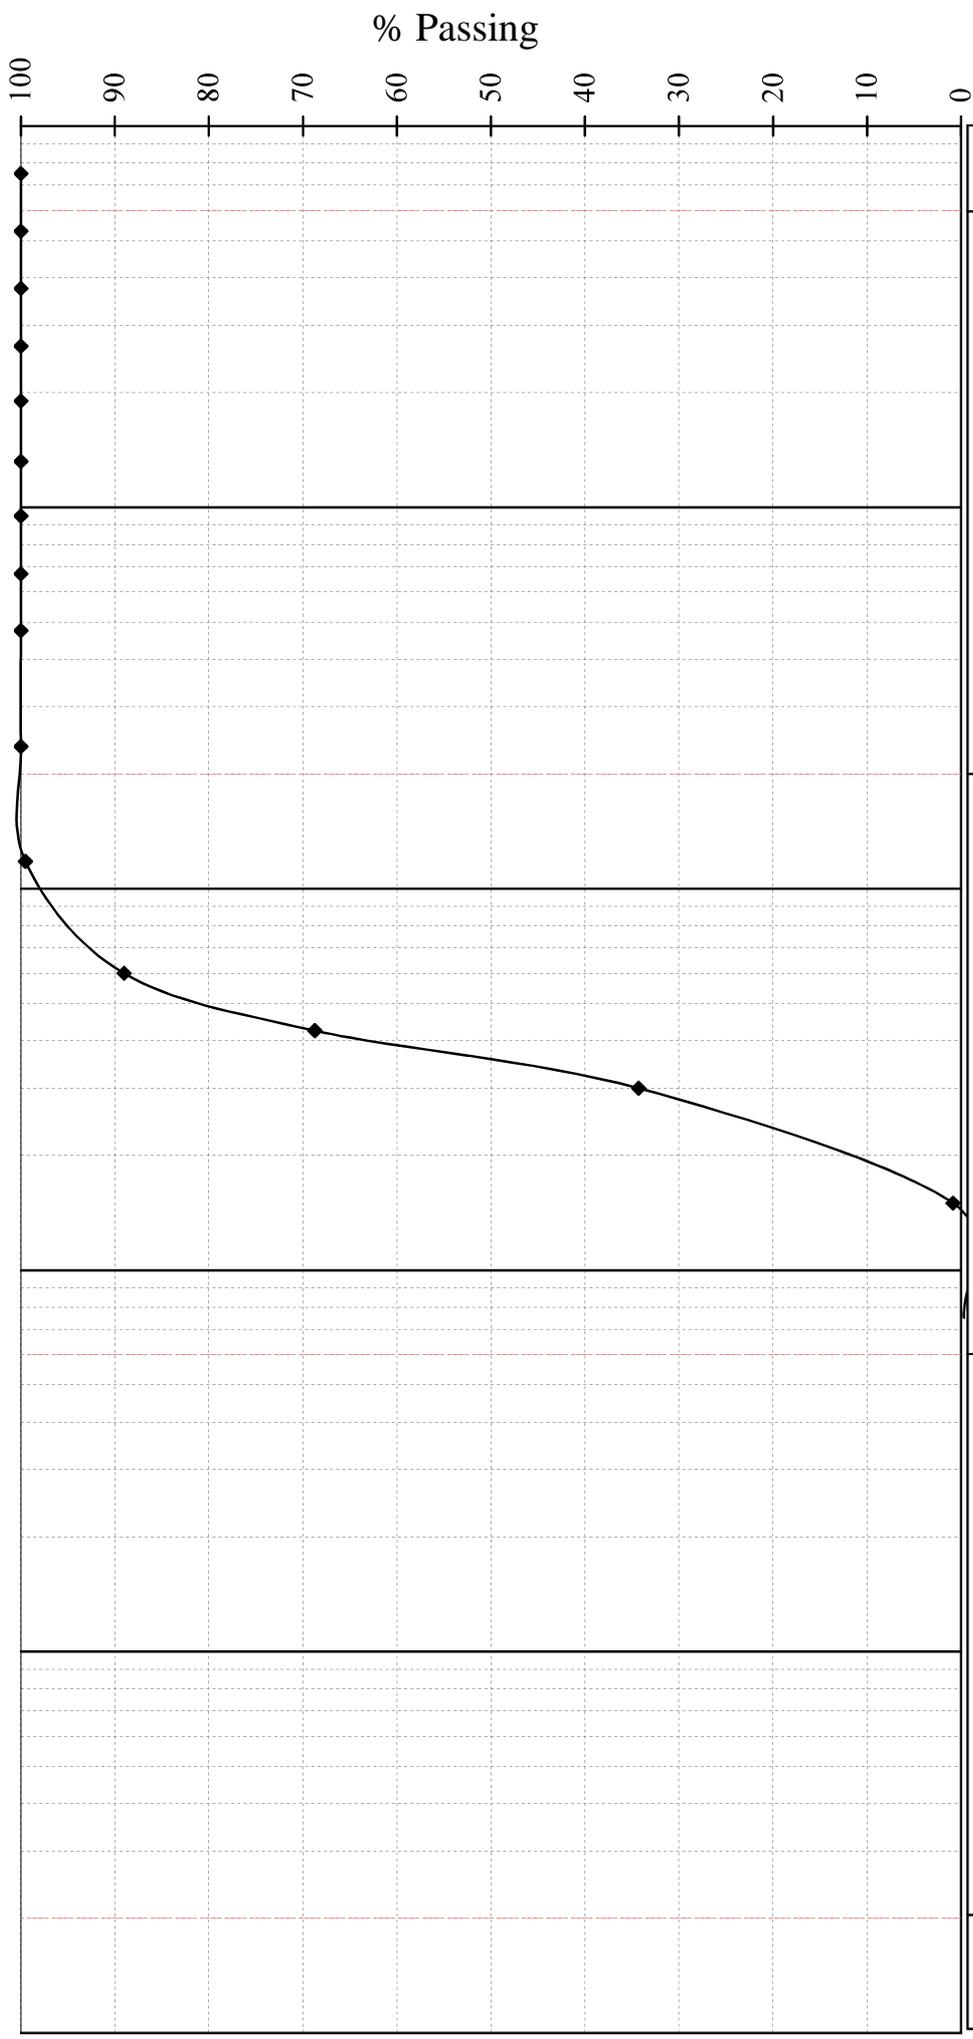
Job/Location: ..... East Corrimal Beach ..... Client: WCC ..... Environment: ..... Lab No.: W10284 ..... Sample No.: ..... TPI6: .....

**0.001 mm**      **0.01 mm**      **0.1 mm**      **1 mm**      **10 mm**      **100 mm**  
 Classification: *uniform sand*       $D_{10}$  (mm): 0.18       $D_{30}$  (mm): 0.27       $D_{50}$  (mm): 0.35       $D_{60}$  (mm): 0.39       $C_c = 1.1$        $C_u = 2.1$   
 Form No. S04      Jan 2007

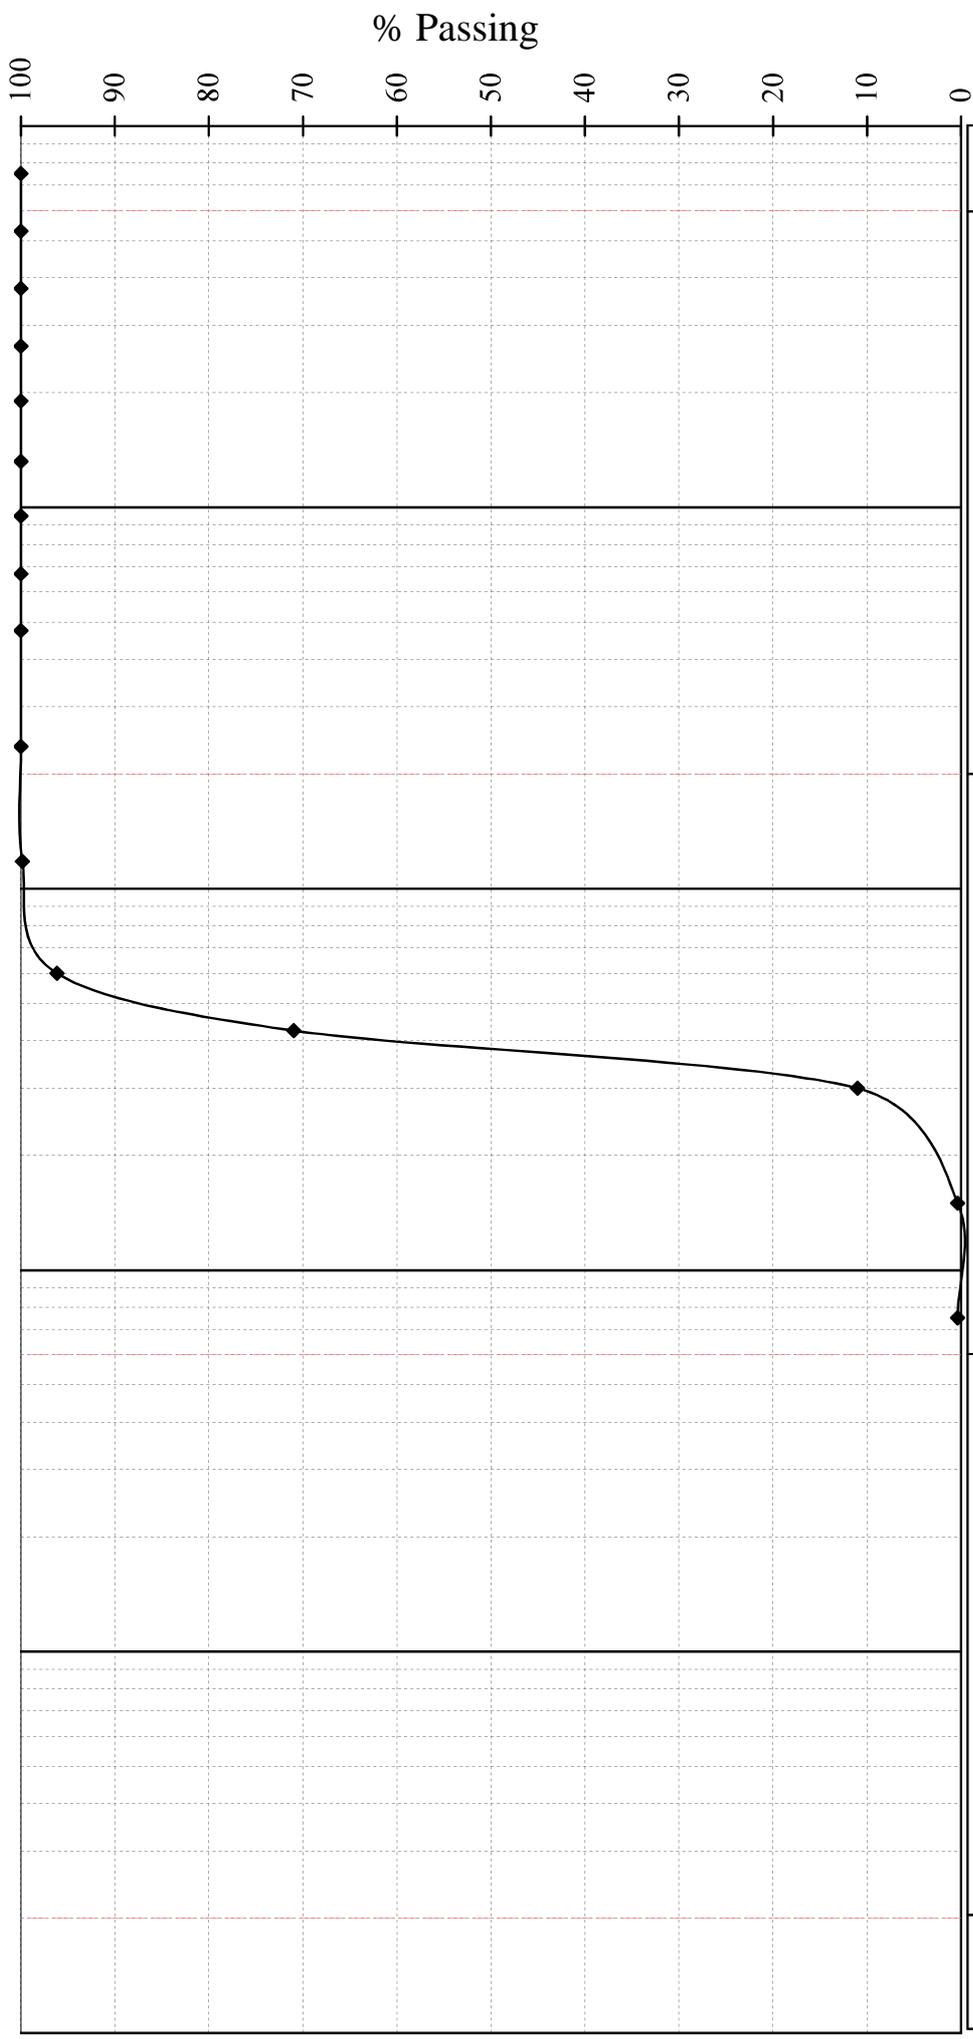
Job/Location: Towradgi Beach (van park)      Client: WCC Environment      Lab No.: W10284      Sample No.: TPI8

Classification: *uniform sand*       $D_{10}$  (mm): 0.28       $D_{30}$  (mm): 0.33       $D_{50}$  (mm): 0.38       $D_{60}$  (mm): 0.40       $C_c = 1.0$        $C_u = 1.4$

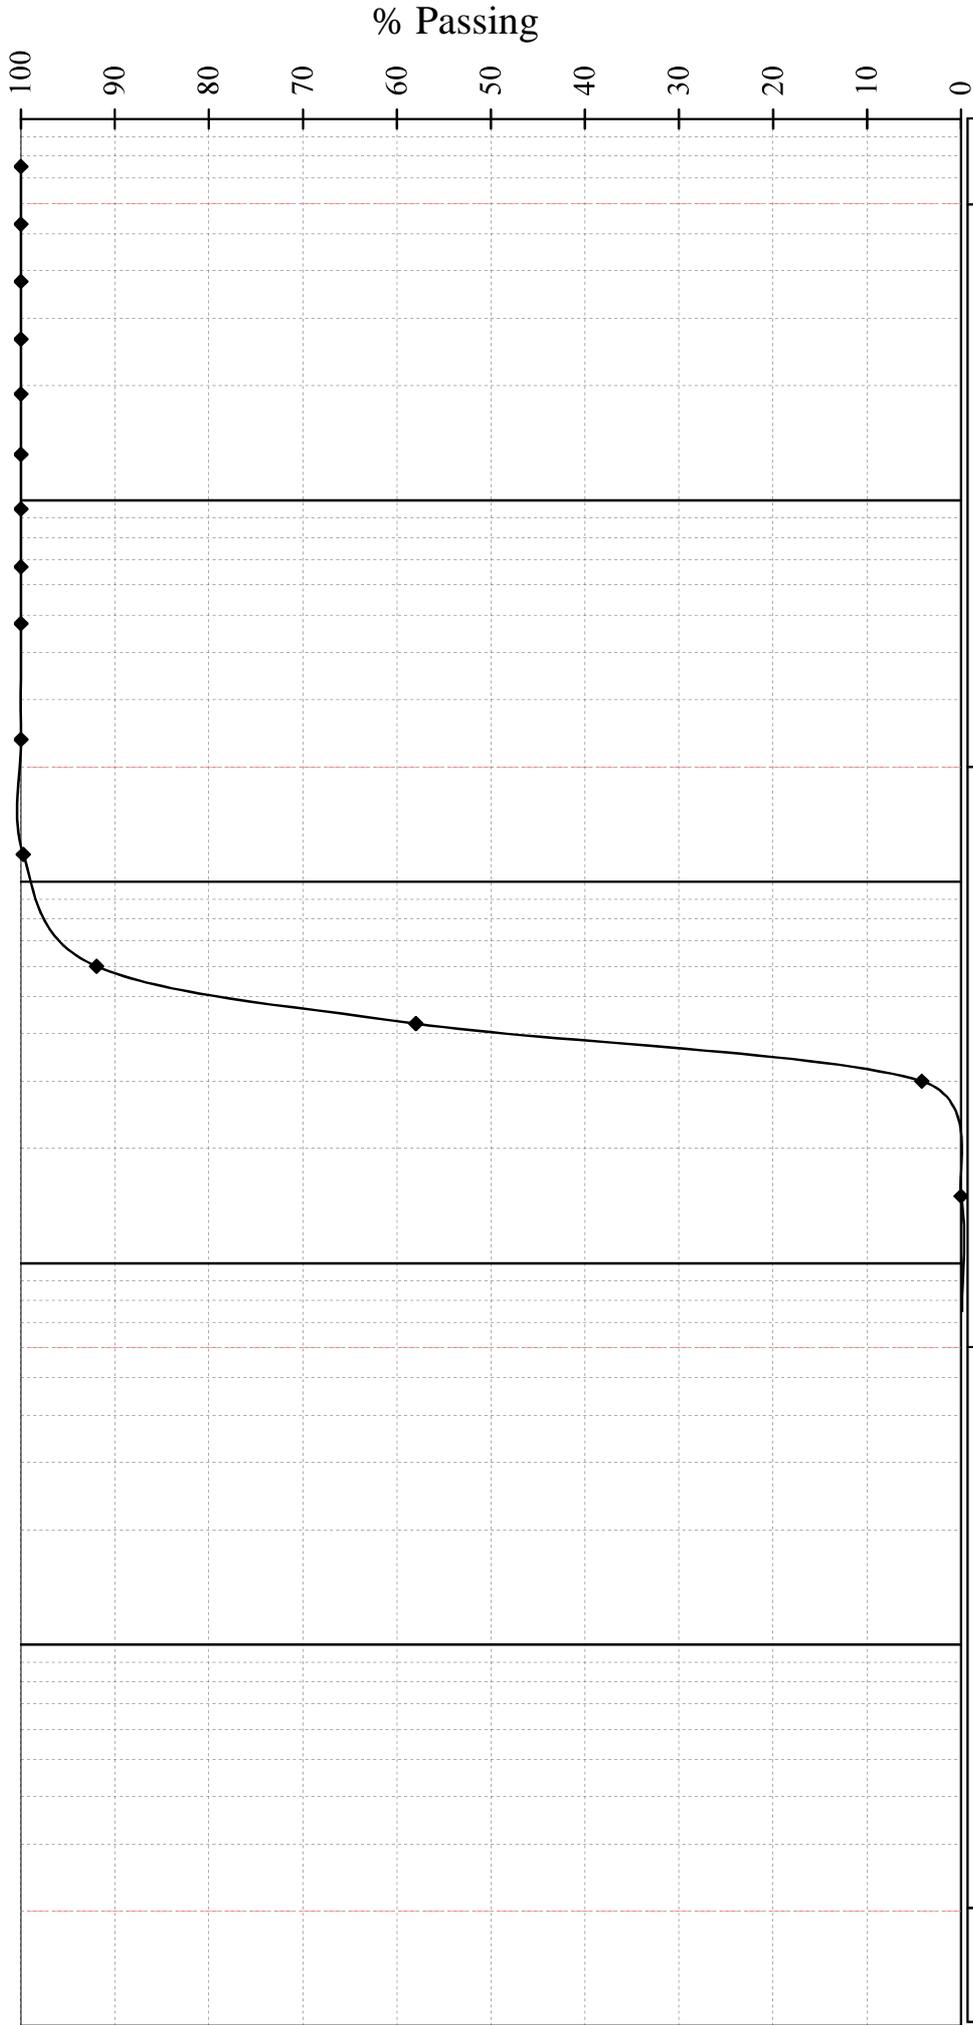
Job/Location: Puckey's Beach (Fairy Meadow)      Client: WCC Environment      Lab No.: W10284      Sample No.: TPI9

Classification: *uniform sand*       $D_{10}$  (mm): 0.31       $D_{30}$  (mm): 0.35       $D_{50}$  (mm): 0.40       $D_{60}$  (mm): 0.43       $C_c = 0.9$        $C_u = 1.4$
