# **Wollongong City Council Coastal Zone Study**

## **Volume 2 - Appendices**

# **WCC Geotechnical Data**

Re: **WOLLONGONG COASTAL HAZARDS STUDY  
GEOTECHNICAL INVESTIGATION**

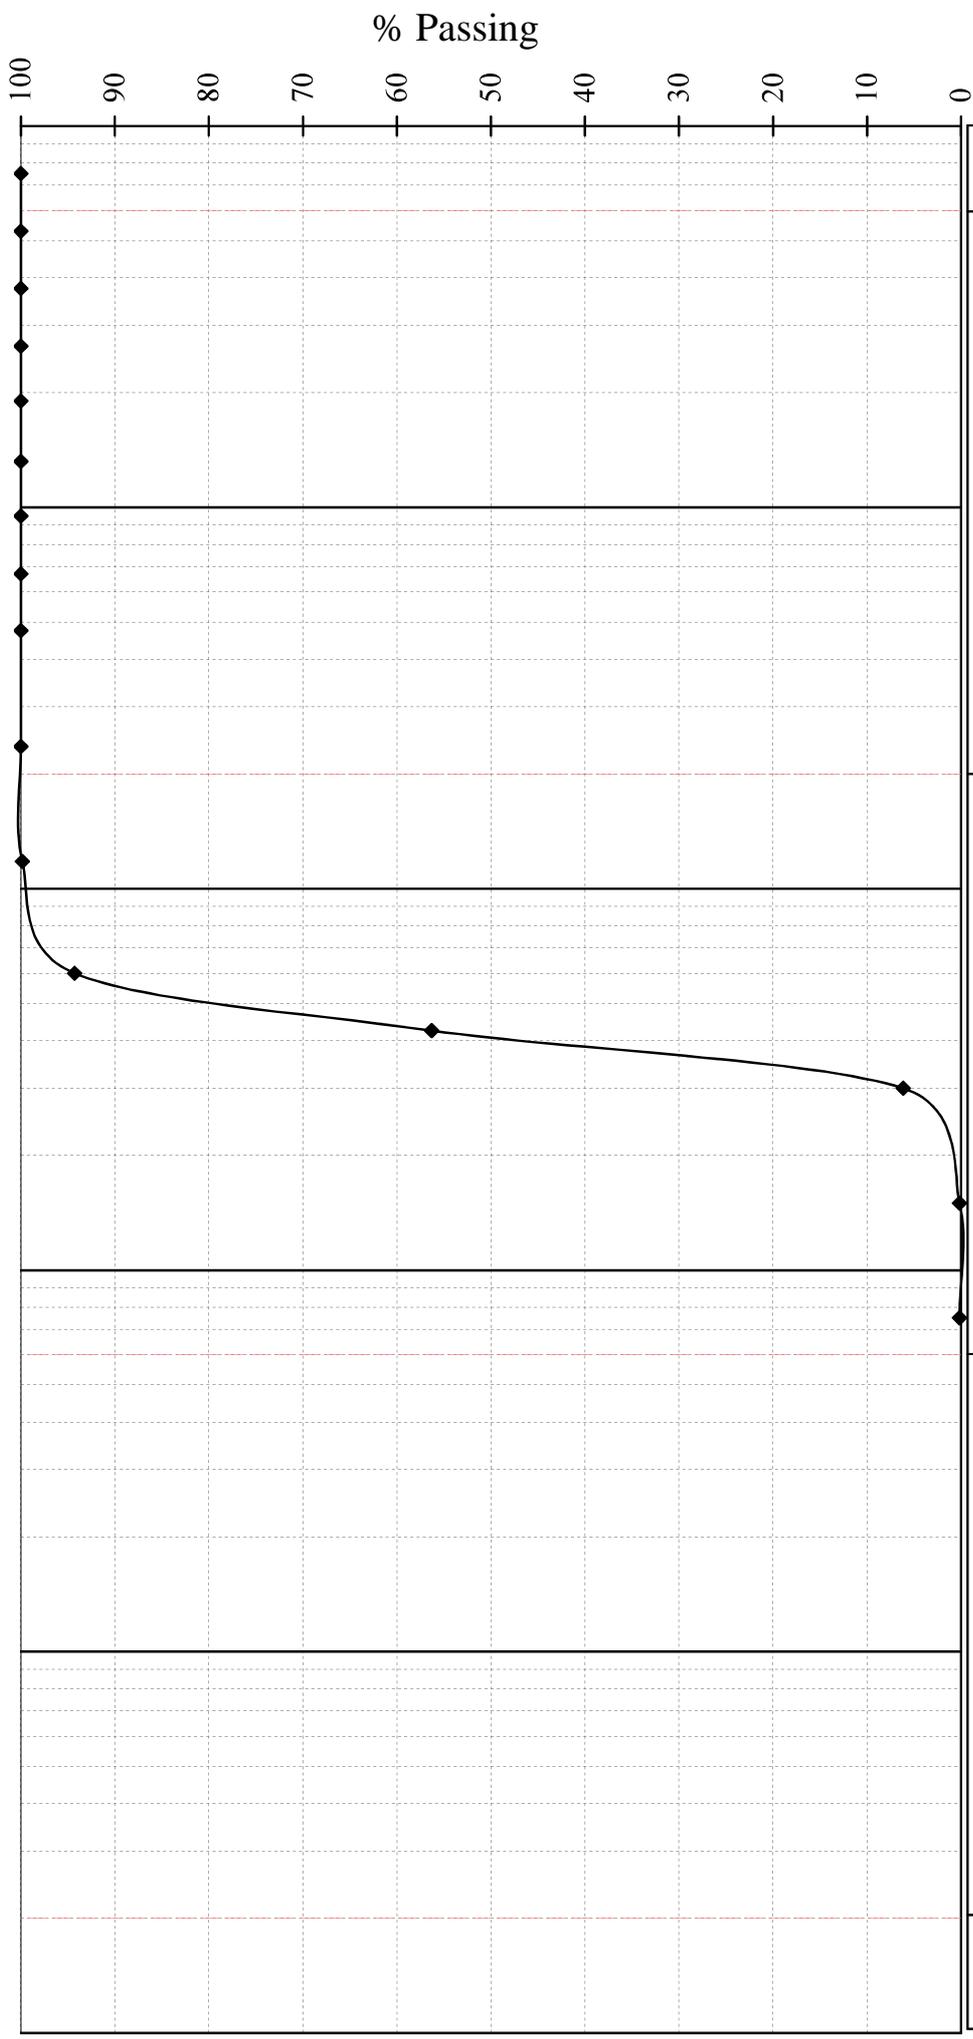
Job/Location: Wollongong (South) Beach  
 Client: WCC Environment  
 Lab No.: W10284  
 Sample No.: TP20

Classification: *uniform sand*  
 $D_{10}$  (mm): 0.31     $D_{30}$  (mm): 0.35     $D_{50}$  (mm): 0.41     $D_{60}$  (mm): 0.44  
 $C_c = 0.9$      $C_u = 1.4$   
 Form No. S04    Jan 2007

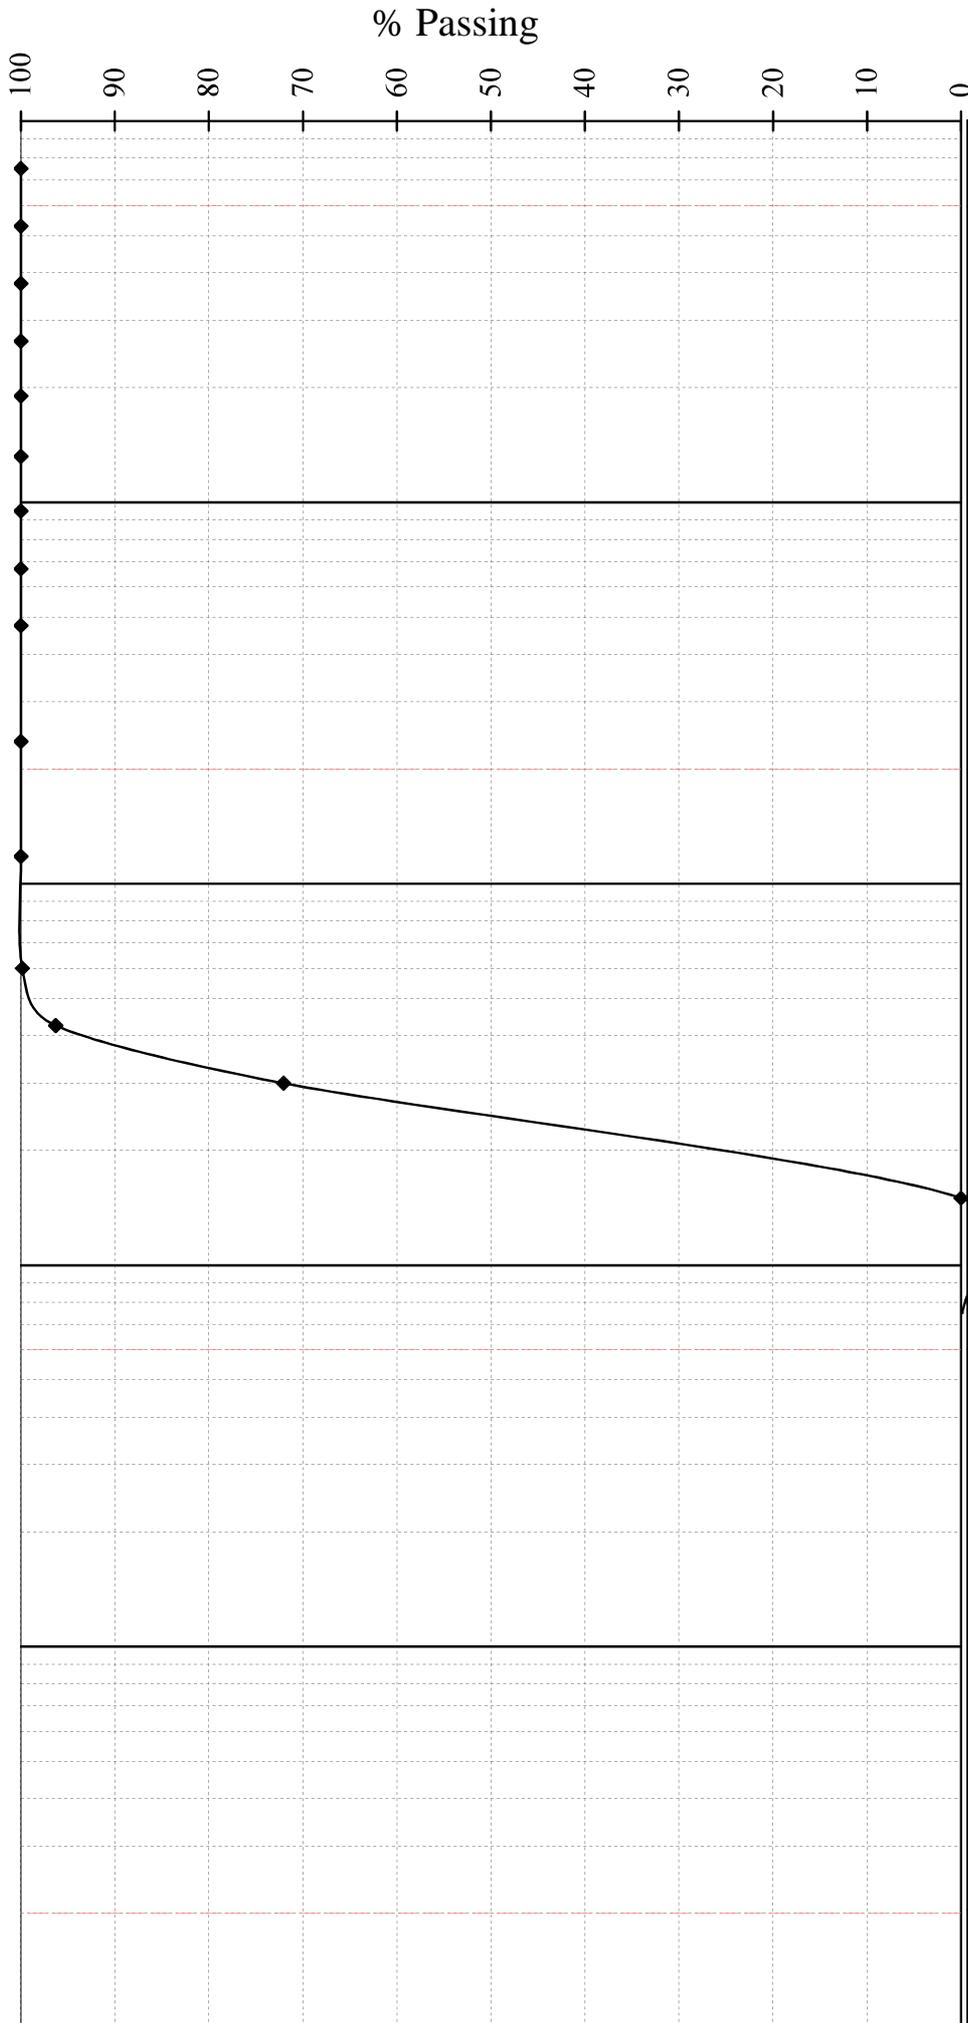
TP22

Classification: *uniform sand*

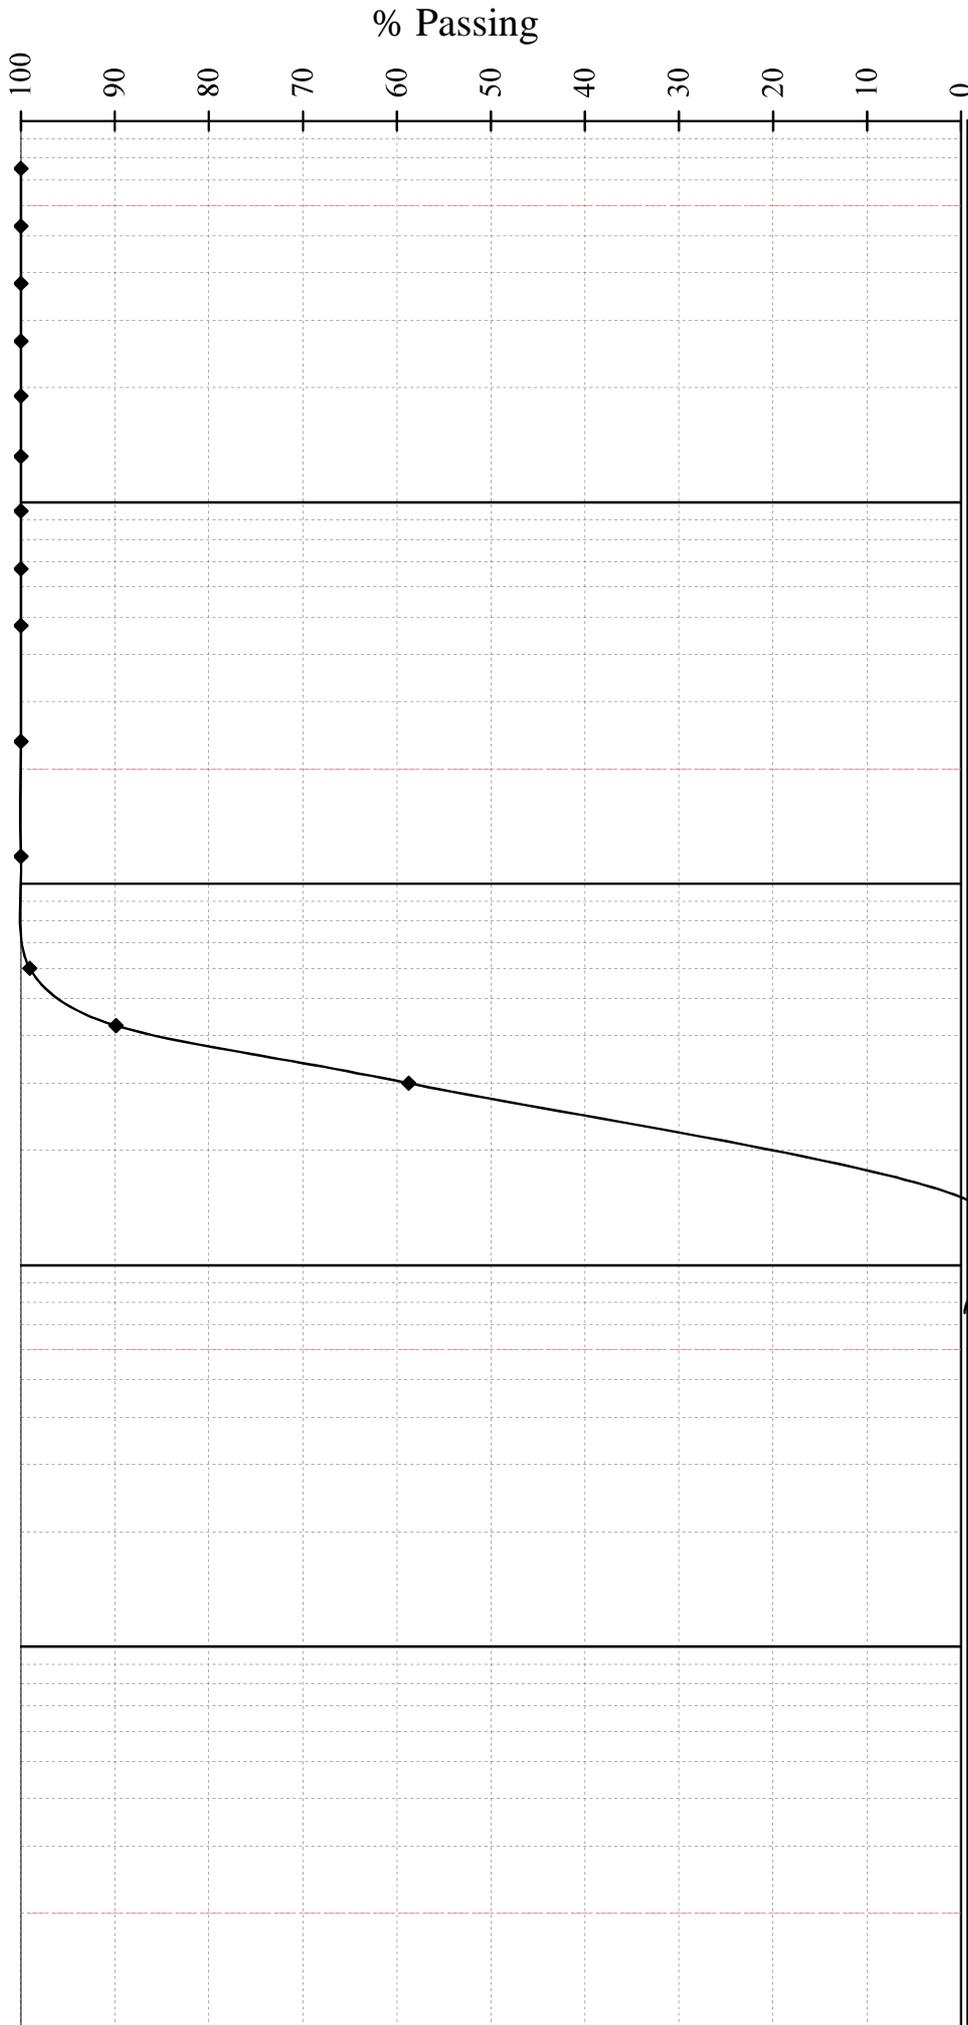
Sample No. TP23

Classification: *uniform sand*     $D_{10}$  (mm): 0.17     $D_{30}$  (mm): 0.21     $D_{50}$  (mm): 0.27     $D_{60}$  (mm): 0.30     $C_c = 0.9$      $C_u = 1.8$

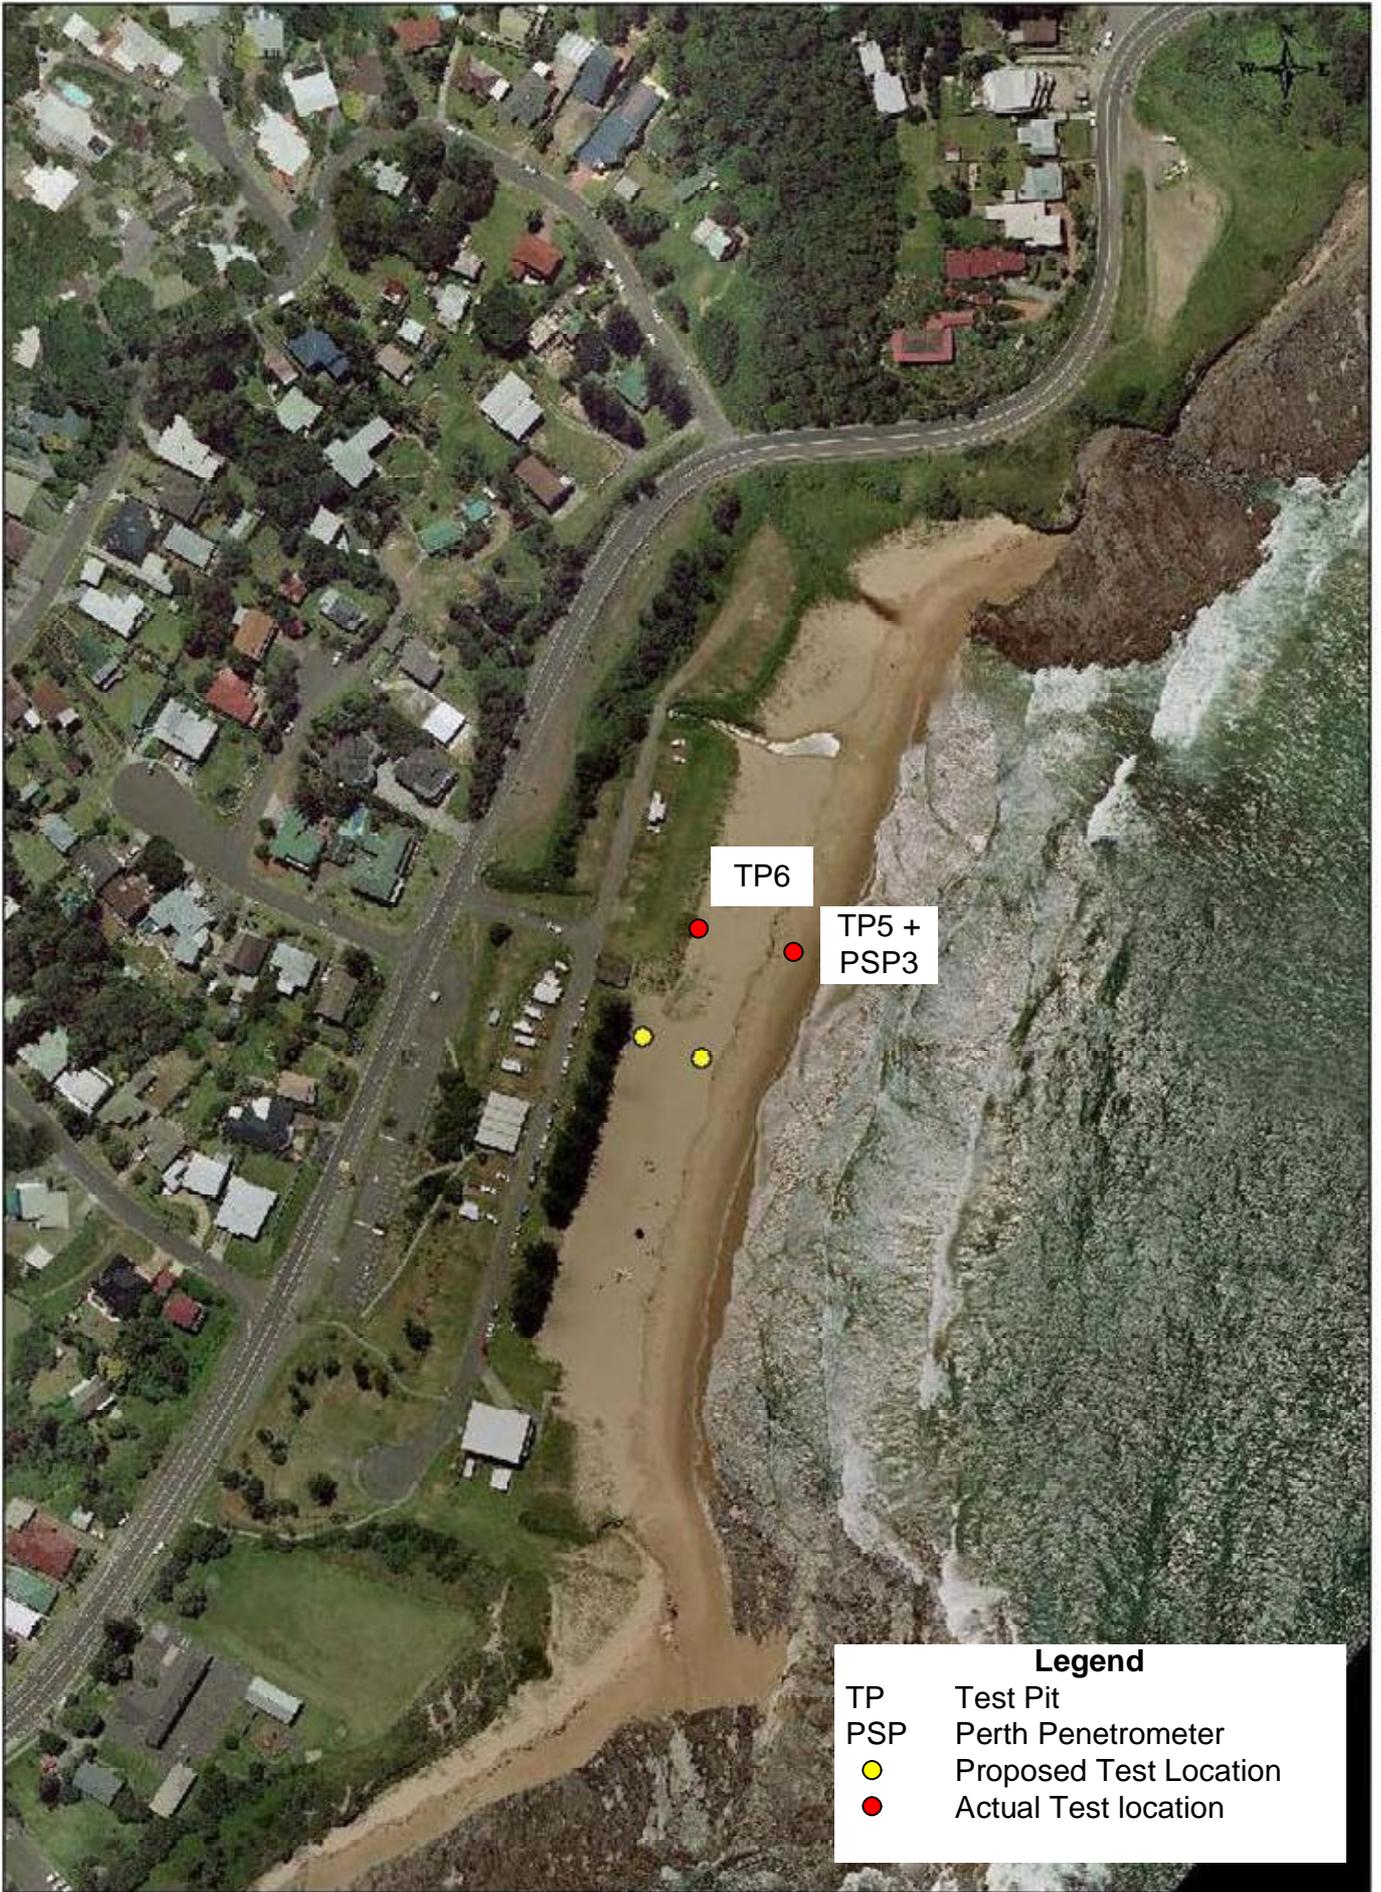
TP5 +  
PSP3

Legend	
TP	Test Pit
PSP	Perth Penetrometer
●	Proposed Test Location
●	Actual Test location

The location of the test pits and PSP's are shown on the attached drawings

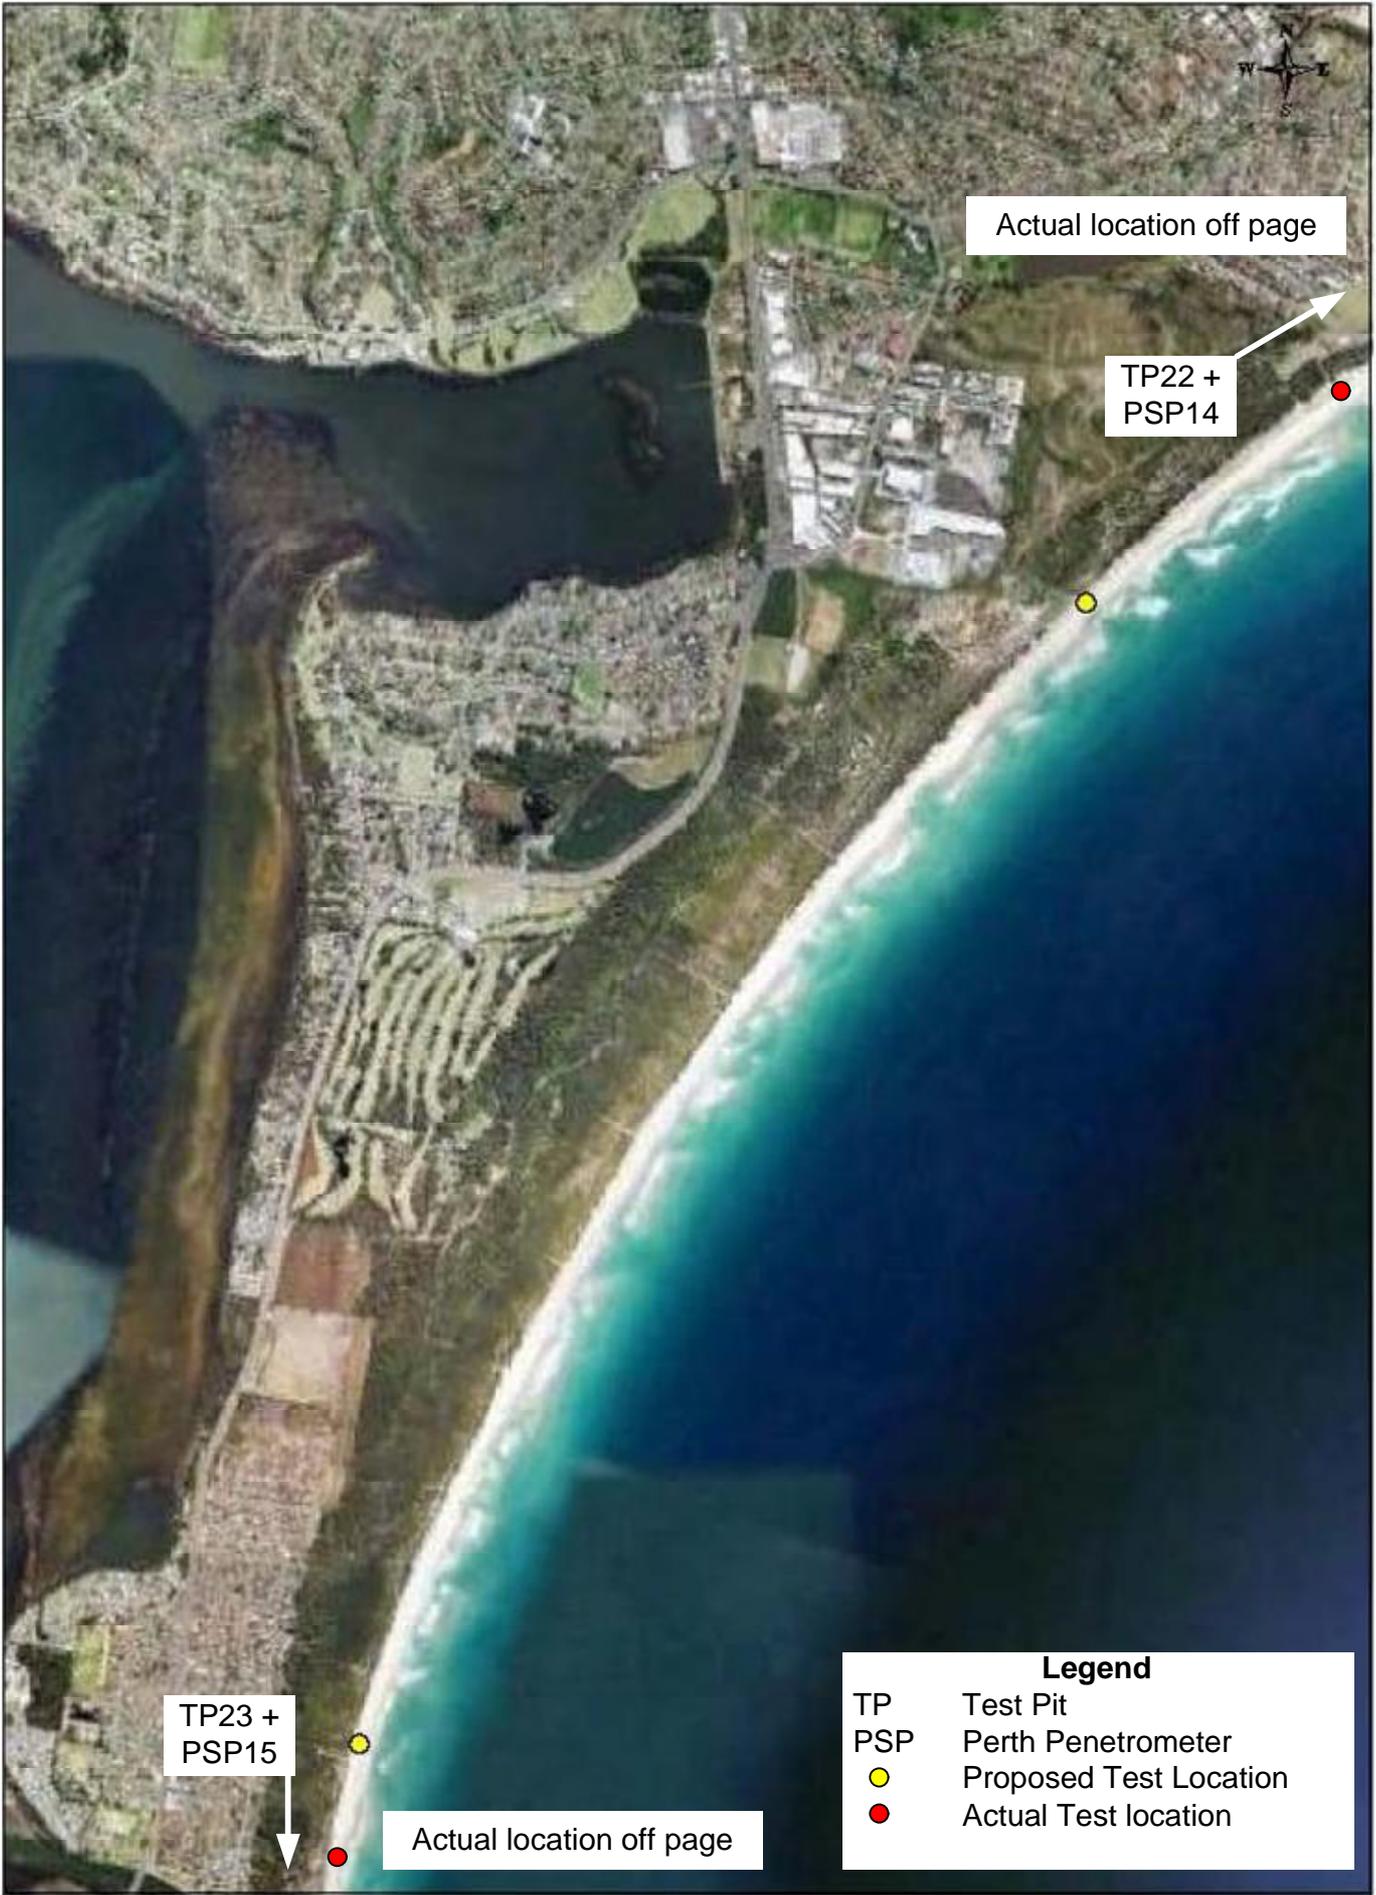
TP22 +  
PSP14

Actual location off page
