REPORT

Whartons Creek

Entrance Management Study and Plan

Client: Wollongong City Council

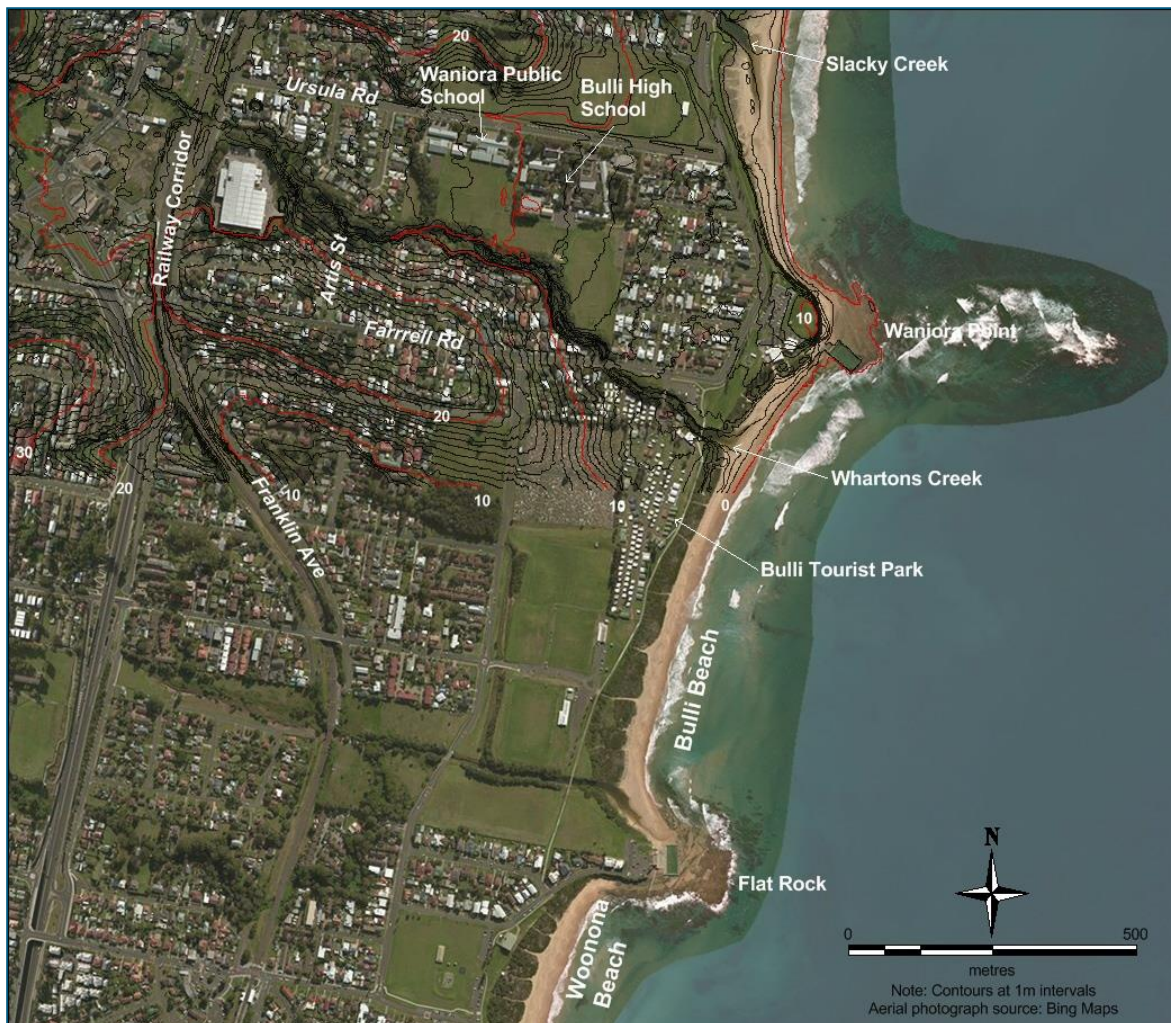
Figure 1 Whartons Creek Locality

Whartons Creek is located within the Wollongong Local Government Area (LGA) and flows from its headwaters in the Illawarra Escarpment through Bulli to the northern end of Bulli Beach, see **Figure 1**. The creek entrance is trained by gabion walls on both sides and is intermittently closed and open to the ocean. Migration of the entrance breakout channel to the north towards Bulli Surf Life Saving Club (SLSC) can result in the development of a steep erosion scarp and back beach scour over a lateral distance of up to 150 m. This results in beach safety and amenity issues and impacts on beach accessways and dune vegetation. This project, to reduce impacts from creek breakouts to the north, was identified in the *Dune Management Strategy Implementation Plan*, endorsed by Wollongong City Council (WCC) in August 2013.

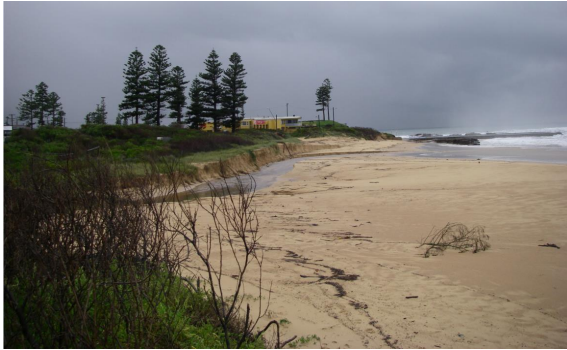
Plate 1 Breakout channel scour (WCC 28/6/2014)

Plates 1 to 2 illustrate the severity of erosion due to breakout channel scour. **Plate 3** shows closed beach accessways and warning signage installed by Wollongong City Council (WCC) when there is a risk to public safety and **Plate 4** shows damage to a board and chain beach access one month after a breakout.

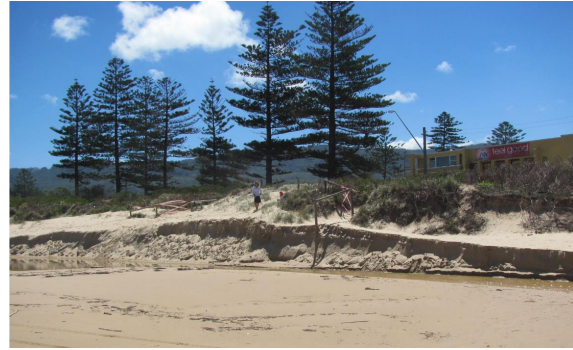
Plate 2 Steep scarp near SLSC (WCC 19/11/2013)

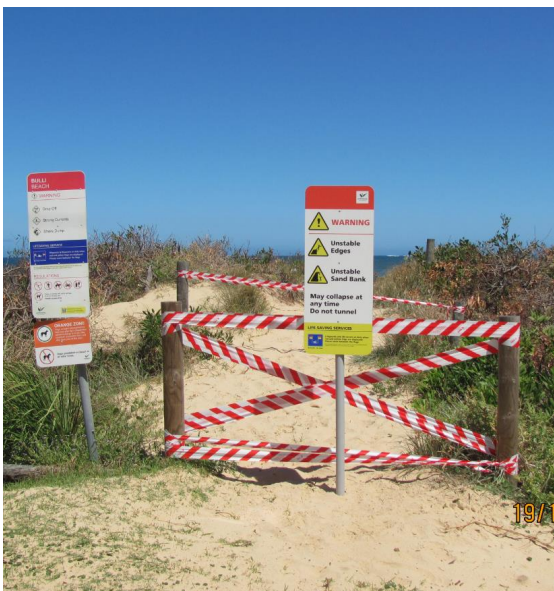
Plate 3 Closed beach accessway (WCC 19/11/2013)

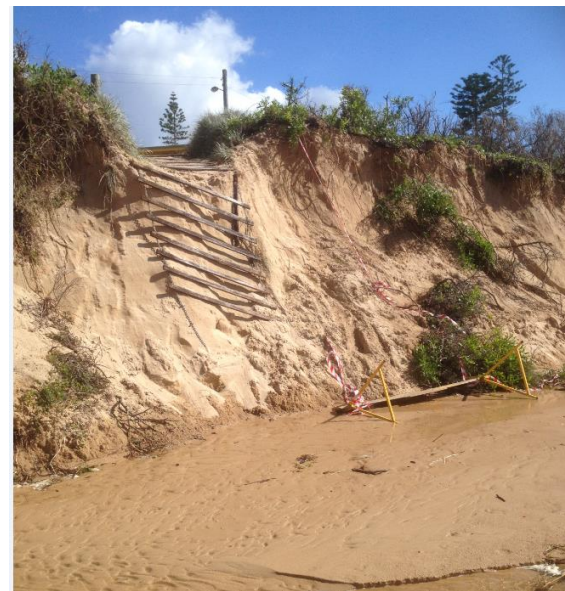
Plate 4 Damaged beach access (WCC 27/12/2013)

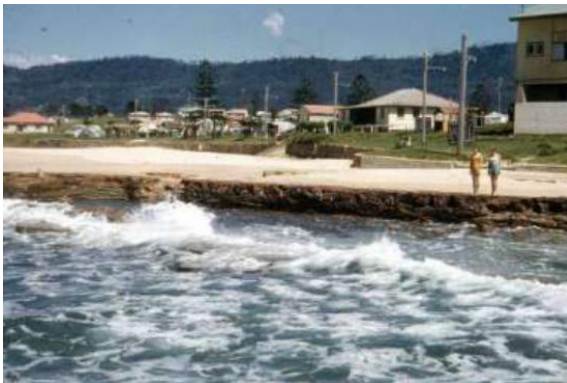
Plate 5 Sandstone wall early 1950s (Bulli SLSC)

- A retaining wall/ seawall (now buried in the vegetated dune) is located in front of the SLSC and extends south for about 70 m. An early 1950s photo (**Plate 5**) provided by Bulli SLSC shows the sandstone wall in the background, and a 1958 photo shows the wall and steps in front of the SLSC (**Plate 6**). WCC excavated two test pits in front of the SLSC in 2014 that revealed the wall was constructed of hand-packed sandstone with rendered face. It was founded on beach rounds/ armour layer without a lower footing bed or piling evident. WCC's geotechnical engineer concluded that the wall appears too low and is of a construction that falls well short of current engineering standards for seawalls.

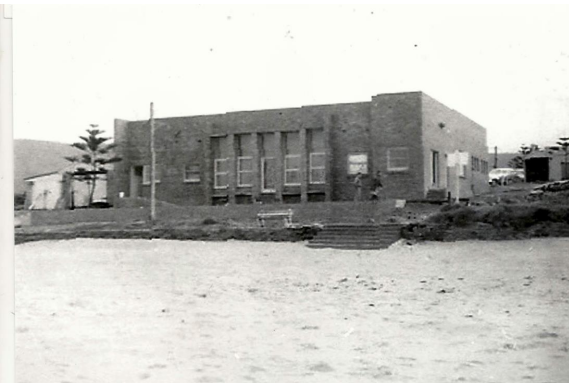
Plate 6 Sandstone wall and steps 1958 (Bulli SLSC)

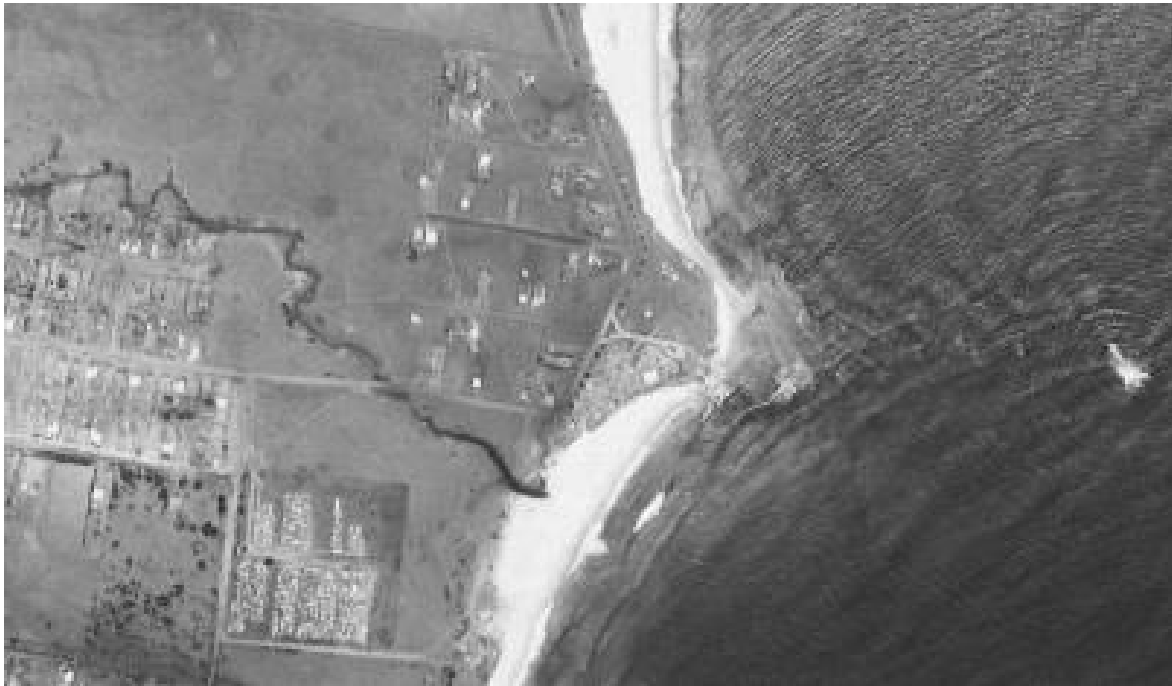
Plate 7 1948 Aerial photograph showing area largely devoid of vegetation and original rock pool (WCC)

- From a review of historical aerial photographs between 1948 and 2006, when Whartons Creek was open it generally meandered to the north or directly southeast on Bulli Beach, although the entrance was usually closed.

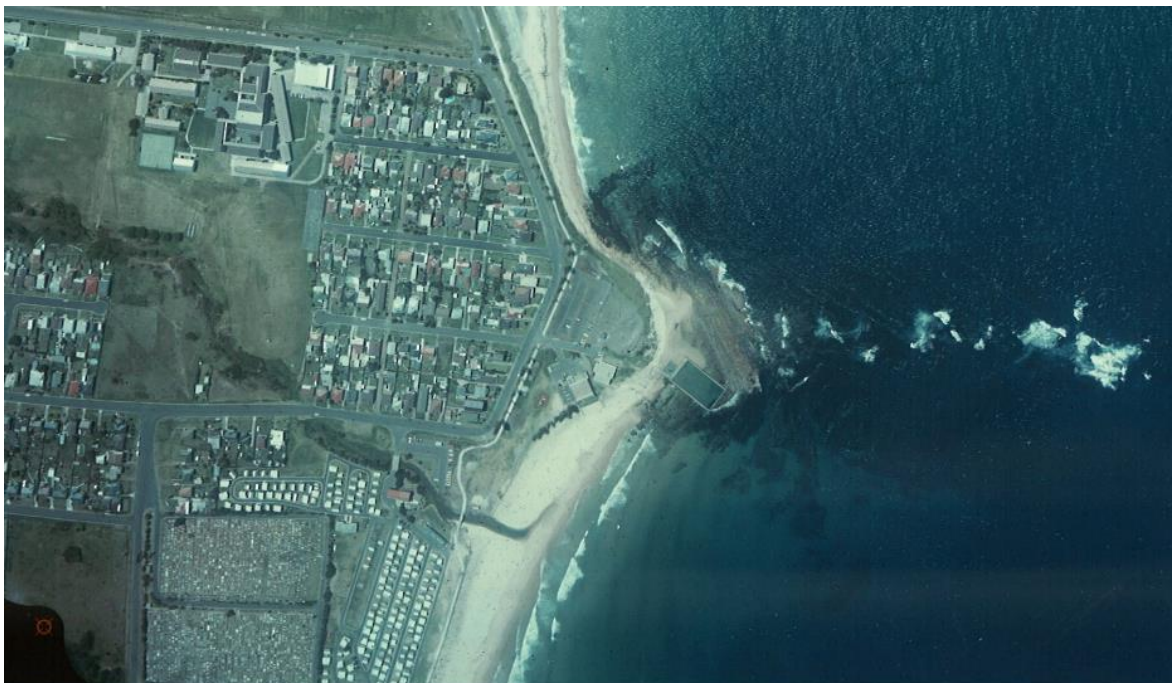
Plate 8 1986 Aerial photograph showing back beach devoid of dune vegetation (WCC)

- As shown in the aerial photographs, the sand/ vegetation interface at the northern end of Bulli Beach is more seaward than in 1948, with dune rehabilitation works in the mid-1980s leading to substantial seaward migration.

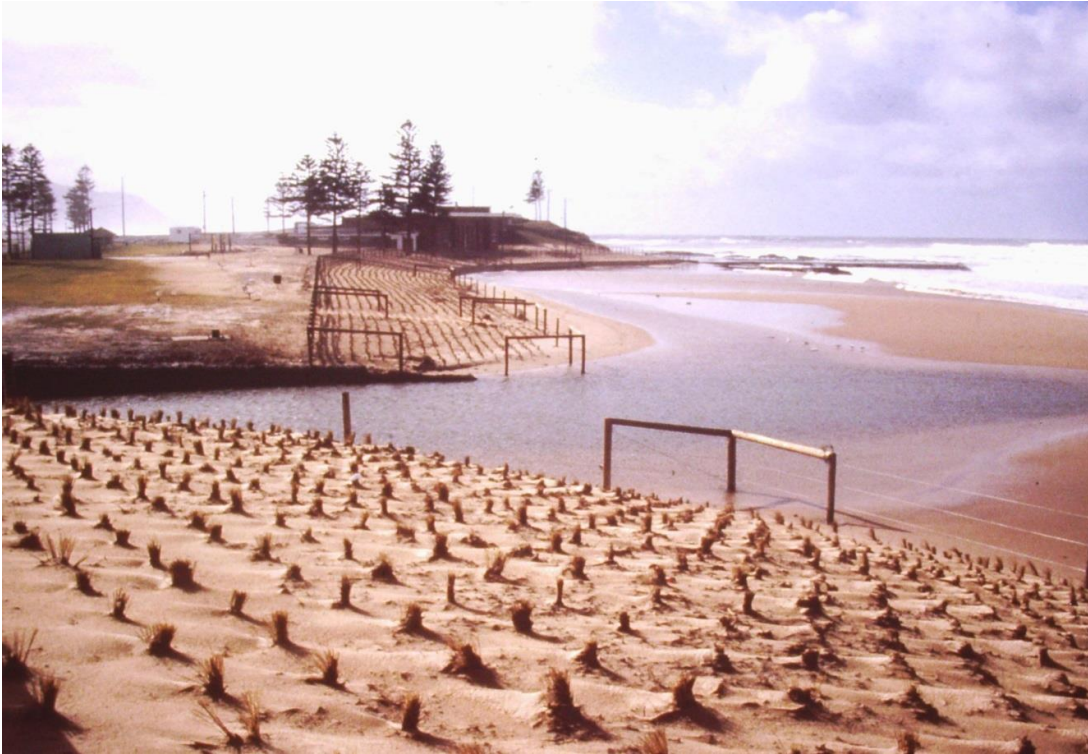
Plate 9 1986 Photograph showing recent dune planting and breakout to north (OEH 1986)

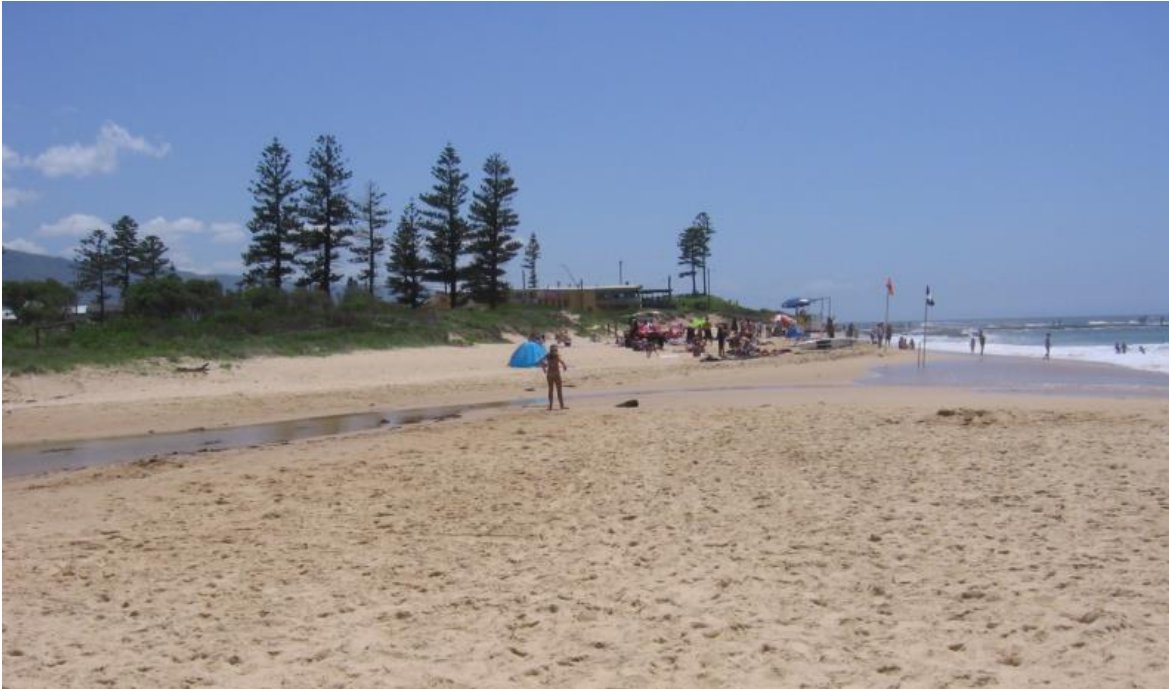
Plate 11 Flagged swimming area north of creek (WCC 23/1/2015)

The Bulli SLSC and Bulli Beach Café are located at Waniora Point as well as the children's and main rock pools, see **Figure 2**. The northern end of Bulli Beach is a popular patrolled area for locals and tourists, with the Bulli Tourist Park and Ruby's Kiosk located on the southern side of Whartons Creek. The flagged swimming area can be anywhere between the SLSC and up to 100 m south of Whartons Creek, depending on conditions. **Plate 11** shows the flagged area near the SLSC in January 2015, with the creek channel meandering to the northeast.

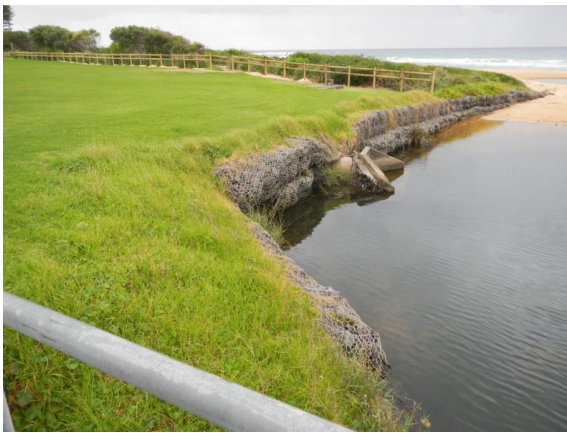
Plate 12 Northern side of Whartons Creek entrance

As noted in **Section 1.1**, rock filled gabions line the creek on each side of the entrance below the footbridge, see **Plates 12** and **13**. The gabions appear to have slumped slightly on the northern side of the creek, leaving a gap between the stormwater headwall and creek bank (see **Plate 14**). At the beach end the gabions have collapsed, rocks have been removed, and at times broken wires protrude through the sand (see **Plate 15**).

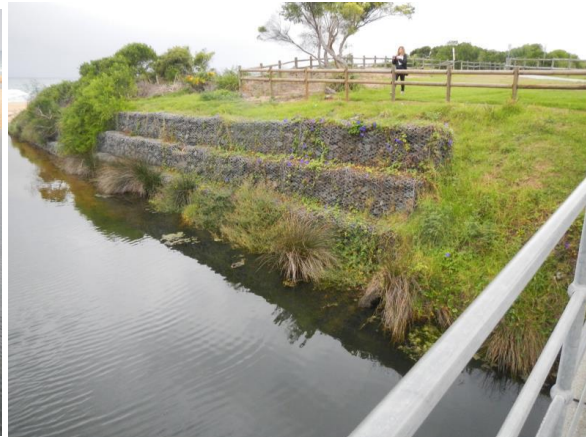
Plate 13 Southern side of Whartons Creek entrance

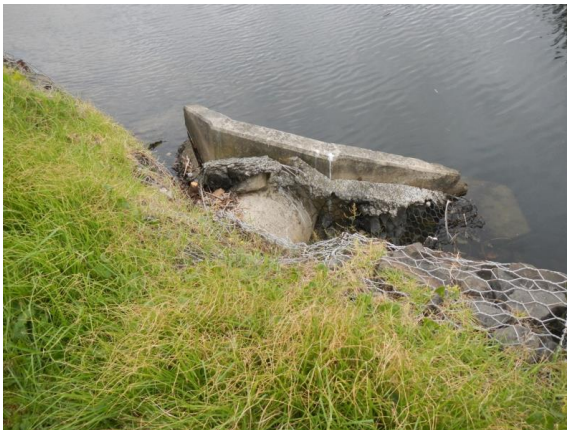
Plate 14 Stormwater pipe headwall

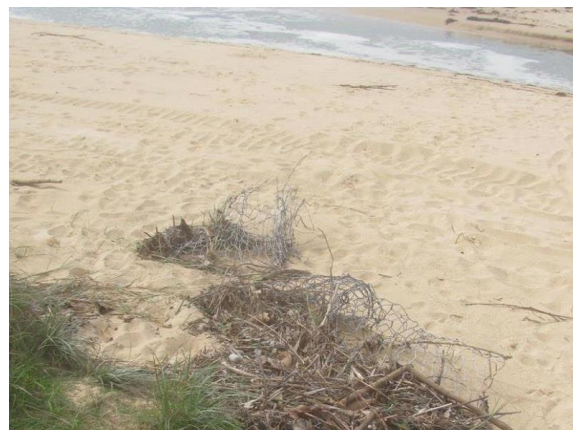
Plate 15 Gabion wires on beach (WCC 20/02/2015)

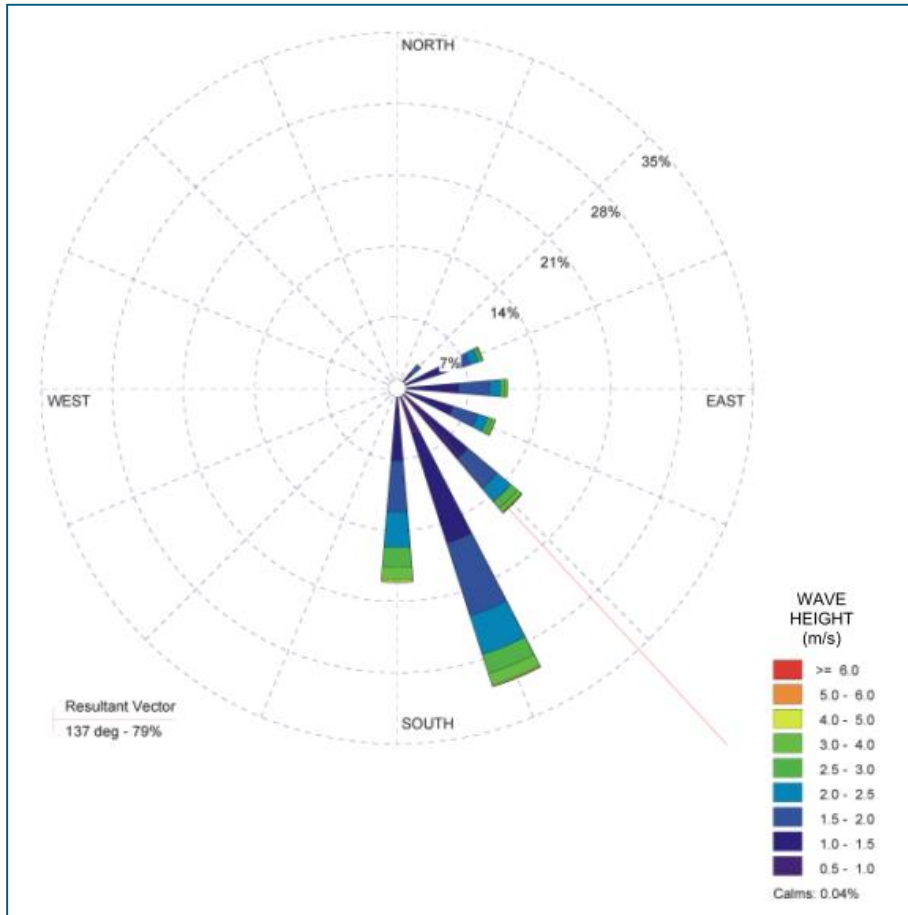
Figure 3 Annual Average Wave Climate Port Kembla (1992-2005) (CLT 2010)

The dominant offshore wave direction along the Wollongong coast is from the SSE. The average annual wave climate from the Port Kembla waverider buoy is shown in **Figure 3**.

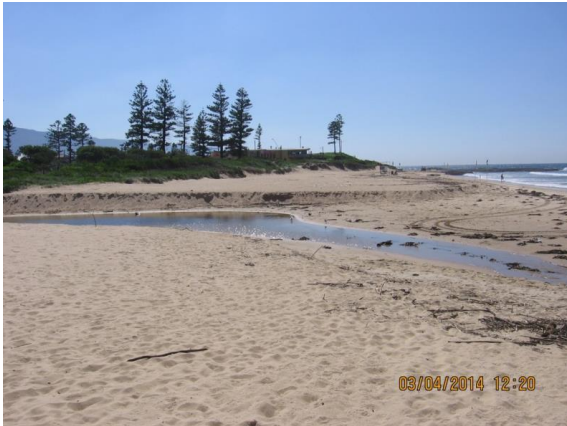
Plate 17 Entrance flowing southeast (WCC 3/4/2014)

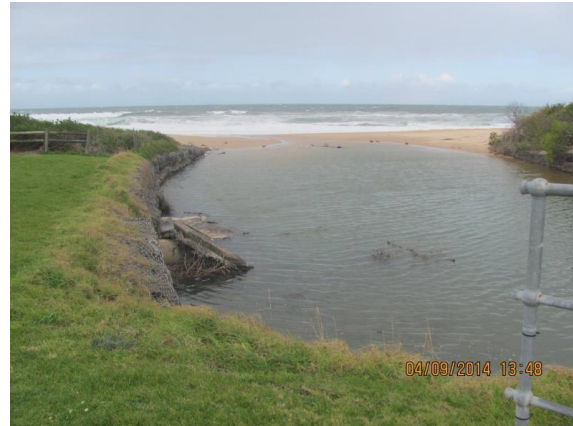
Plate 18 Seas washing over berm into creek (WCC 4/9/2014)

- The entrance was open again by 22 August 2014 after an average daily rainfall of 19 mm from 12 August 2014 and essentially remained so for 6 months. The entrance orientation first tracked east, then northeast. Overwash into the entrance during high seas was observed at the end of September, see **Plate 18**. Entrance shoaling was noted in late October 2014.

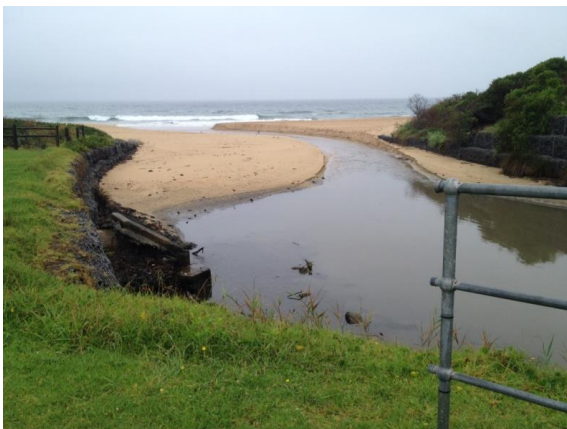
Plate 19 Open entrance after heavy rain (WCC 11/1/2015)

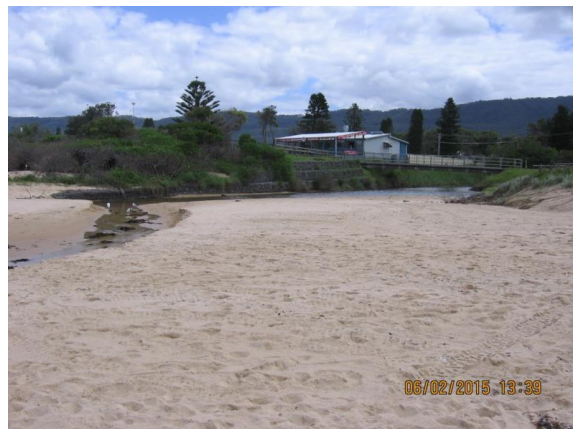
Plate 20 Entrance open and flowing north (WCC 6/2/2015)

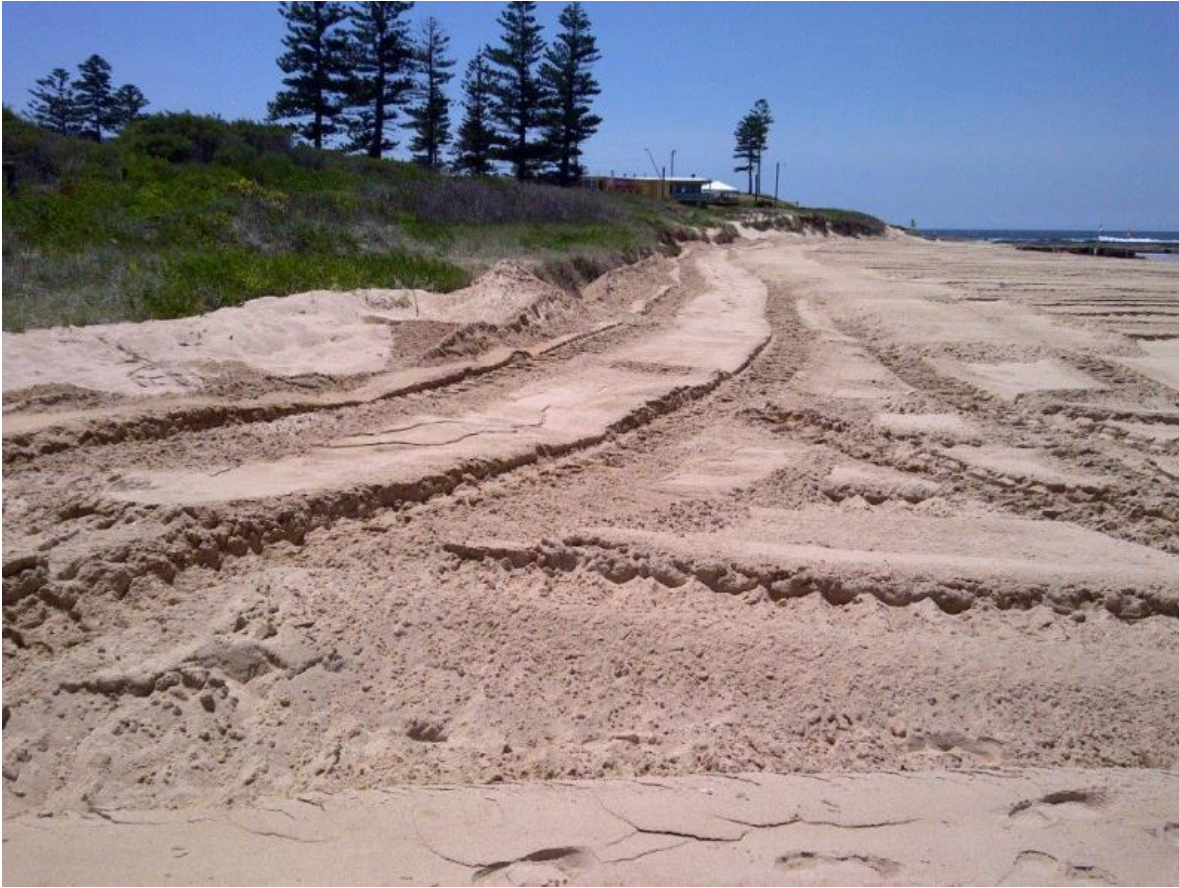
Plate 21 Reshaping of beach/ dune following entrance scour (WCC Feb 2014)

The last creek diversion works undertaken by WCC in February 2014 involved excavation of an area approximately 3 m wide by 10 m in length to a depth of 1 m (30 m³ of sand). This sand was placed on the northern side of the excavated channel and then moved by a dozer and spread over the back of the beach to fill the creek scour channel as shown in **Plate 21** (WCC 2013). The cost associated with creek realignment and reshaping the beach was approximately \$20,000. Based on monitoring data, the impact of these works resulted in a south to southeast entrance channel orientation for only about two months before reshaping of the beach berm under natural processes resulted in the entrance channel reverting to the east/ northeast.

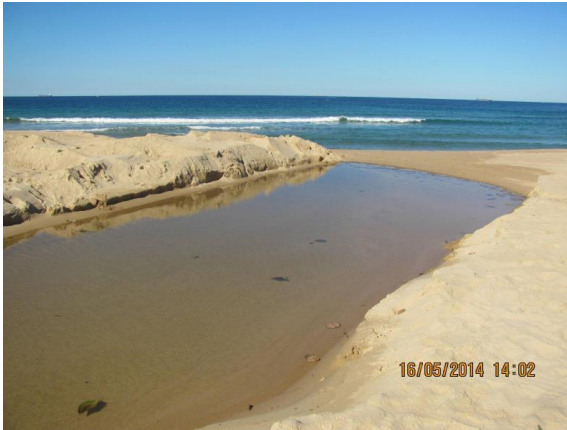
Plate 22 Entrance following 2014 works (WCC 16/5/2014)

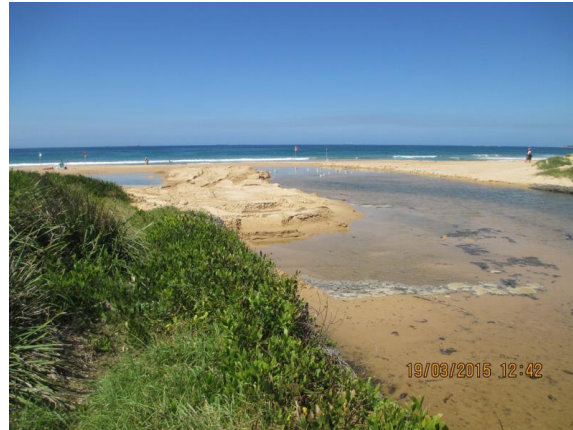
Plate 23 Entrance following 2015 works (WCC 19/3/2015)

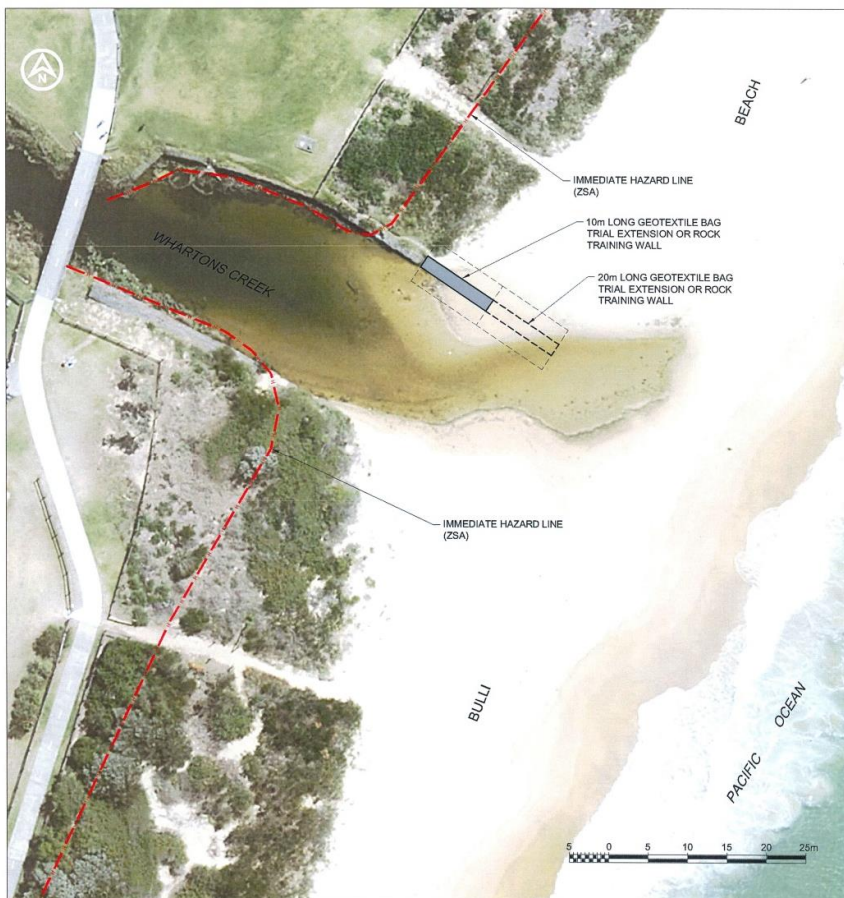
Figure 8 Training Wall Extension Concept Plan [100 year ARI immediate Zone of Slope Adjustment line shown CLT (2010)]

More efficient entrance training may result in an increase in the frequency of entrance breakouts. Being a soft engineering option means the geotextile entrance training wall could be readily adapted to changing conditions, such as any change in shoreline position due to sea level rise and the position of the toe of the vegetated dune should further shoreline accretion (perhaps unexpectedly) occur.

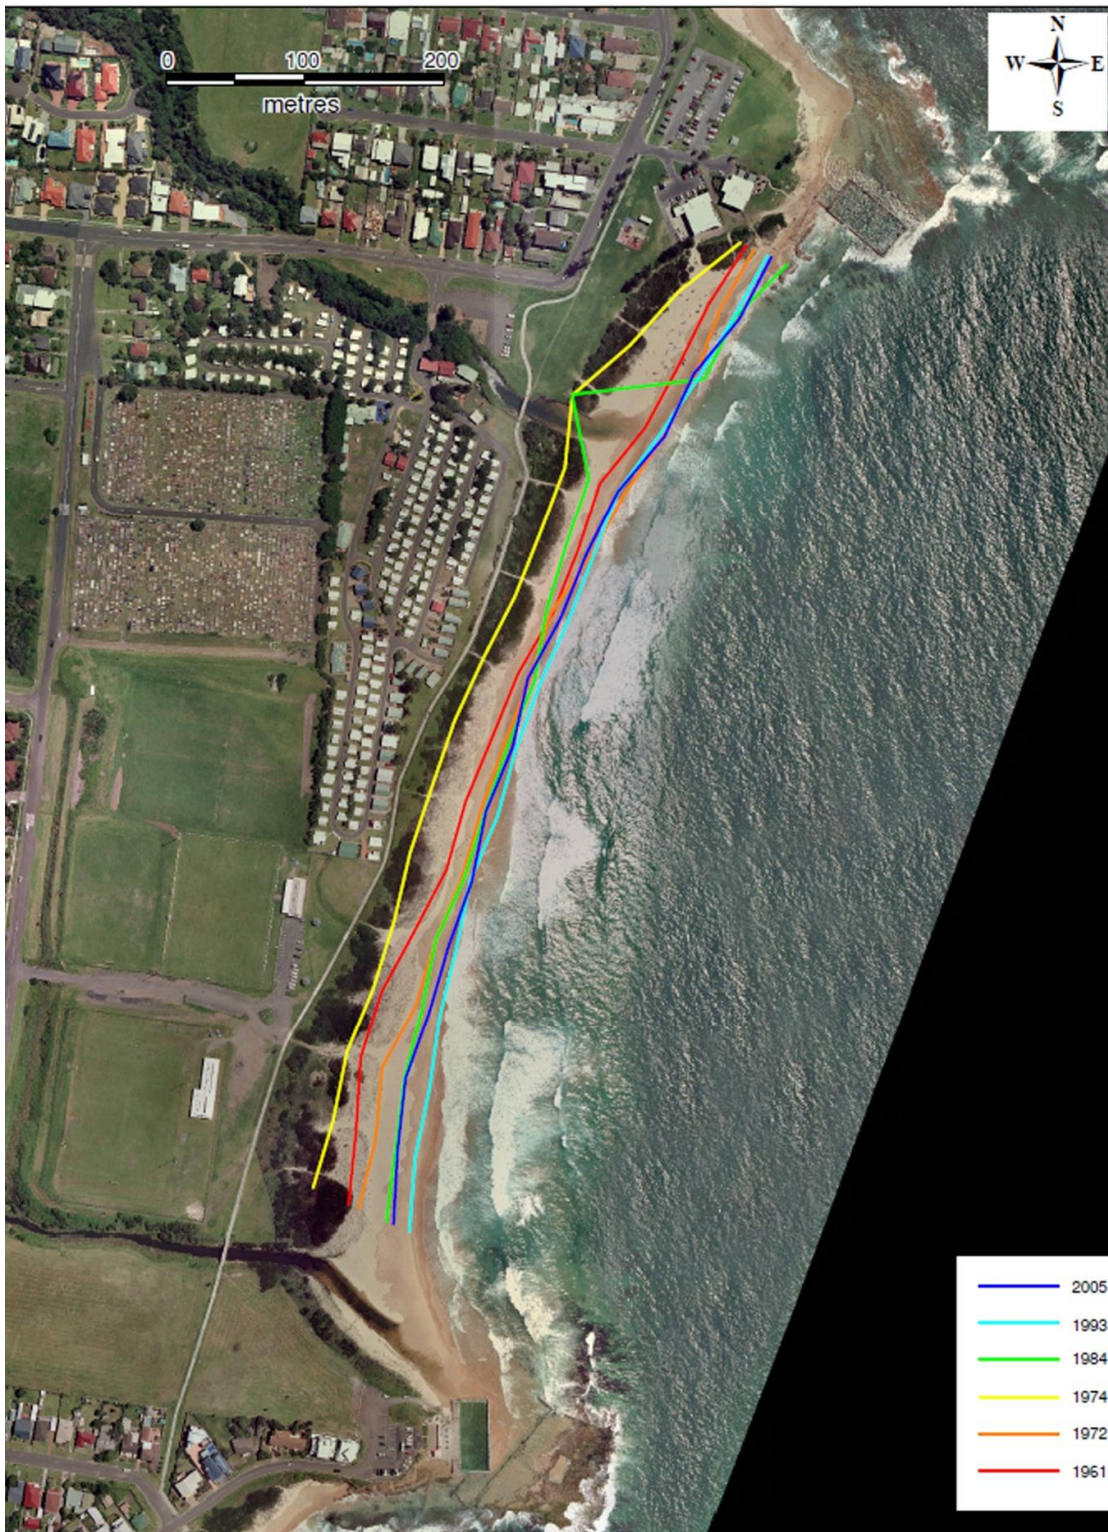
Figure 2 Historical 2 m AHD Shoreline Change (CLT 2010)

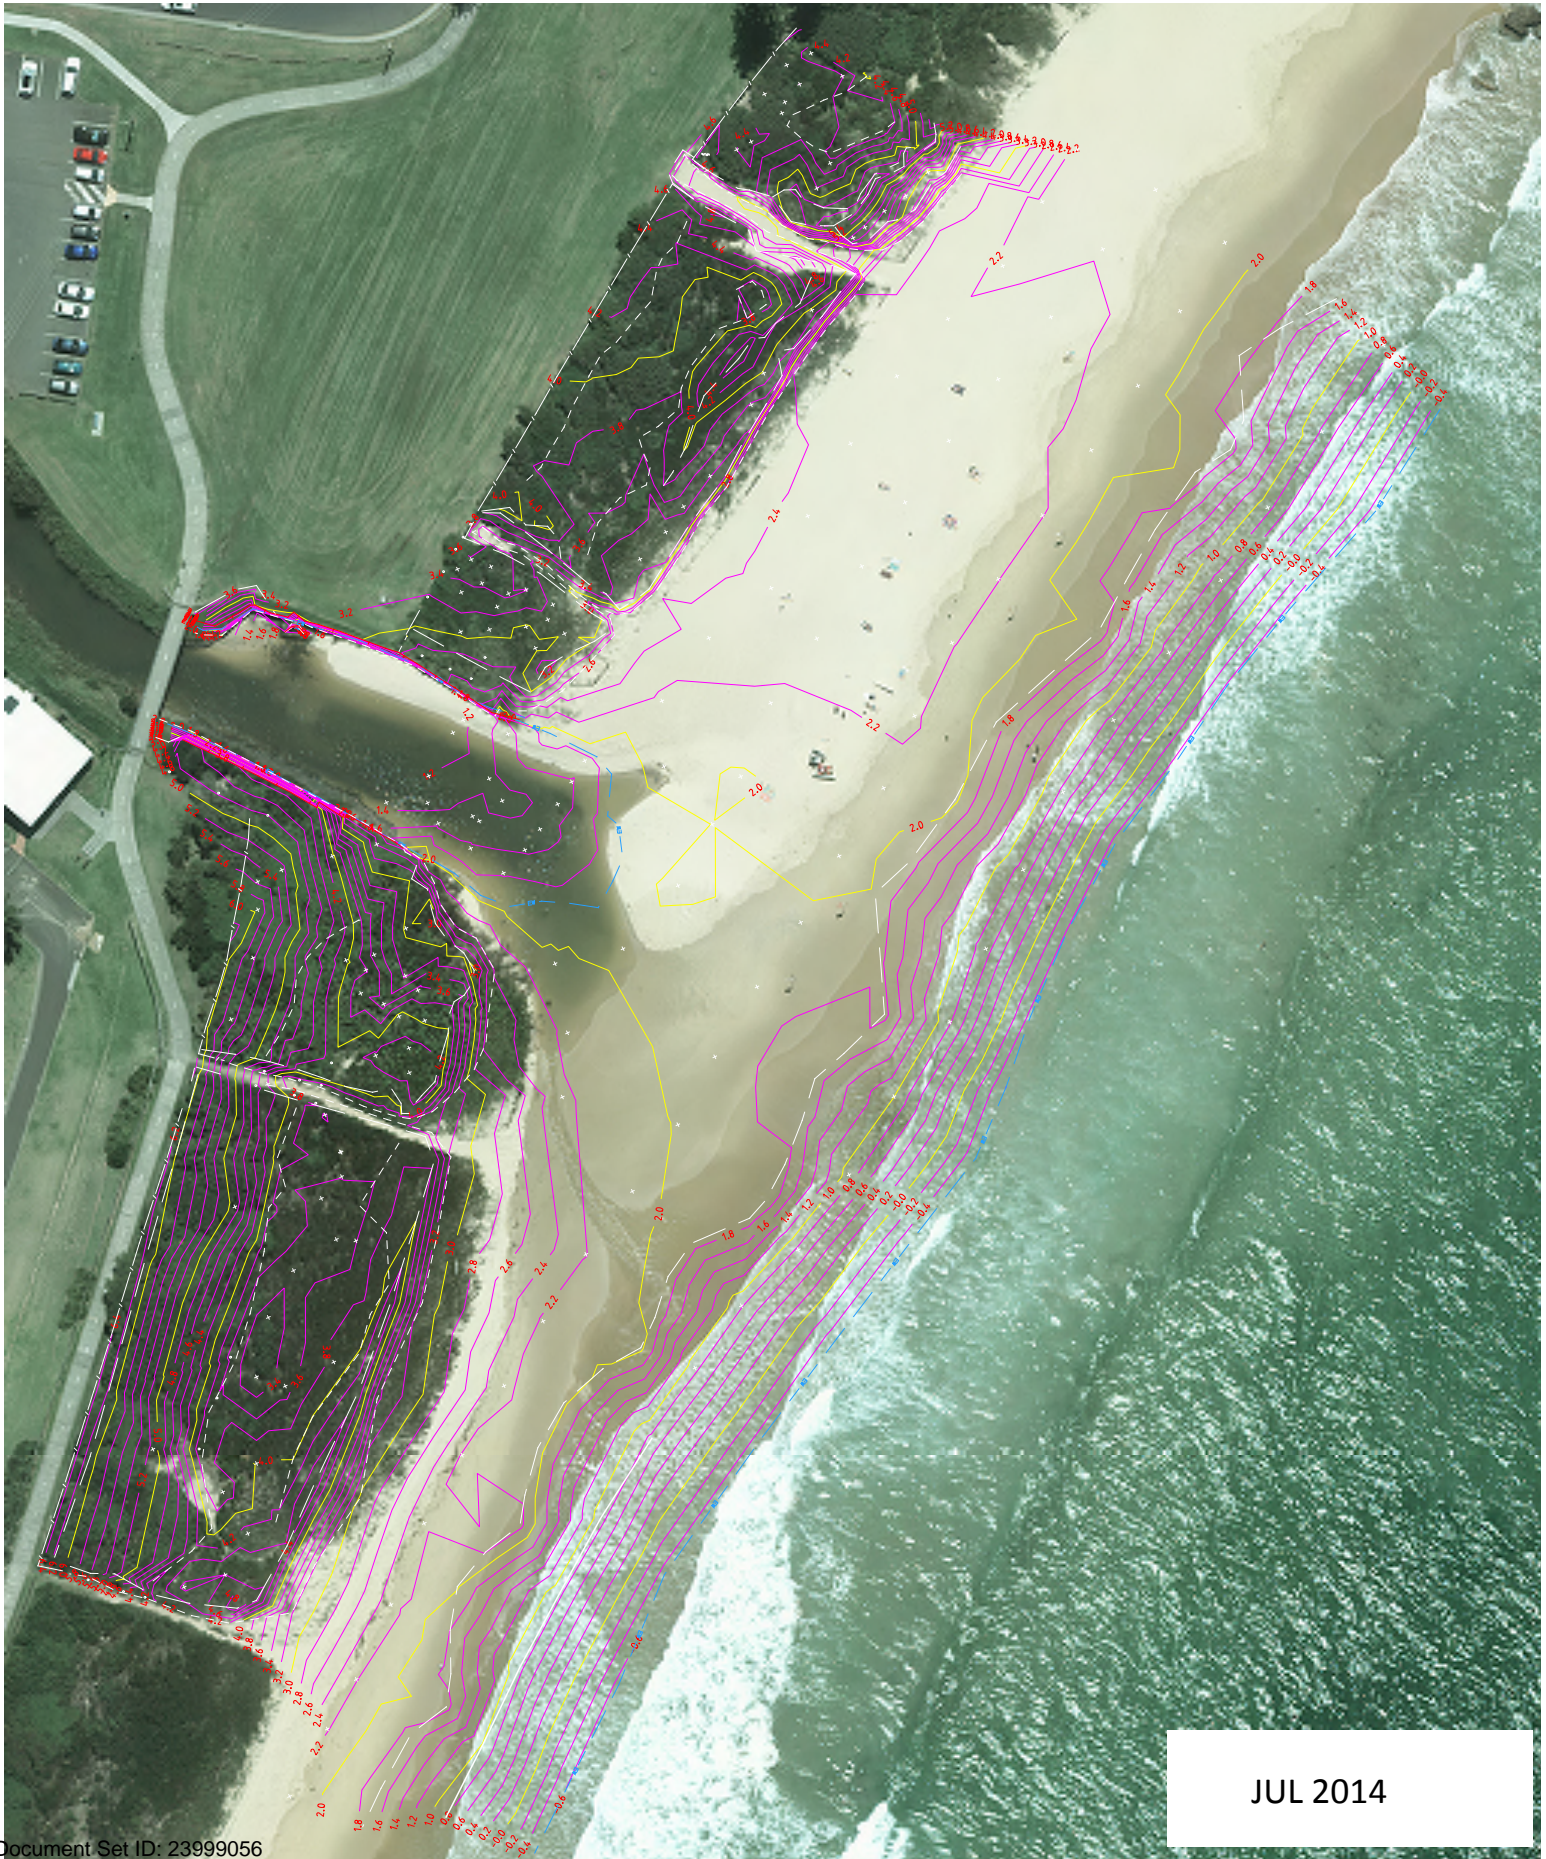
JUL 2014

WCC carried out topographic surveys at approximately one month intervals at the entrance to Whartons Creek between July 2014 and June 2015. A copy of these surveys follows.
