Information Synthesis Report

Lake Illawarra

June 2019

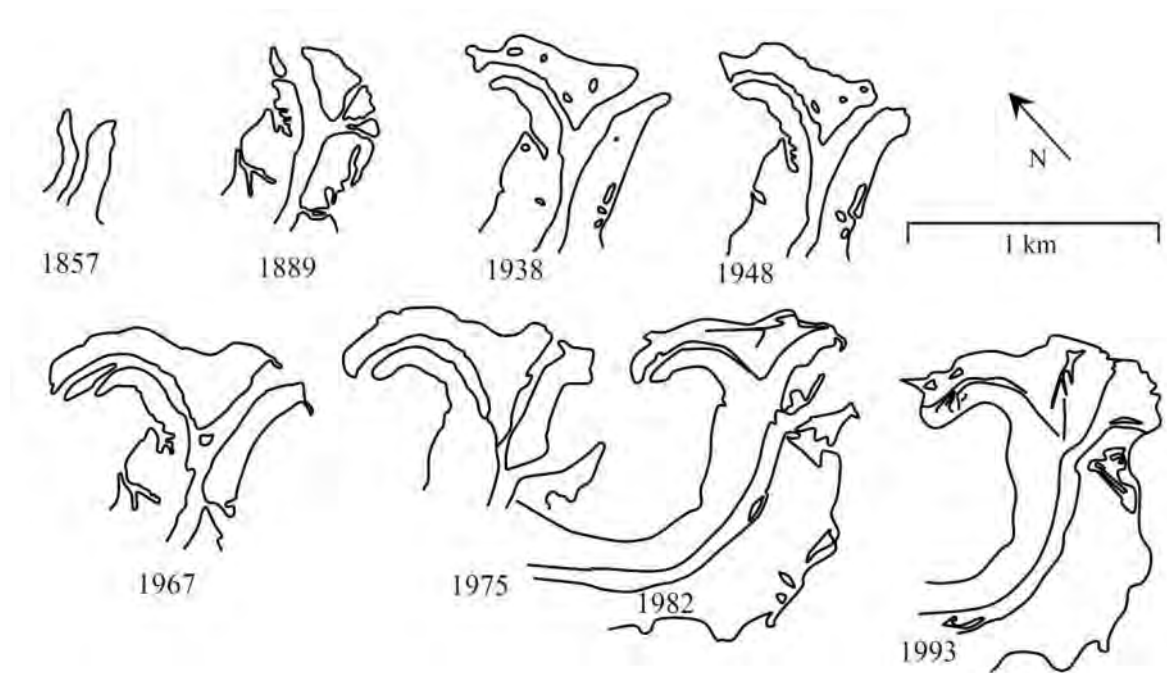
Figure 2-4 Macquarie Rivulet delta, demonstrating dramatic growth in response to increased sedimentation rates associated with post-European land use (Sloss et al, 2004)*

delta is a recent landform, as the elevated rates of sedimentation post 1850's resulted in significant delta growth (Sloss et al., 2004). Hopley et al. (2007) and Hopley (2013) have since quantified the impacts of catchment modifications to both the Mullet and Macquarie rivulet deltas. Sedimentation rates have also been established based on higher resolution geochronological analysis, and it has been found that sedimentation rates fluctuate with time and variable land use Hopley et al. (2007) and Hopley (2013).

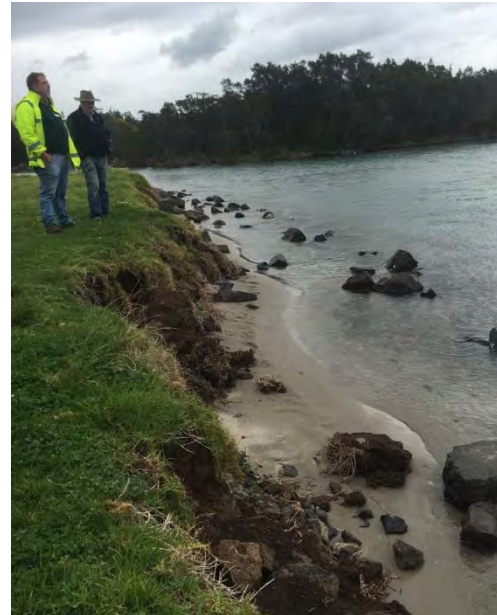
Figure 2-5 Examples of Erosion near Reddall Reserve

Since the completion of the audit described above, the Lake itself has continued to respond to the changing tidal regime and erosion continues to increase, particularly within the entrance channel on the Windang Peninsula. There was also a large east coast low Event in June 2016 which resulted in significant erosion in a number of locations including, Windang, Boonerah Point, Deakin Reserve, Ski way Park and Reddall Reserve. In this case, the foreshore condition and bank erosion mapping given in the LI CMP may not have captured all recent erosion events. Other studies have also been

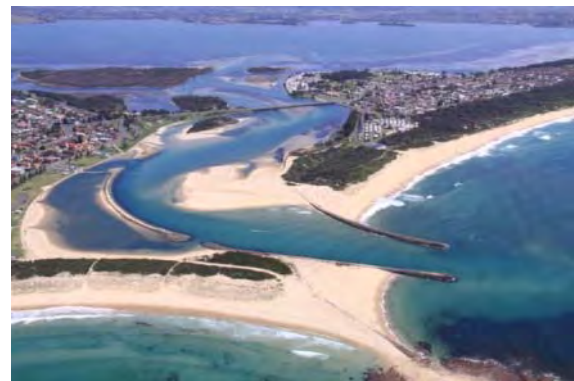
2009: trained entrance, with twin breakwaters and southern training wall fixing the entrance opening position.

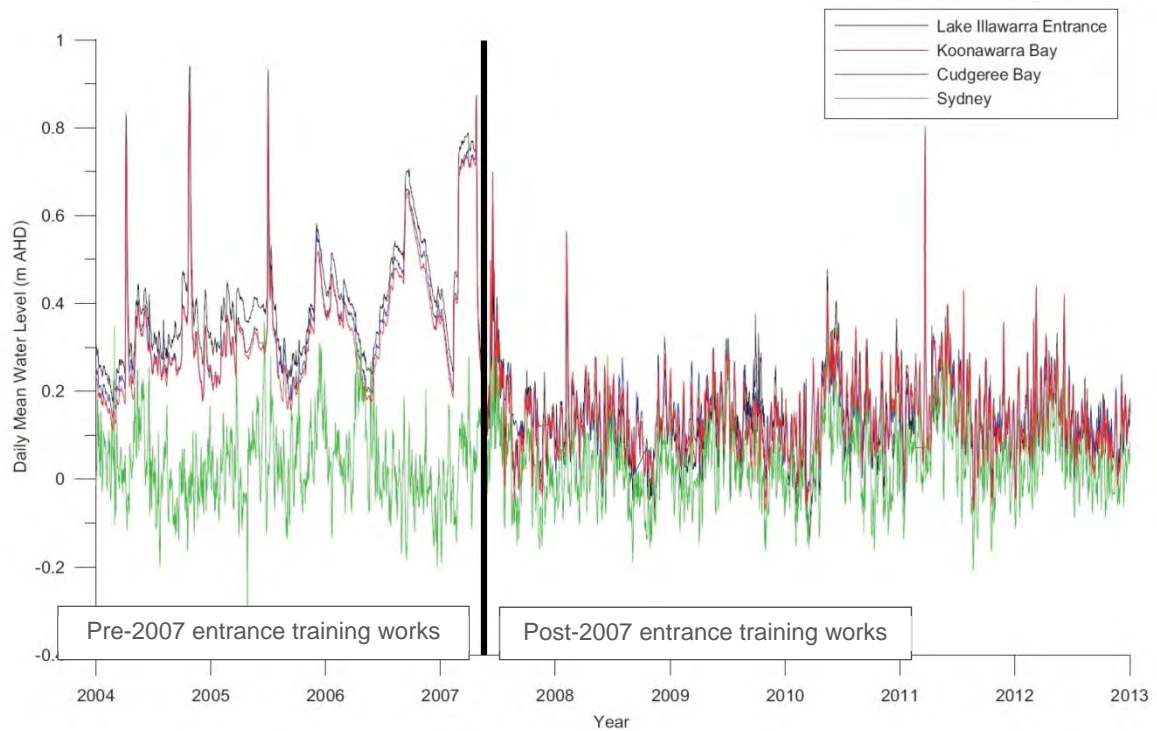
Figure 2-9 Daily water levels within the Lake, pre-and post-entrance training, relative to Sydney Ocean Tide levels (Source: MHL, 2013)

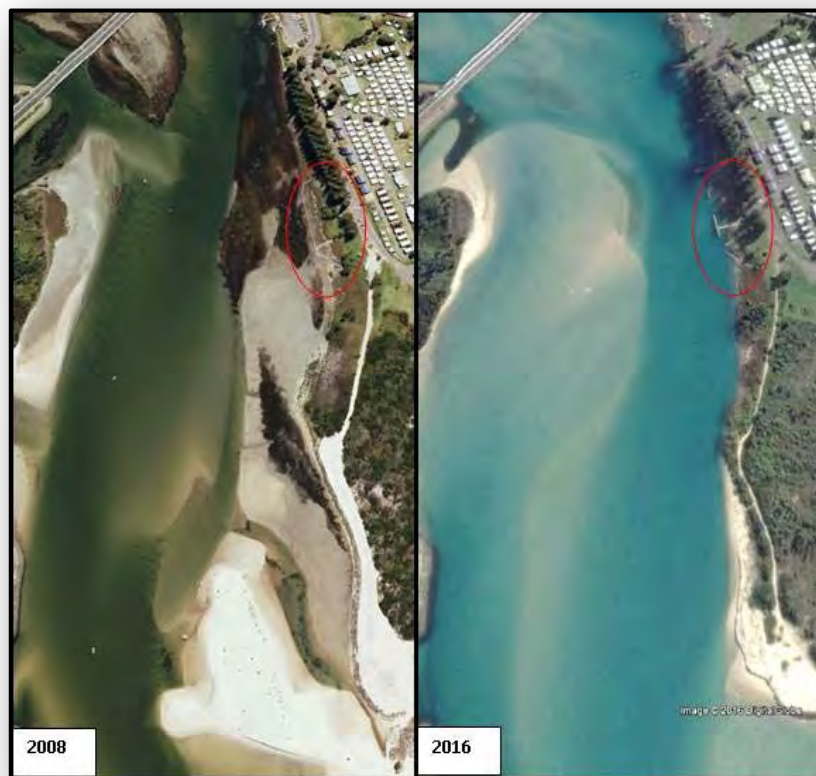
Figure 2-10 Shoreline erosion downstream of Windang Bridge (Source Wiecek *et al.*, 2016)

- More recent observations have shown how scouring is continuing to increase rapidly in front of the groynes along the Windang foreshore, along the southern breakwater, and underneath the northern portion of Windang bridge where management works are now required to ensure the bridge pylons aren't undermined. Foreshore erosion is also occurring along Berageree, Bevans and Picnic Islands, as well as significant movement of shoals either side of Windang bridge and along the Windang foreshore west of the bridge, due to ongoing channel adjustments. These changes in entrance morphology are continuing to have impacts on both built and natural assets.

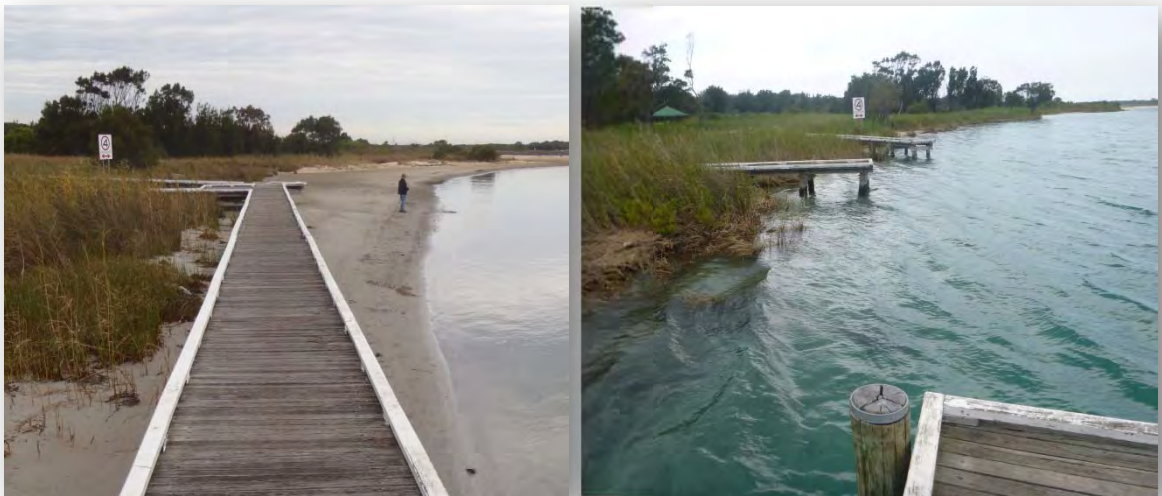
Figure 2-11 Damage to sections of the boardwalk downstream of Windang Bridge, showing sections of a boardwalk that have been removed due to piles being undermined from tidal scour (2012 -2015) (Source Wiecek et al., 2016)

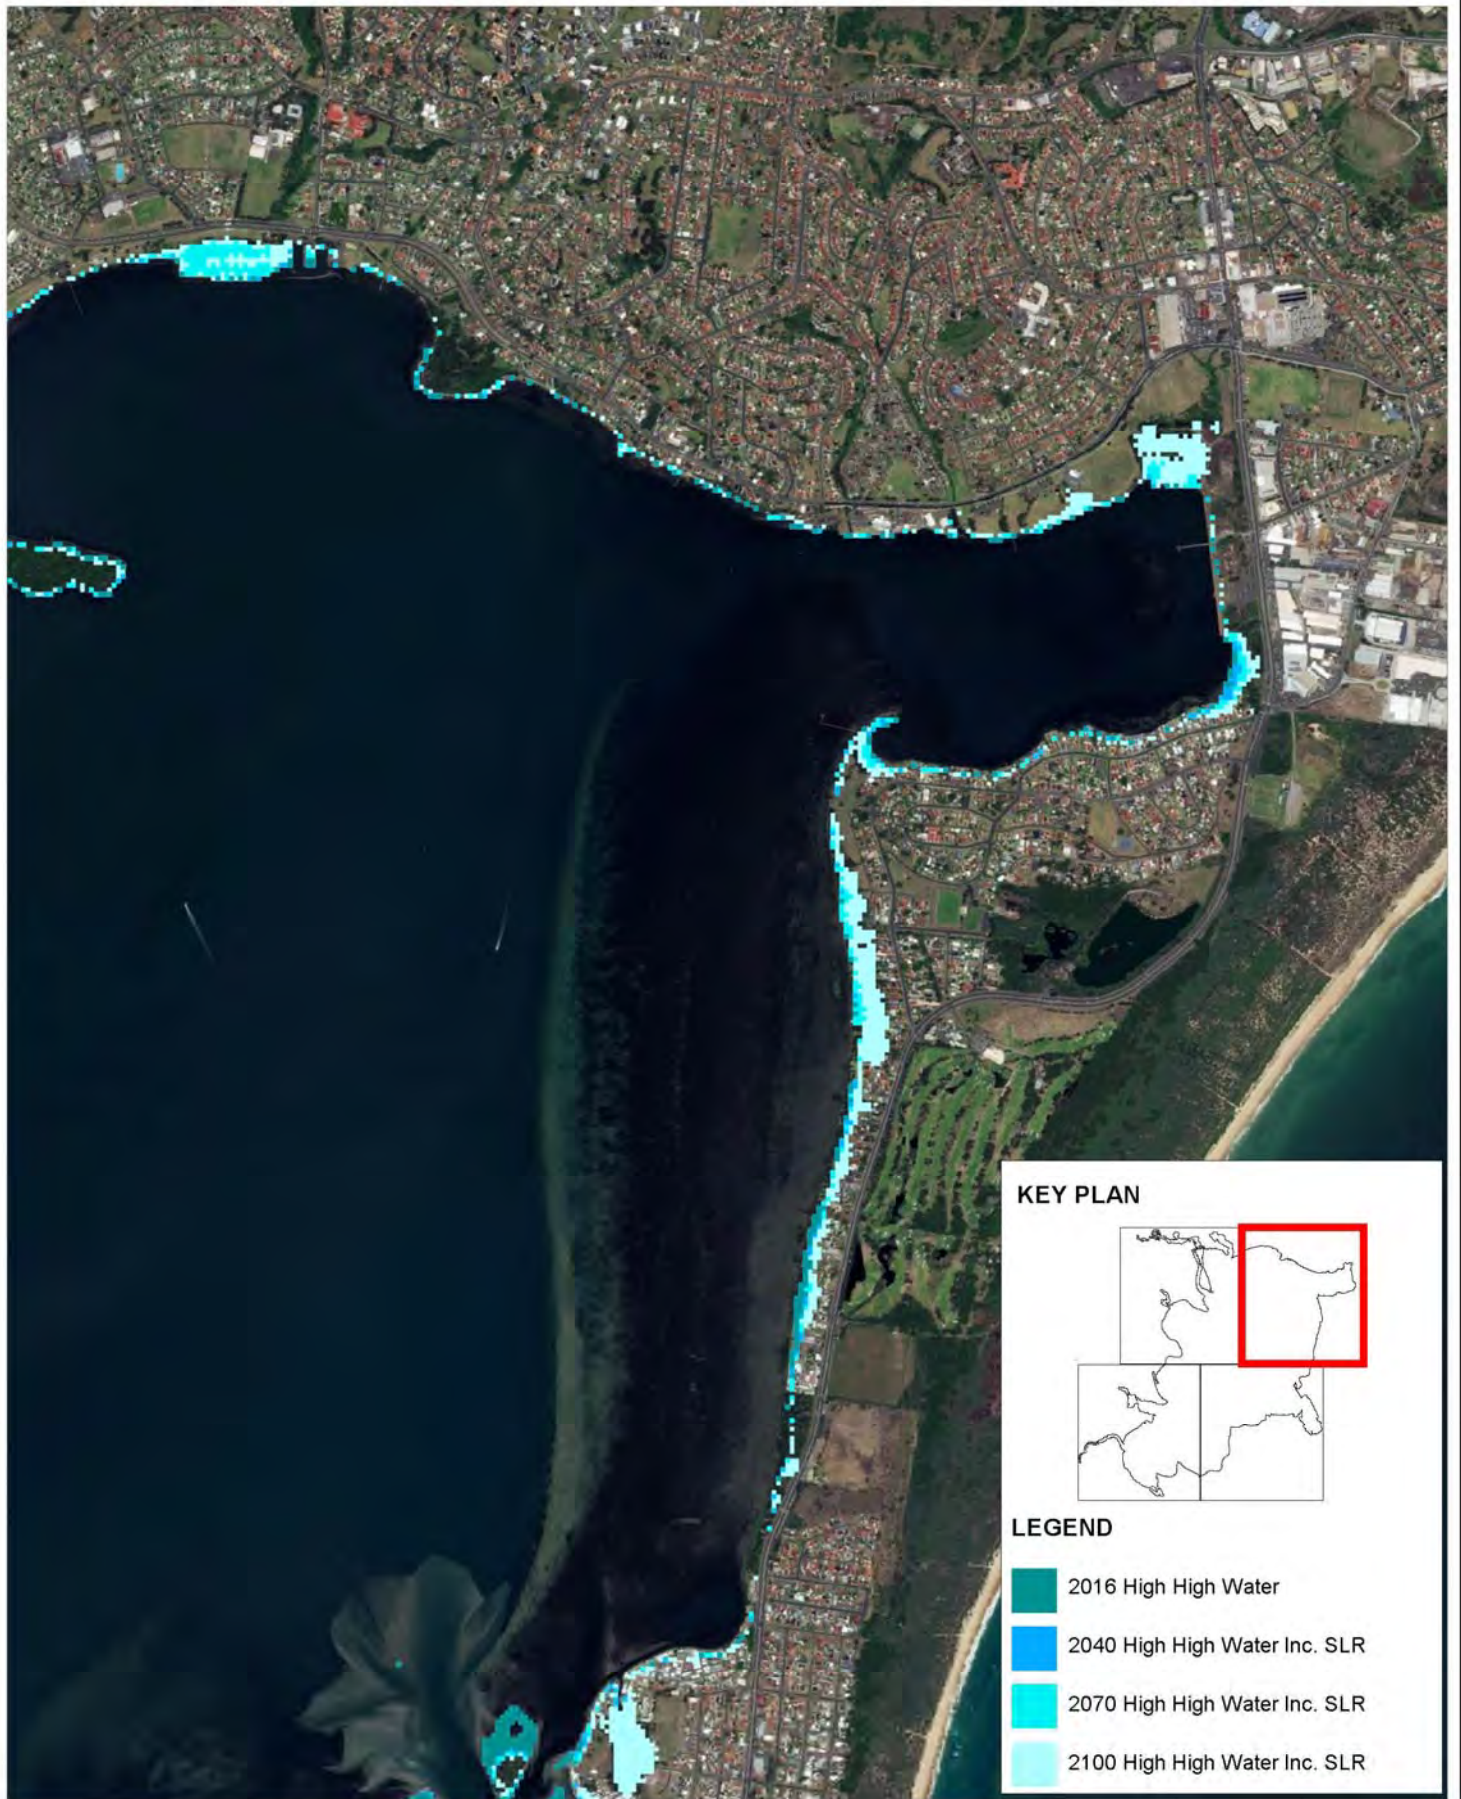
Title:
Tidal Inundation Model Extents for 2016, 2040, 2070 and 2100

² Tidal range (TR) increases were determined by Wiecek et al (2016) analysis of measured tidal data from Lake Illawarra since permanent entrance opening. The decelerated TR scenarios are taken as half the expected TR increase expected for the tidal planes, i.e. Mean High Water Spring (MHWS) and High High Water Solstice Spring (HHWSS).
